WATER QUALITY MONITORING PROJECT FOR DEMONSTRATION OF CANAL REMEDIATION METHODS FLORIDA KEYS

Report of activities: September 7th, 2016

Florida Keys National Marine Sanctuary Steering Committee

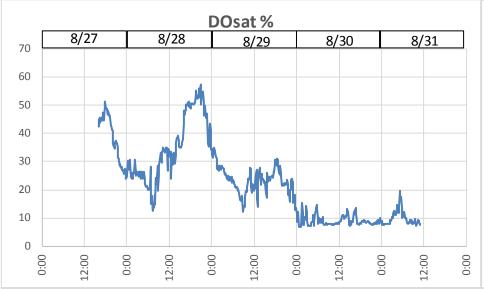
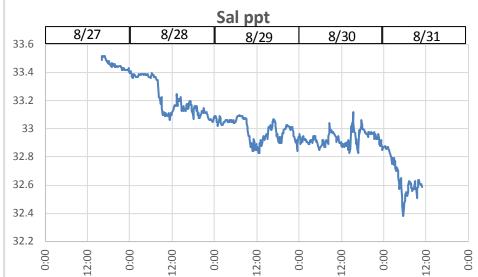
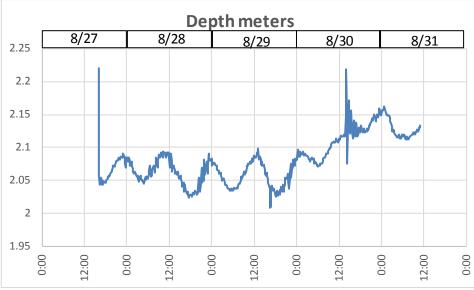
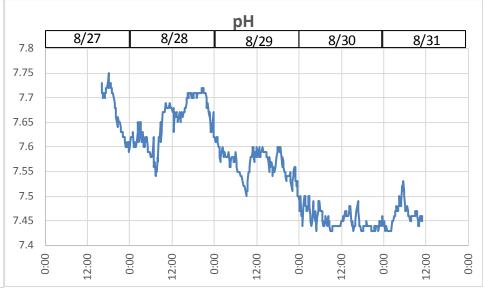
Canal #29. Remediation technology: Backfilling. Completed Jul-15

LEGEND
			Pre-rem	ediation	Post-ren	nediation		Above Target
			r-14	t-14	-16	r-16	3-16	Below Target
			31-Mar	16-0ct	4-Feb-	28-Apı	27-Aug	Oxygenation has improved significantly
	Surface	29						in bottom waters of
% Dissolved	water	Control 28						the remediated canal.
Oxygen Saturation	Bottom	29						Bottom DO declined in Aug 2016 due to storm
Sata: deloi!	water	Control 28						Hermine.

- Surface waters well oxygenated before and after remediation
- Surveys show increase %DO saturation in shallower new bottom waters after the canal's depth was risen from 35 feet to 8 feet
- Rain and wind during TS Hermine may have caused a drop in %DOSat

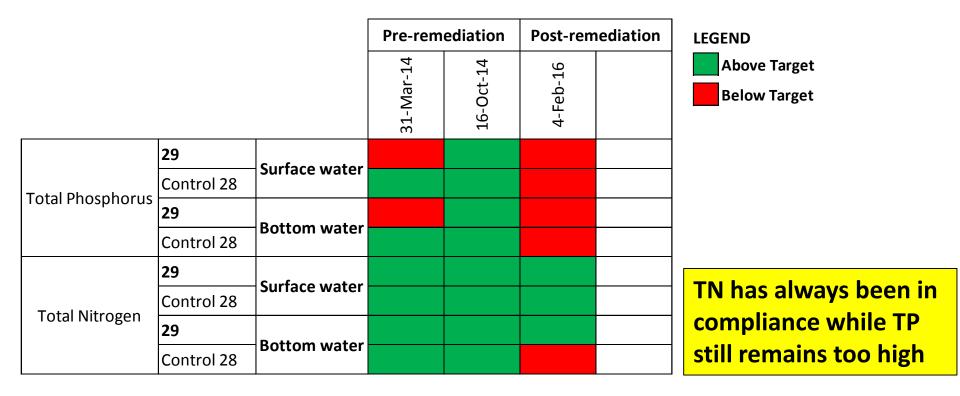
Canal #29. Remediation technology: Backfilling. Completed Jul-15

- Pre-remediation and first post-remediation surveys rendered TP concentrations out of compliance
- Surface and Bottom TN concentrations in compliance in all events before and after remediation

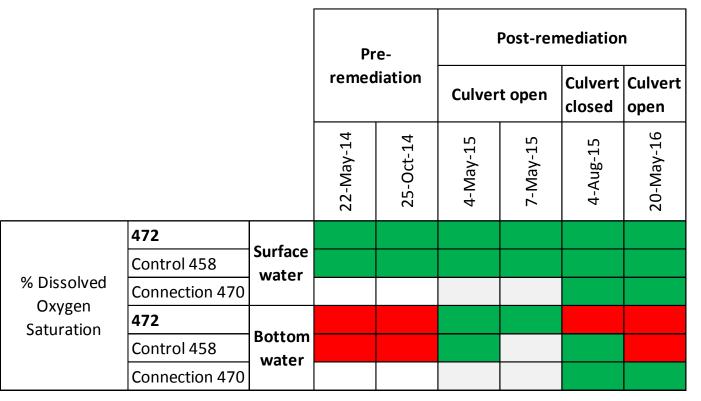
Canal #472. Remediation technology: Culvert installation. Completed May-15 and was closed shortly after, unplugged May-16

Mixed results. No definitive improvement trend for bottom waters after re-opening culvert

- Surface waters well oxygenated during monitoring before and after remediation.
 Heavy seaweed build up observed in late May 2015
- %DO saturation increased in bottom waters of remediated canal when culvert was opened the first time indicating an enhancement of natural tidal flushing

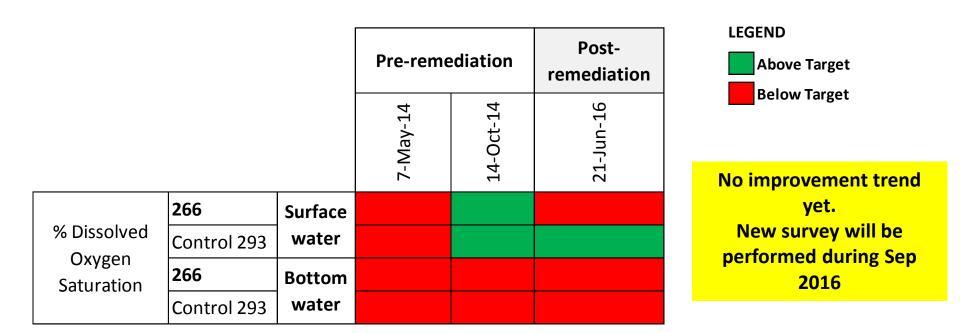
Canal #266. Remediation technology: Weed barrier/organic removal. Completed May-2016

- Pre and post-remediation surveys showed highly variable %DO saturation in surface waters
- Pre and post-remediation surveys rendered %DO saturation in bottom waters out of compliance

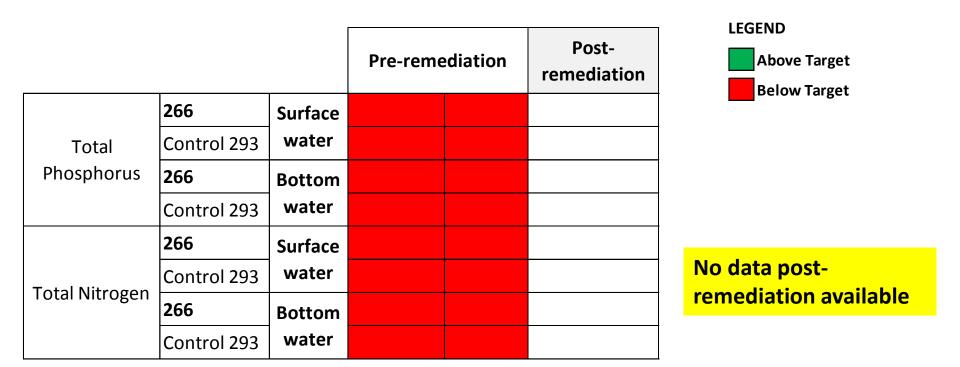
Canal #266. Remediation technology: Weed barrier/organic removal. Completed May-2016

Surface and Bottom waters rendered TP and TN concentrations out of compliance before remediation

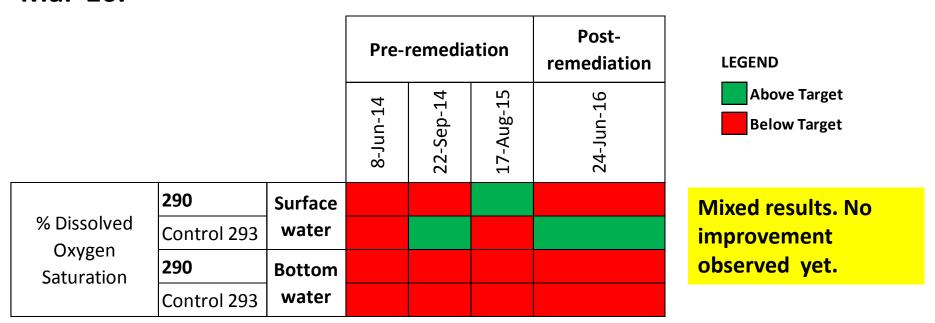
Canal #290. Remediation technology: Organic removal. Completed Mar-16.

- Surface waters do not meet %DO saturation target either in most events during monitoring before or after remediation. Notice that an existing air curtain weed gate owned by the homeowners was reinstalled, but some seaweed has entered the remediated canal
- Vacuum dredging was usd to remove 5 feet of organic muck. Following removal of the muck, a 6-inch sand layer was added to allow for benthic habitat proliferation

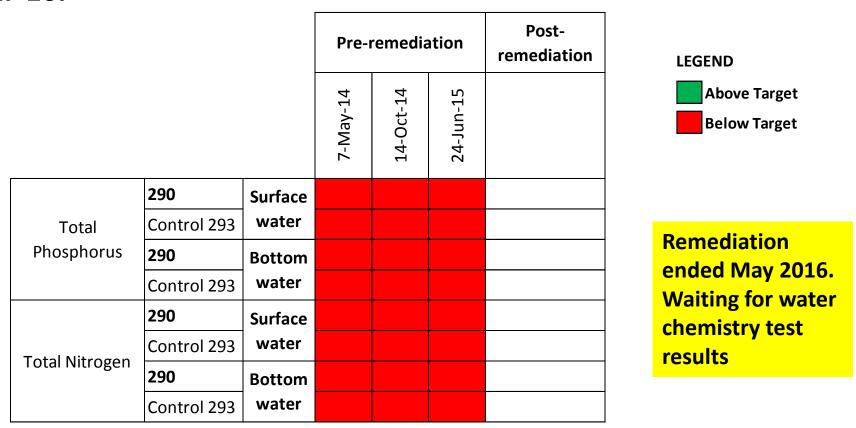
Canal #290. Remediation technology: Organic removal. Completed Mar-16.

- Surface and Bottom waters rendered TP and TN concentrations out of compliance before remediation
- Beginning of chemical analyses to occur 6 months after remediation.

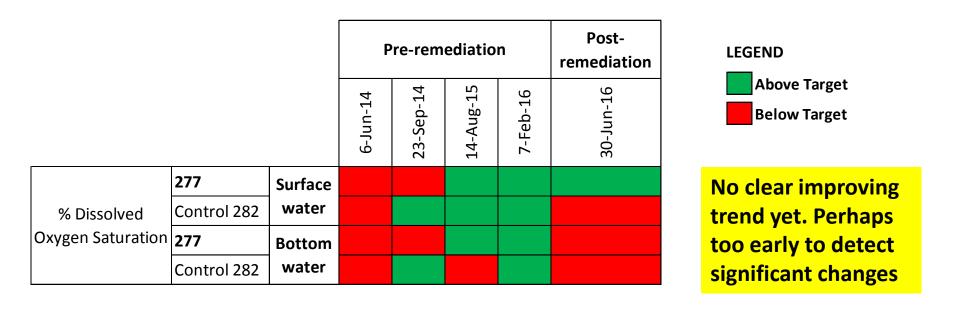
Canal #277. Remediation technology: Culvert installation. 20-Apr-2016

- Surface waters well oxygenated most of the time during monitoring before and after remediation. Water clarity with fish visible at the culvert entrance (MC, Jun 2016), although no differences in turbidity in S/B water has been observed after remediation
- Abundant blue-green algae mats floating on surface (#282) and abundant floating manatee grass present in canal #277
- %DO saturation in bottom waters of remediated canal remains below target values approx.
 2 months after culvert was opened the first time

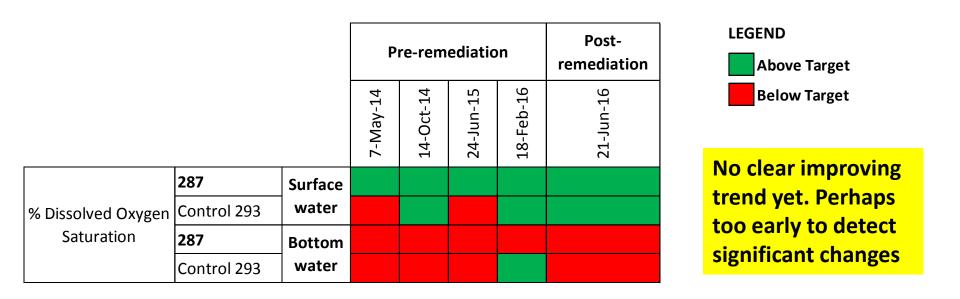
Canal #287. Remediation technology: Weed barrier. Completed Jun-16

- Surface waters well oxygenated during monitoring before and after remediation.
- %DO saturation in bottom waters of remediated canal remains below target values two weeks after the installation of the air curtain weed gate. Lots of suspended organic debris, settled on floats and sondes

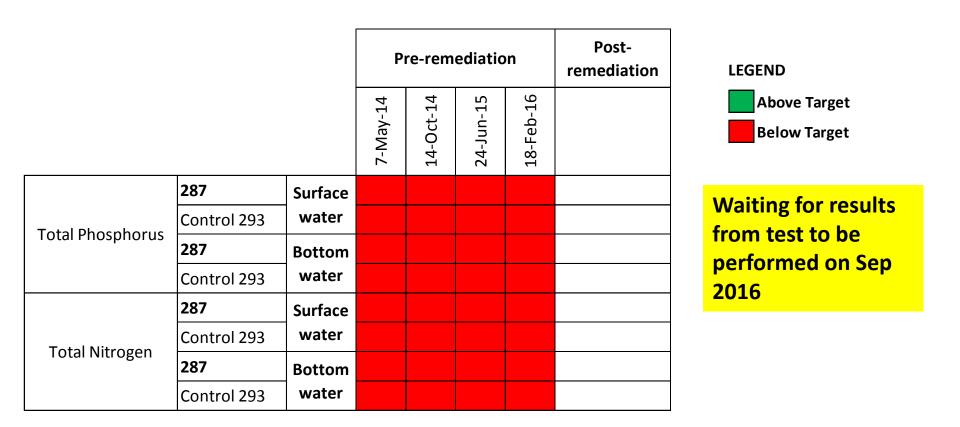
Canal #287. Remediation technology: Weed barrier. Completed Jun-16

Surface and Bottom waters rendered TP and TN concentrations out of compliance before remediation in both, control and treated canal
