Aerial Mapping and Monitoring Techniques Applied by SWFWMD for Seagrass, Swamps, and Coastal Wetland Habitats

Surface Water Improvement and Management Program (SWIM)

Overview

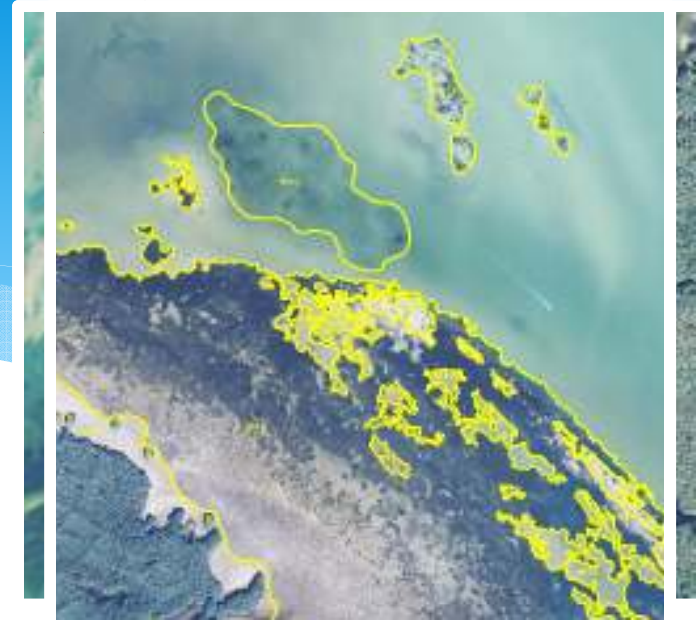
2014 Seagrass Mapping Area of Interest

South West Florida WMD
2852 Tiles, ~ 2539 sq. miles

South Florida WMD
370 Tiles, ~ 330 sq. miles

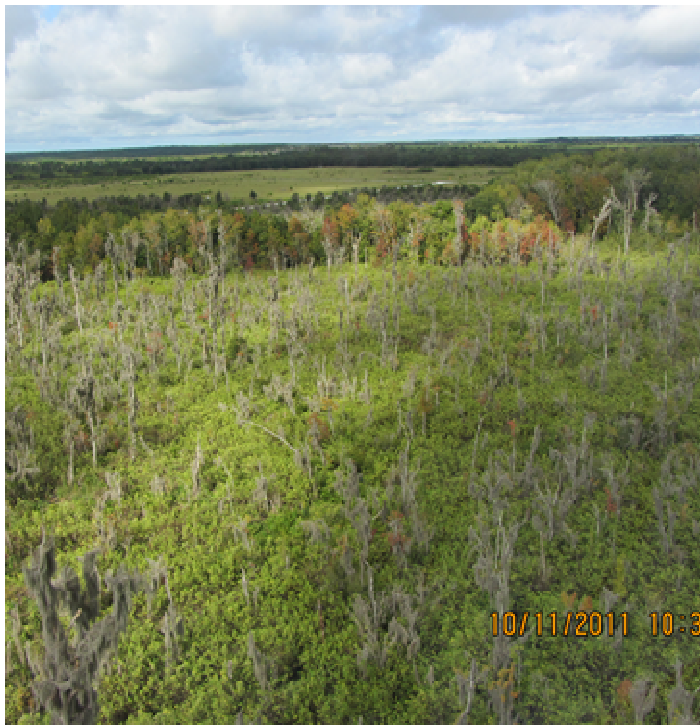
Future Efforts

- * Challenging location to map/poor site access
- * Pilot HD Video with GPS tracking complete
- * Mapping expected to continue in conjunction with hydrologic restoration

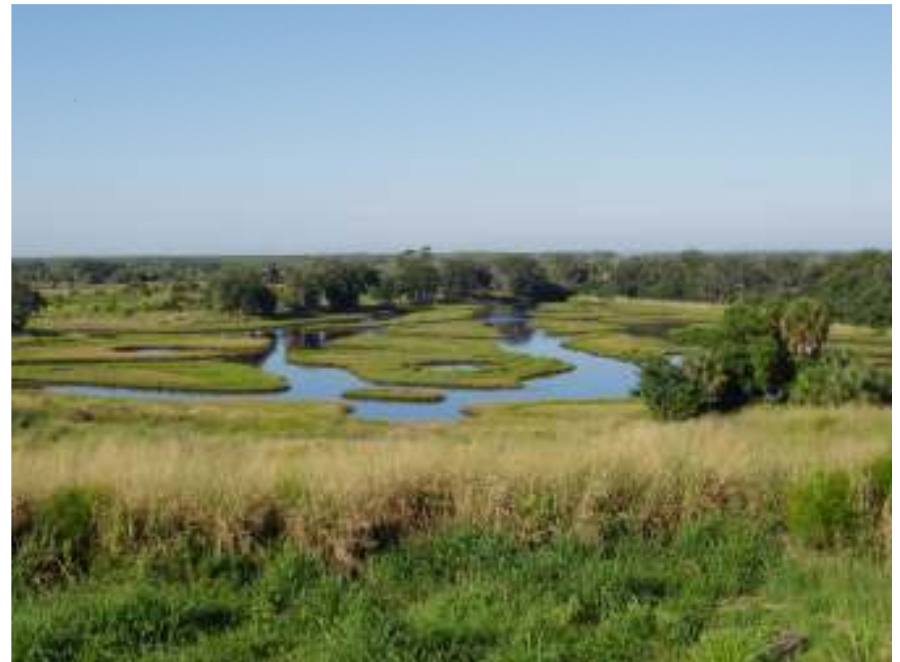
Topo-Bathymetric LiDAR for Coastal Restoration

- * Restoration requires re-grading
- * Accurate topographic information is needed
- * Sabal Palm trees greater than 6' to be mapped for relocation efforts

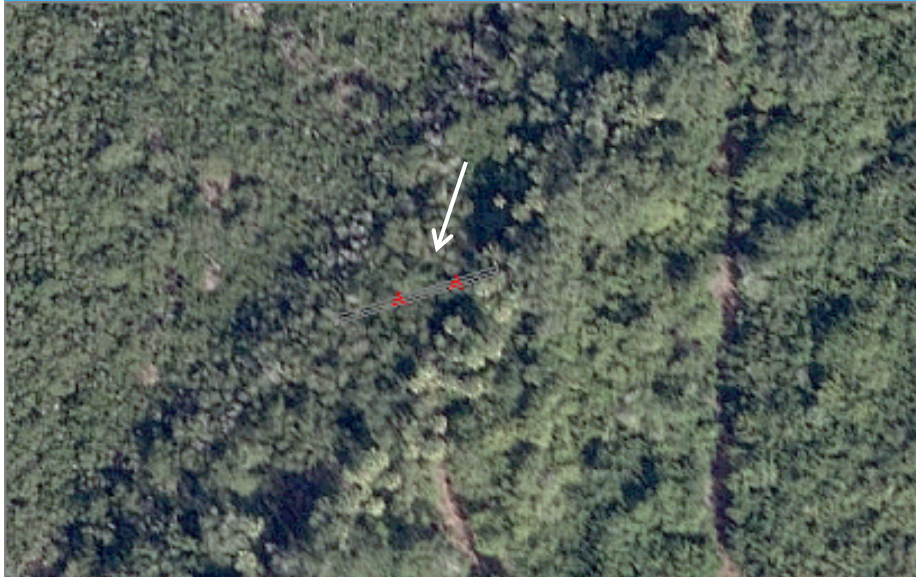
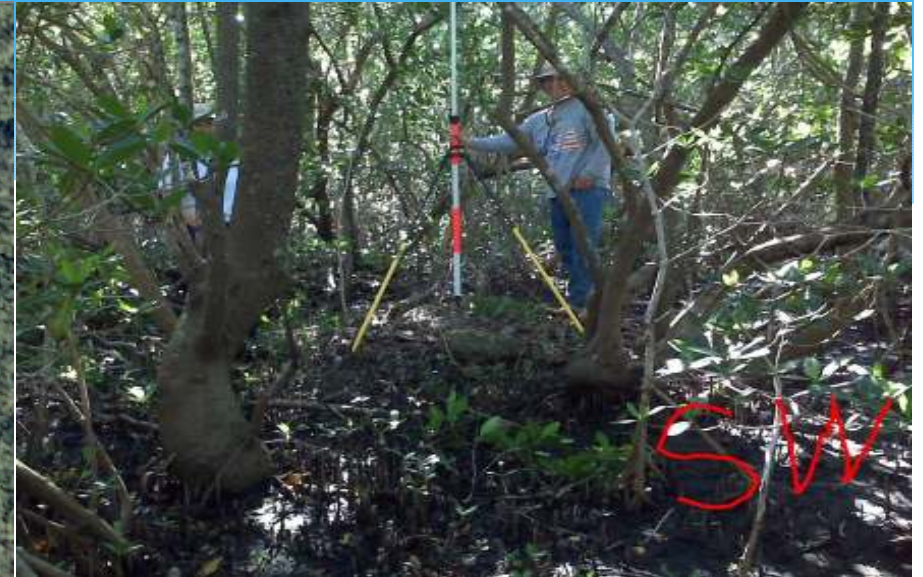
Ground Check Points (Dense Vegetation)

General Accuracy Results

- * The vertical accuracies obtained from both the LMS VQ-820-G and LMS Q680i completely met the Fundamental and Supplemental Vertical Accuracies required for this restoration project,

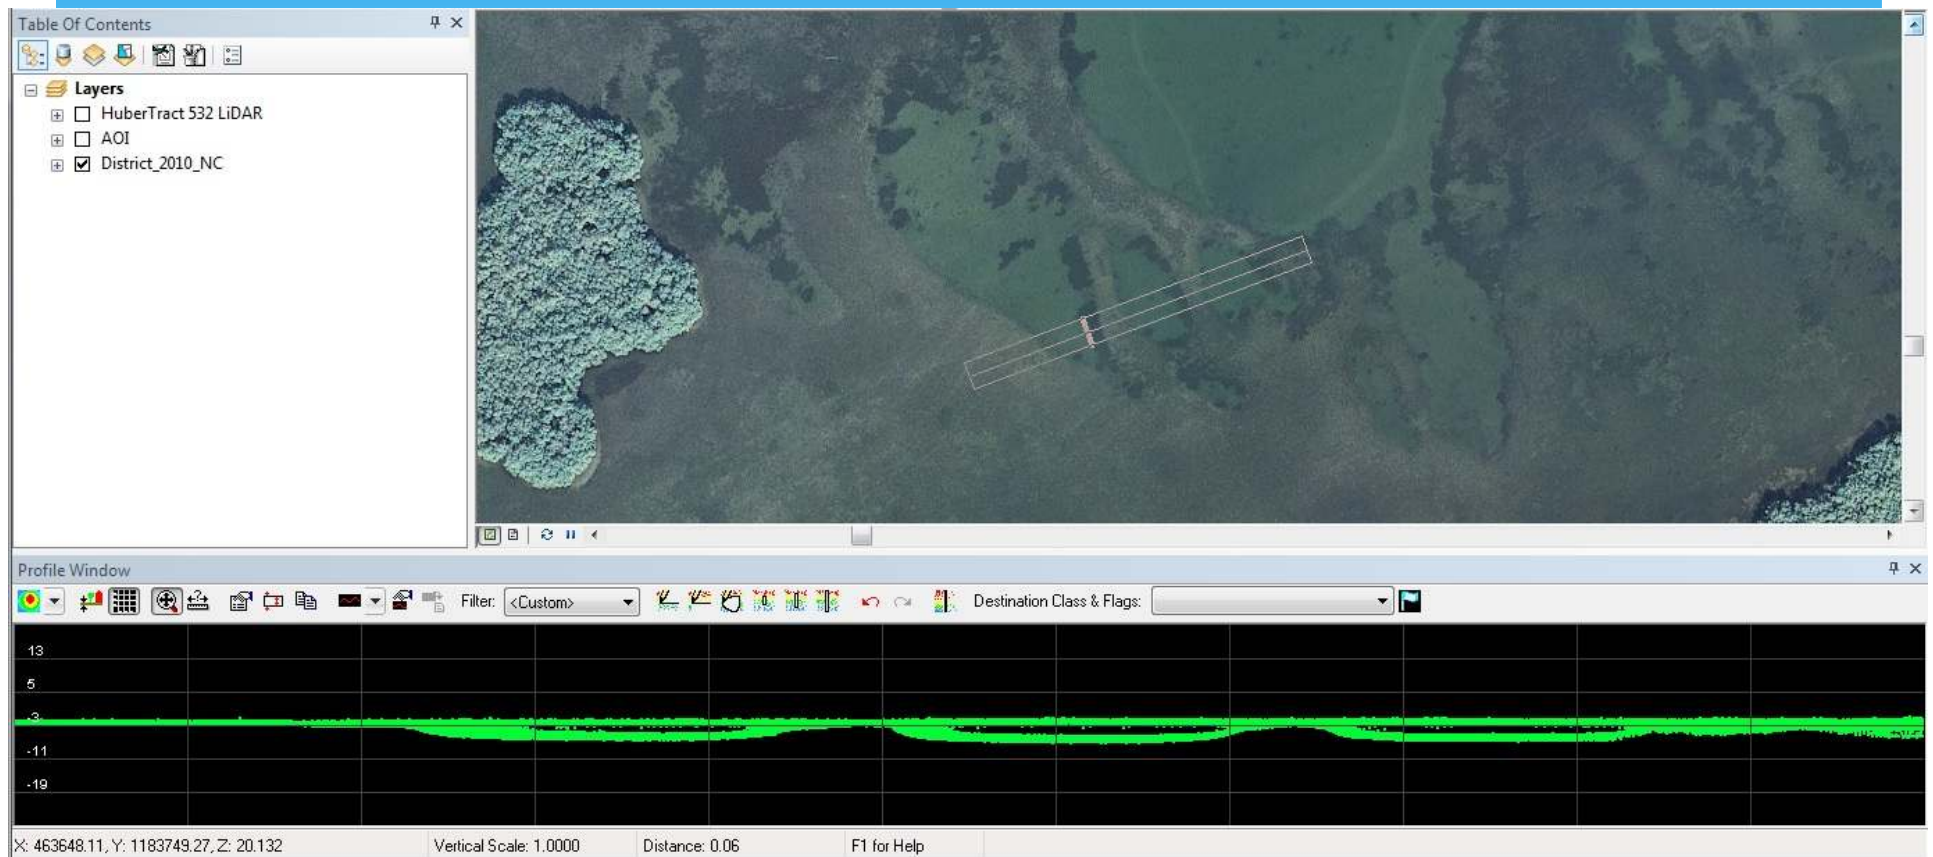
Near-Offshore Bathymetric Results Huber Tract

Off-shore deep-water pools ~ 1.5m below surface

- * The LMS VQ-820-G laser penetrated the water surface of the borrow pit to a depth of one Secchi Disk. The laser penetrated the clear, Terra Ceia Bay water and defines both sea grass beds and oyster bars, and

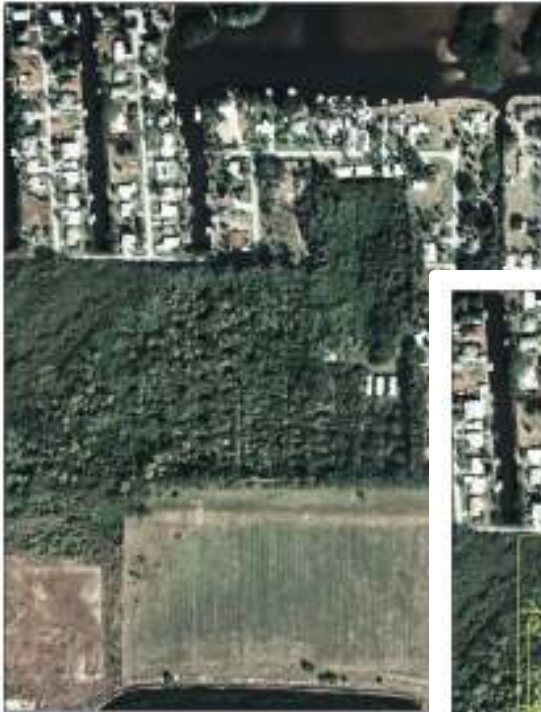
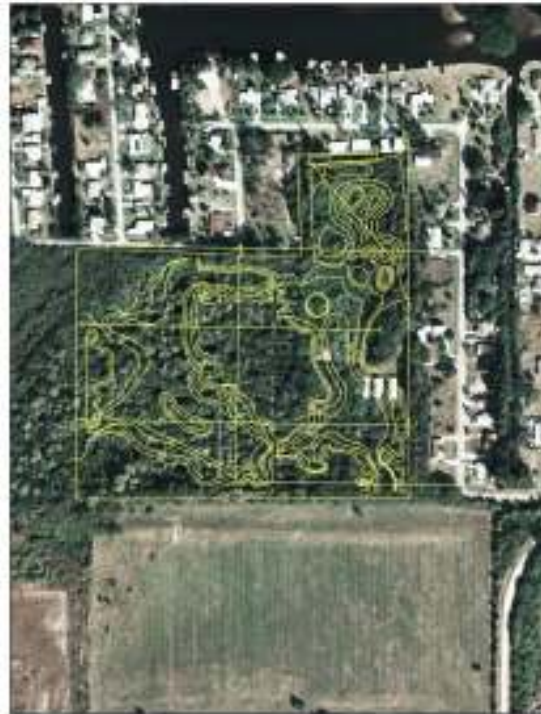
Establish a Baseline

- * Digitize and georeference design plans
- * Create photostations
