# **WATER QUALITY MONITORING**

## **Demonstration of Remediation Methods**

**Florida Keys Canals**  
**10-28-2016**

Henry O. Briceño  
Florida International University  
Southeast Environmental Research Center

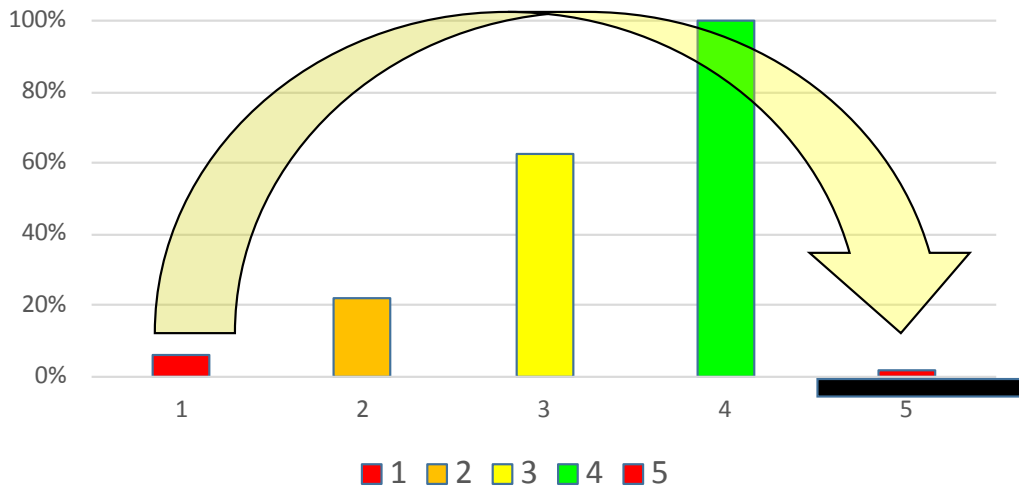
### Big Pine, Tropical Bay, Canal #277 Bottom

%DO Saturation Compliance

277A-Bottom 277A-Surface

6/6/2014	6%	1%
9/23/2014	22%	17%
8/14/2015	63%	100%
2/7/2016	100%	100%
6/30/2016	1%	26%

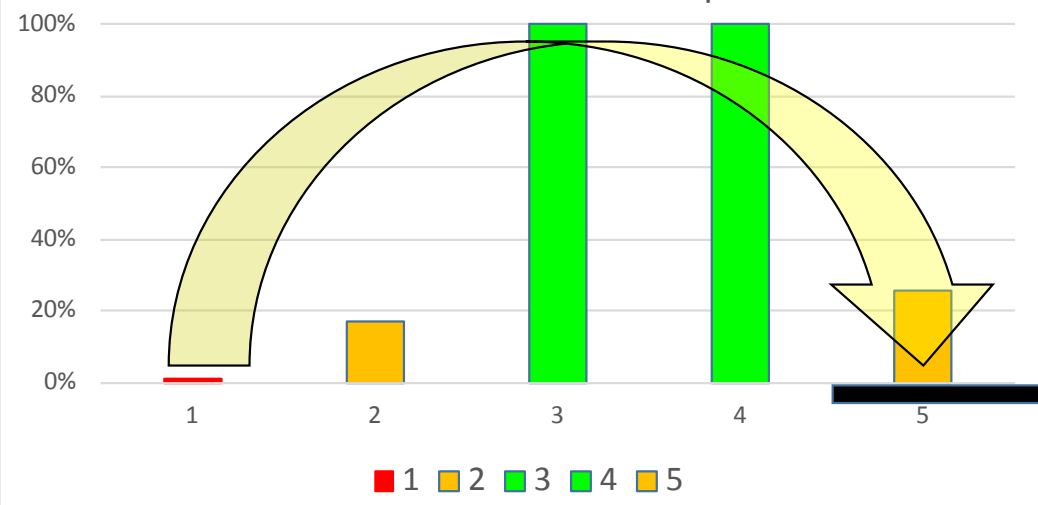
### Big Pine, Tropical Bay, Canal #277 Surface

%DO Saturation Compliance

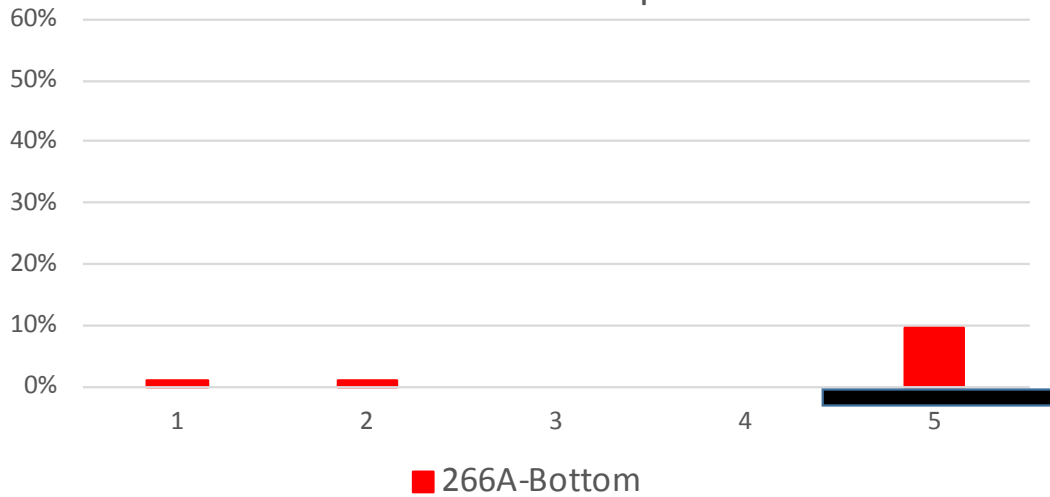
# Big Pine, Dr Arm Subdivision, Canal #266 Bottom

## %DO Saturation Compliance

### 266A-Bottom 266A-Surface

6/9/2014	1%	0%
9/24/2014	1%	68%
8/15/2015		
2/10/2016		
6/21/2016	10%	10%

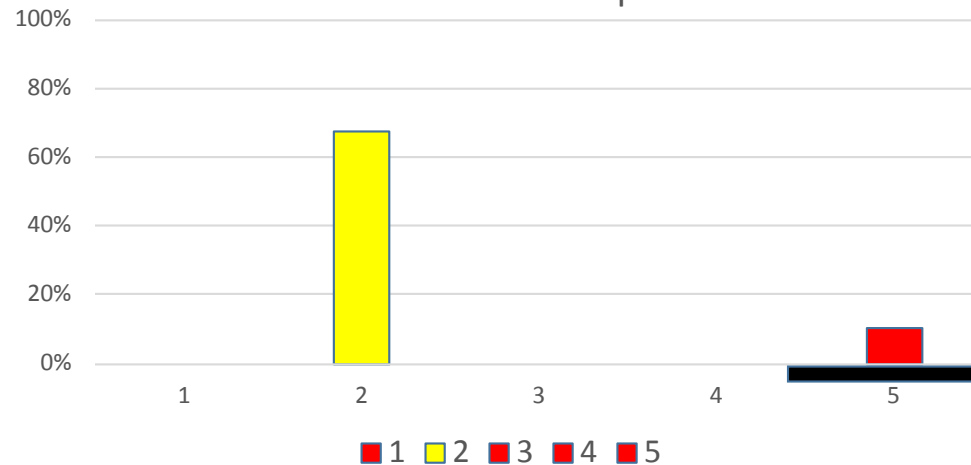
## Big Pine, Dr Arm Subdivision, Canal #266 Surface

### %DO Saturation Compliance

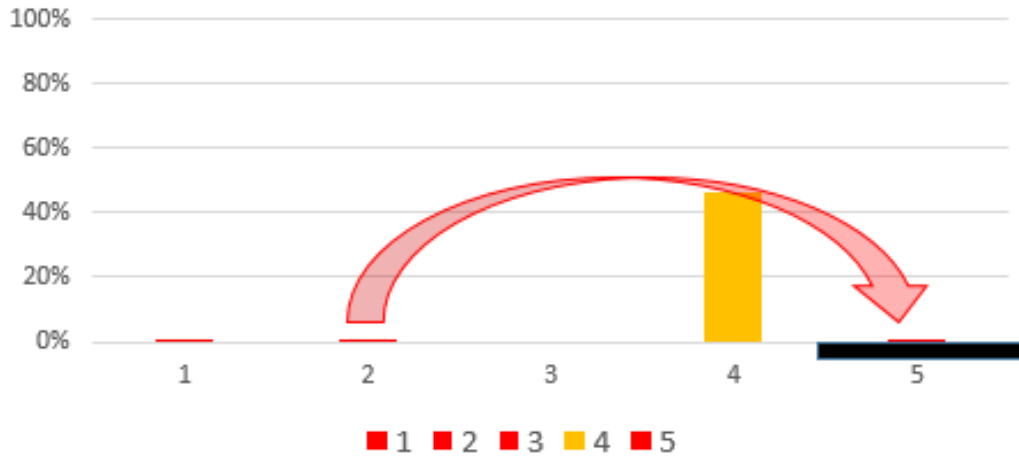
### Big Pine, Hollerich, Canal #287 Bottom %DO Saturation Compliance

### 287A-Bottom 287A-Surface

6/7/2014	1%	53%
9/23/2014	1%	82%
8/15/2015		
2/10/2016	46%	100%
6/21/2016	1%	73%

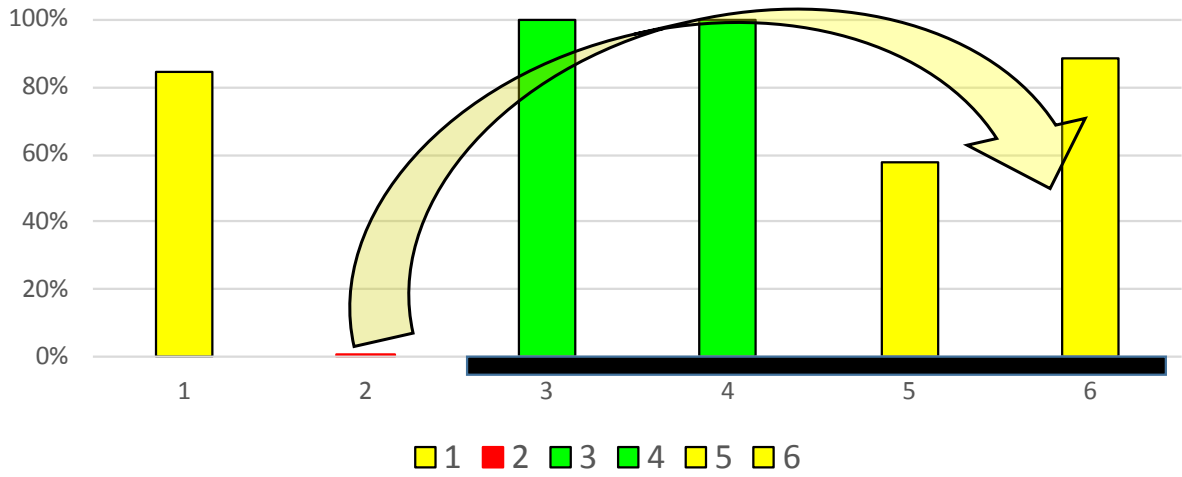
### Key Largo, Sexton Cove, Canal #29 Bottom %DO Saturation Compliance

29A Bottom	29A Surface
3/28/2014	84%	100%
9/12/2014	0%	100%
2/2/2016	100%	100%
4/28/2016	100%	100%
7/28/2016	58%	100%
8/1/2016	88%	100%

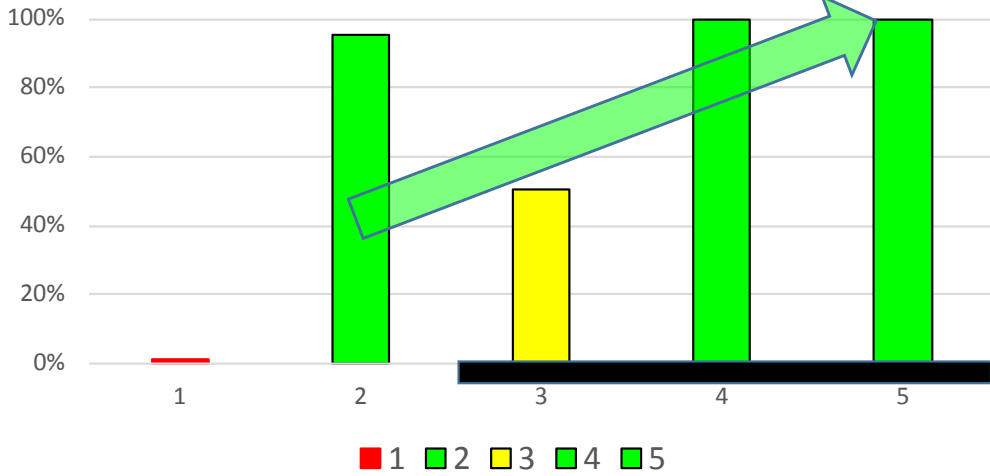
### Treasure Harbor, Canal #137 Bottom %DO Saturation Compliance

137A-Surface	137A-Bottom
4/2/2014	17%	1%
9/16/2014	100%	95%
7/30/2015	68%	50%
1/27/2016	100%	100%
7/19/2016	100%	100%

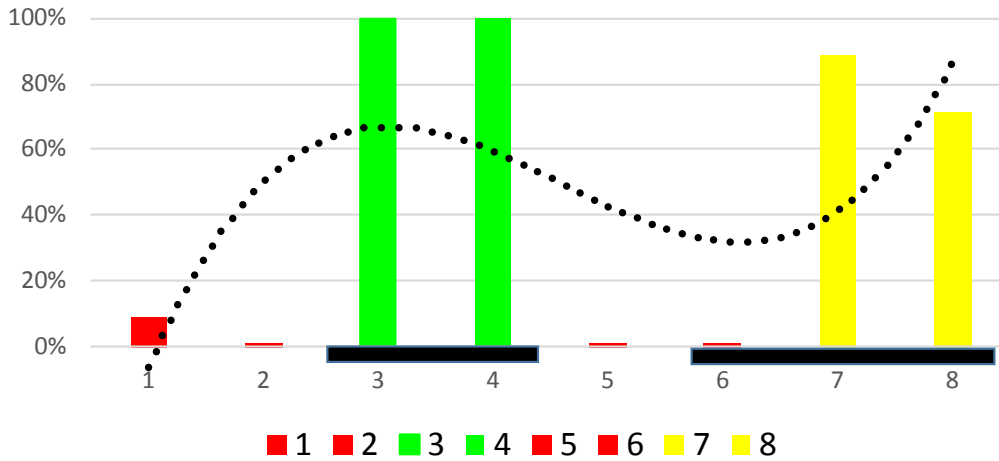
### Geiger Key, Boca Chica, Canal #472 Bottom %DO Saturation Compliance

472A-Bottom	472A-Surface
5/23/2014	9%	100%
9/25/2014	1%	100%
5/4/2015	100%	100%
5/7/2015	100%	100%
8/3/2015	1%	100%
5/16/2016	1%	99%
8/21/2016	89%	94%
8/21/2016	71%	100%
