FKNMS Benthic Habitat Monitoring Program May 2018 Report

**Water Quality Protection Program Steering Committee Meeting
May 22nd, 2018 – Marathon, FL**

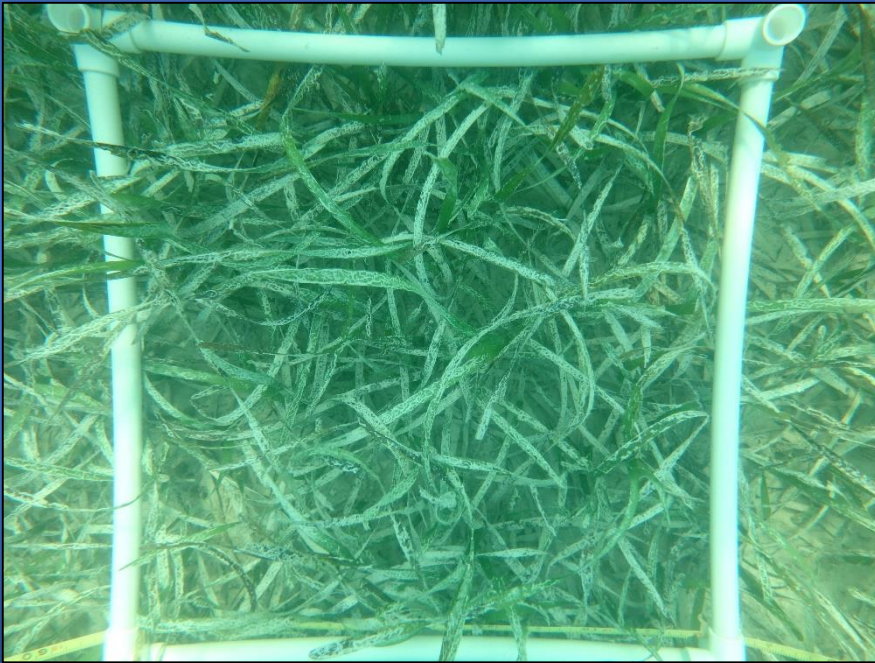
June 2017

Quadrats had lush Tt

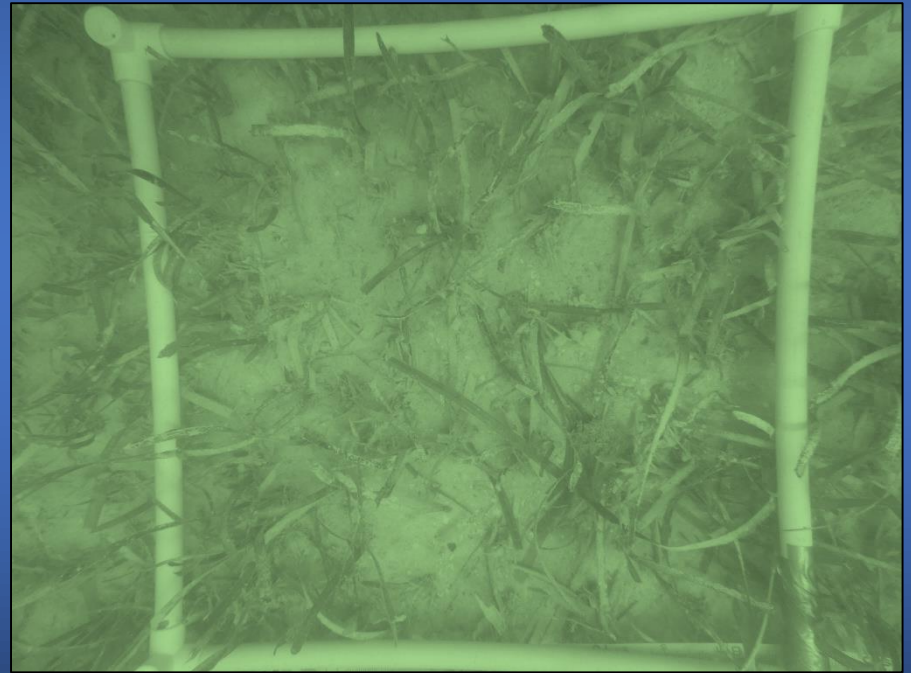
October 2017

> 30% of shoots in quadrat had leaves stripped away

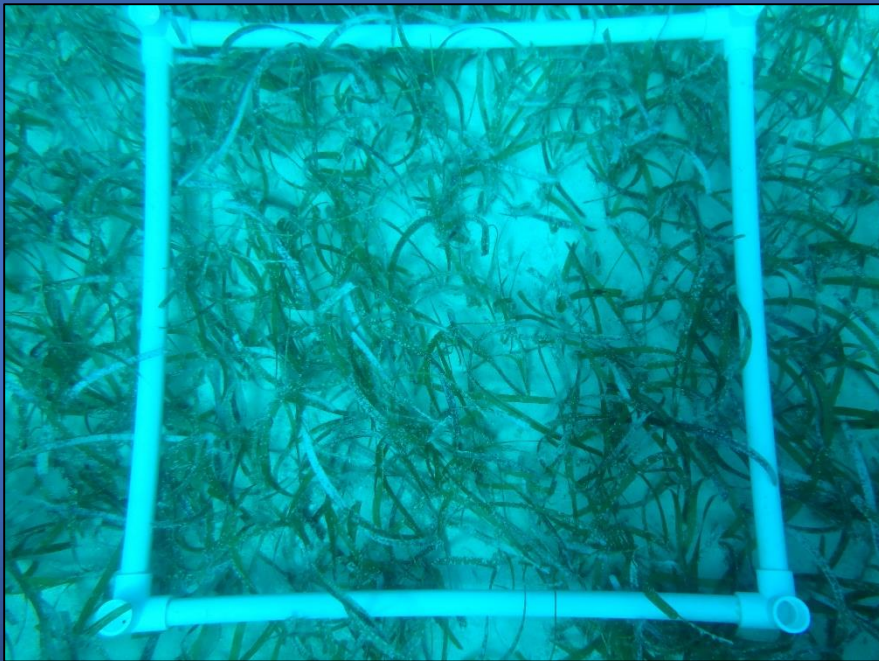
June 2017

Half of quadrats had lush Tt,
half were bare

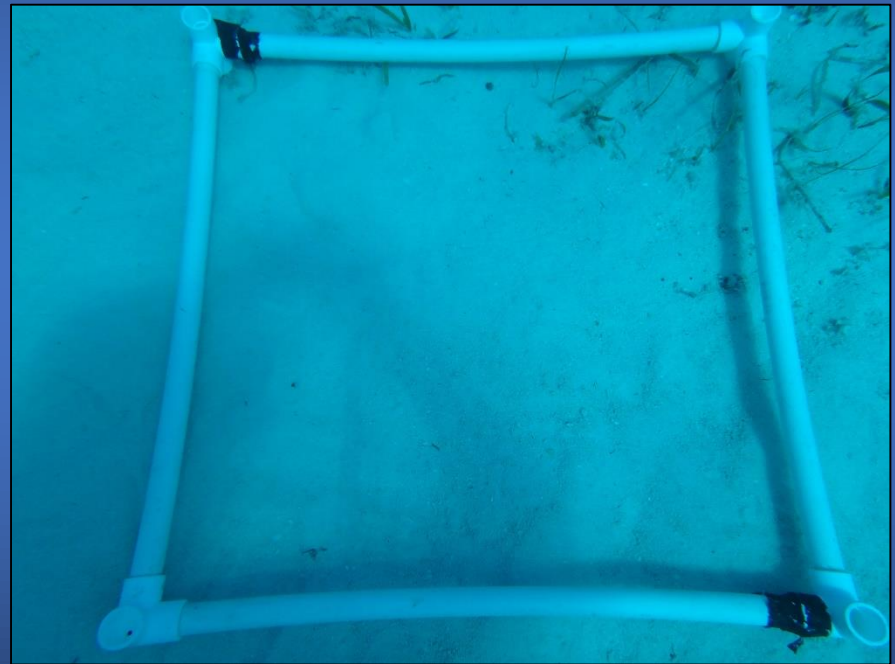
October 2017

Only quadrat left with
seagrass

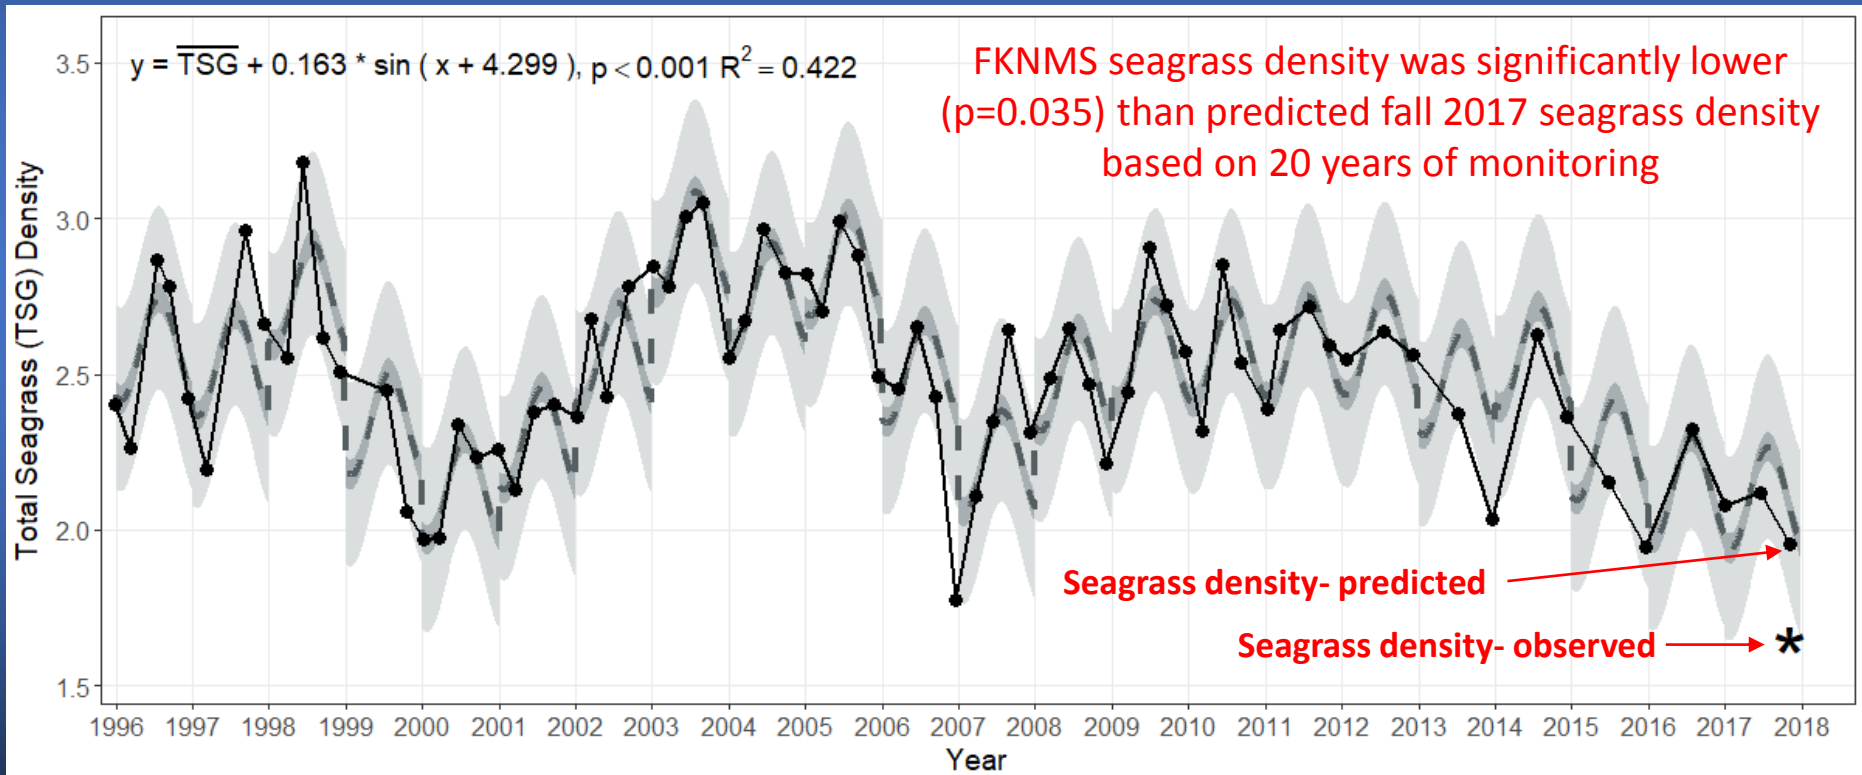
- We generated an autoregressive sinusoidal function that significantly described FKNMS seagrass density from 1996-2017
- We compared the model's predicted fall 2017 seagrass density to the seagrass density that we observed during our monitoring (*)

95% prediction interval

Observed TSG density

95% confidence interval

Sinusoidal model TSG density

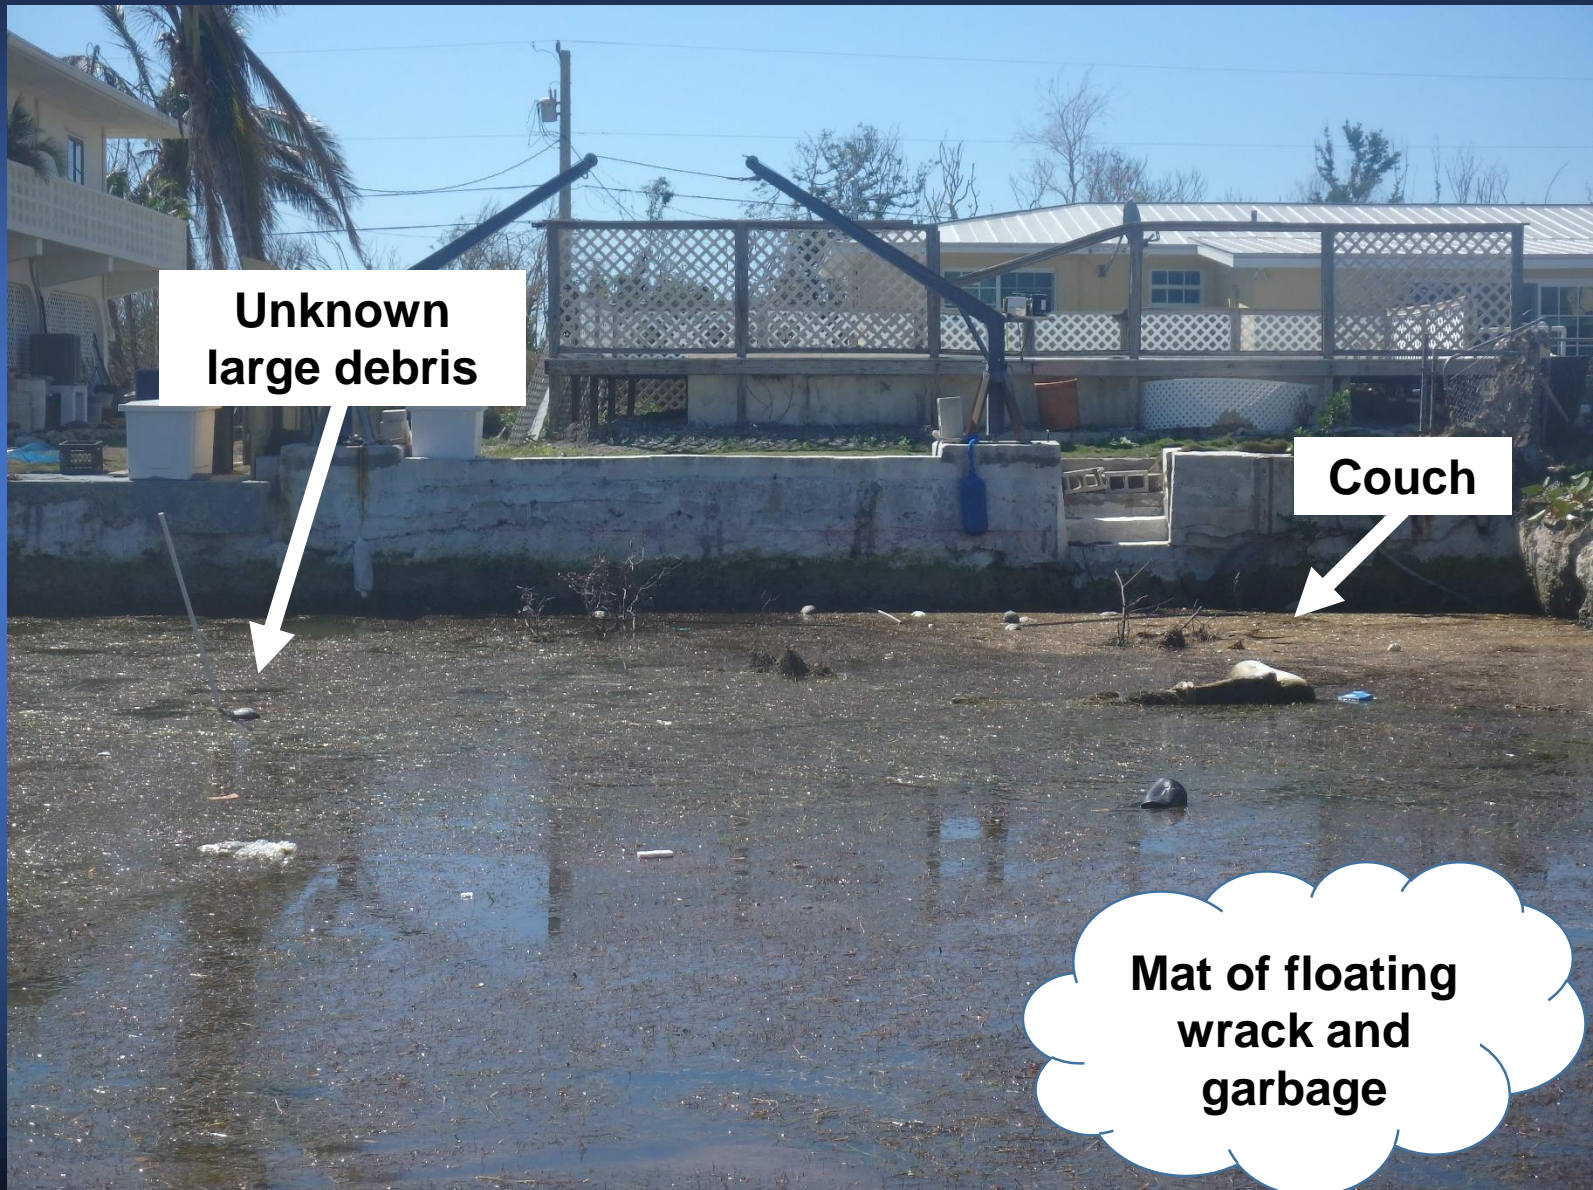
Canal # 282 Post-Irma

**Unknown
large debris**

Couch

**Mat of floating
wrack and
garbage**
