Mapping & Condition Assessment of Oysters in the Pensacola Bay System *Where Are They Now?*

OIMMP & FORS Workshop
May 10 & 11, 2022

Oyster Reef Mapping and Condition Analysis
in East and Blackwater Bays and Lower East Bay River

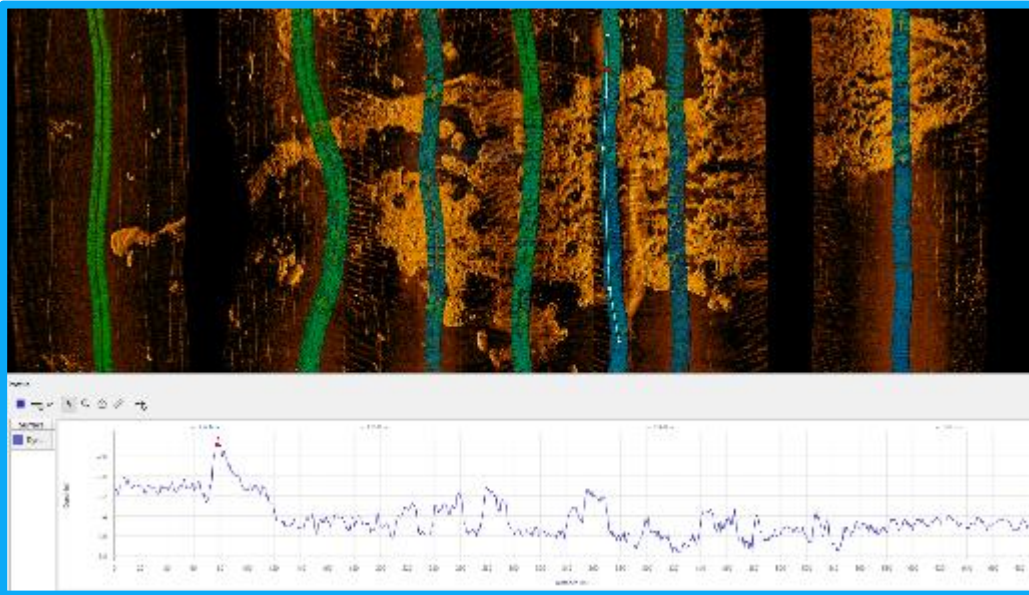
Side Scan Sonar Surveys

Sample side scan composite

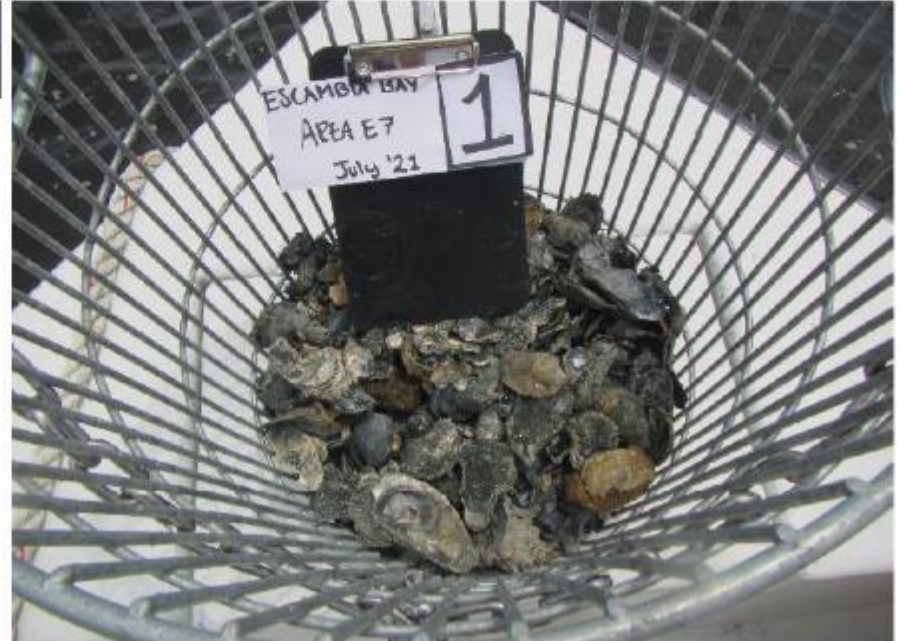
SQUARE METER QUADRANT SAMPLE	
<i>Sample No: 1</i>	
Location: Escambia Bay	Collection Method: Scuba Diver
Oyster Area: E7	Sample Date: 7/21/2021
Parish/County: Escambia County	Latitude: 30°28.920
Depth (ft): 11.1	Longitude: 87°06.898
SQM #1 Basket Photo	
Picture Date: 7/21/2021

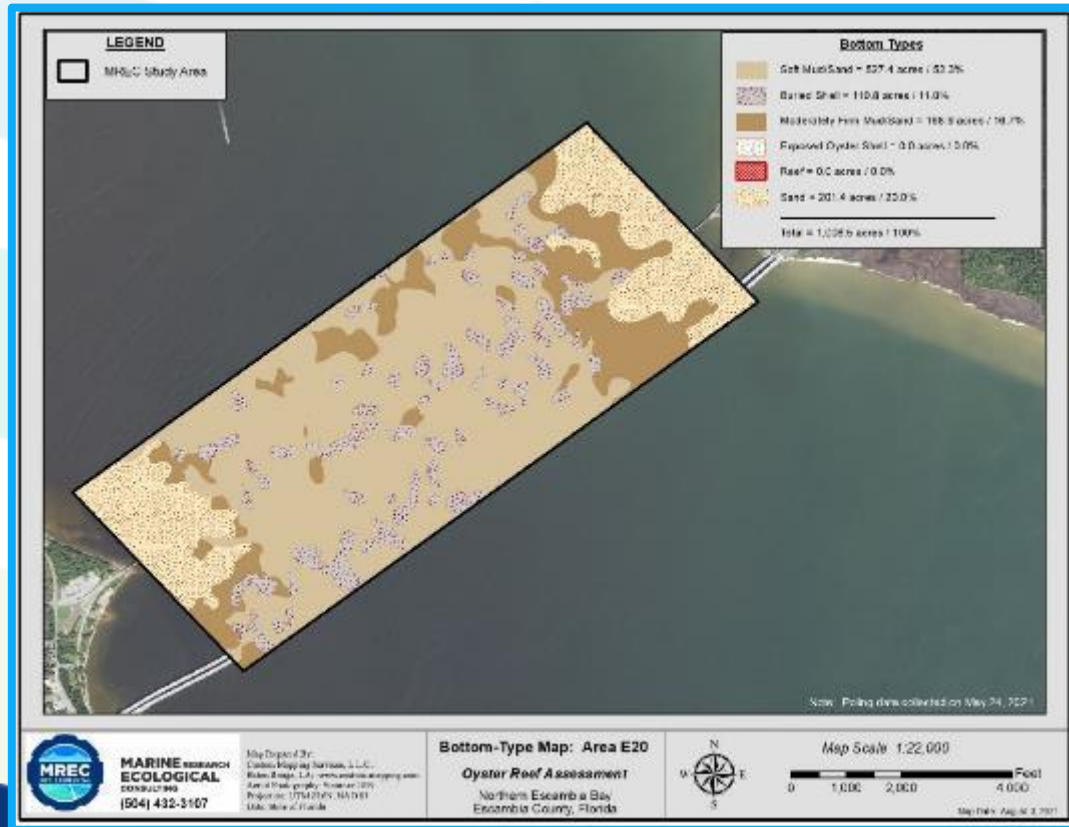
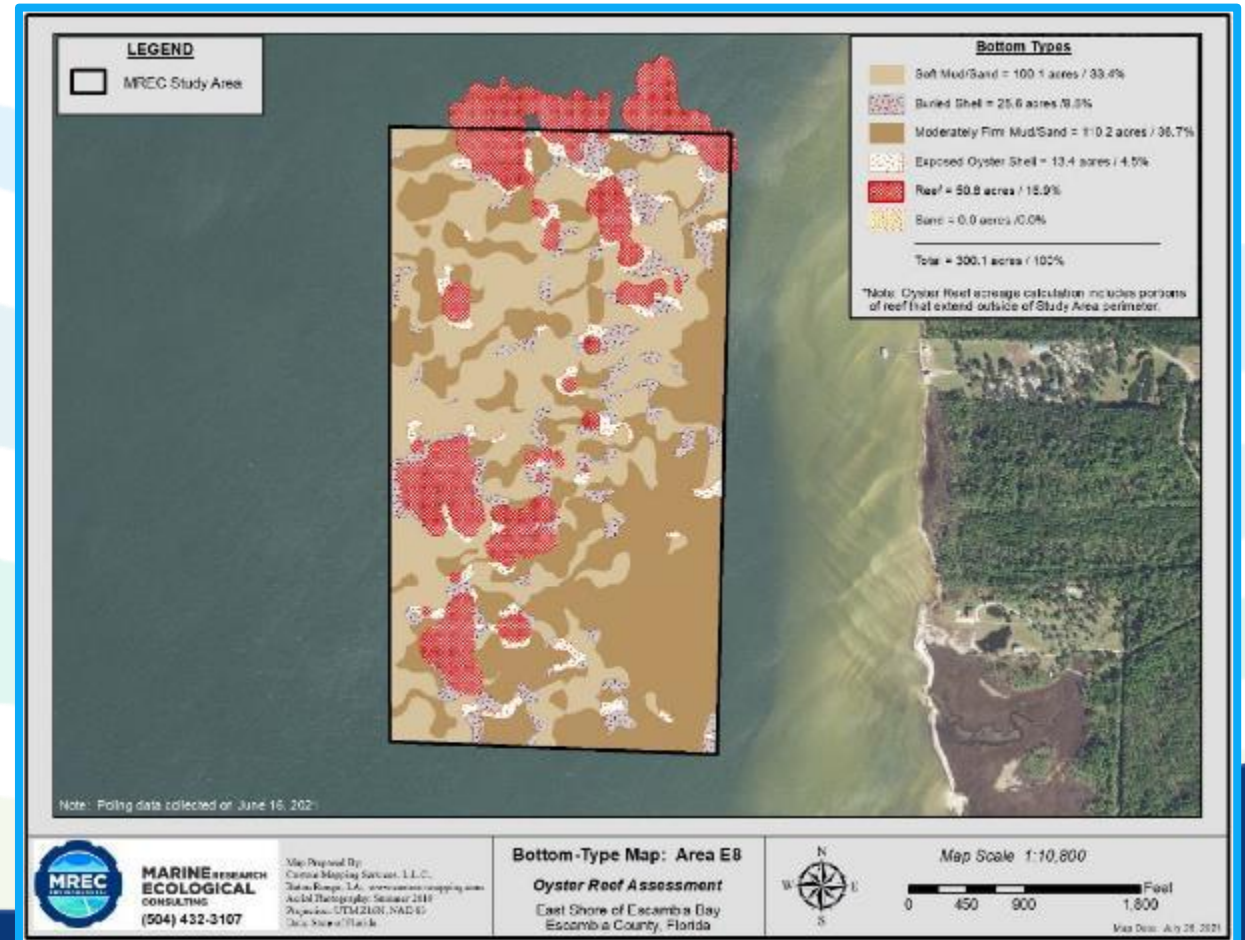
Bottom Types

- Mostly soft mud with areas of buried shell or existing reef
- Recommendation to restore eastern Escambia Bay: good salinity & bottom

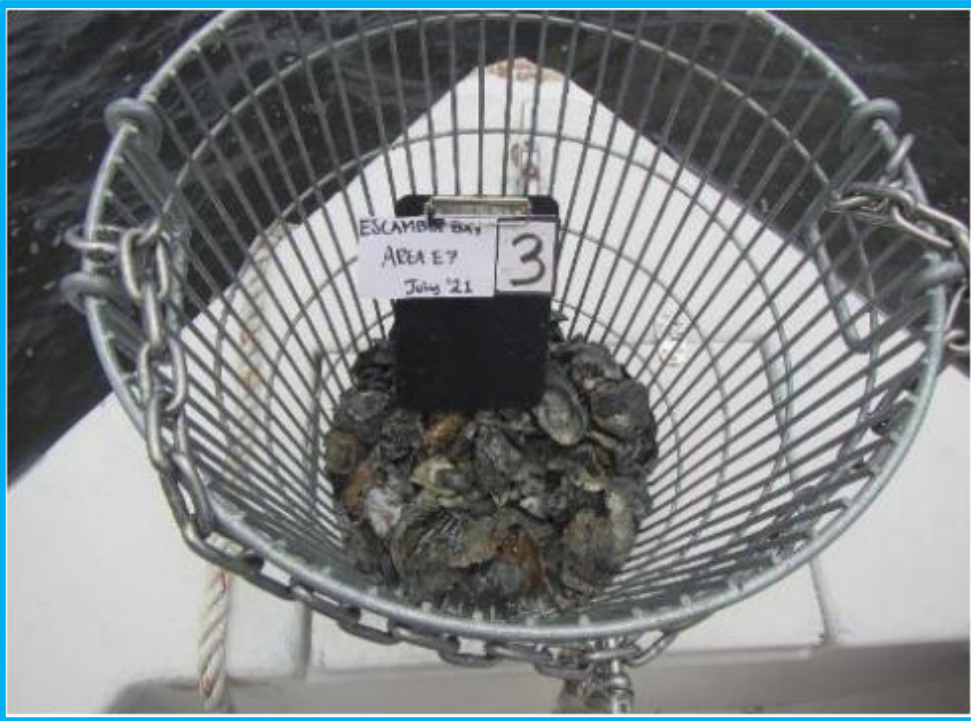
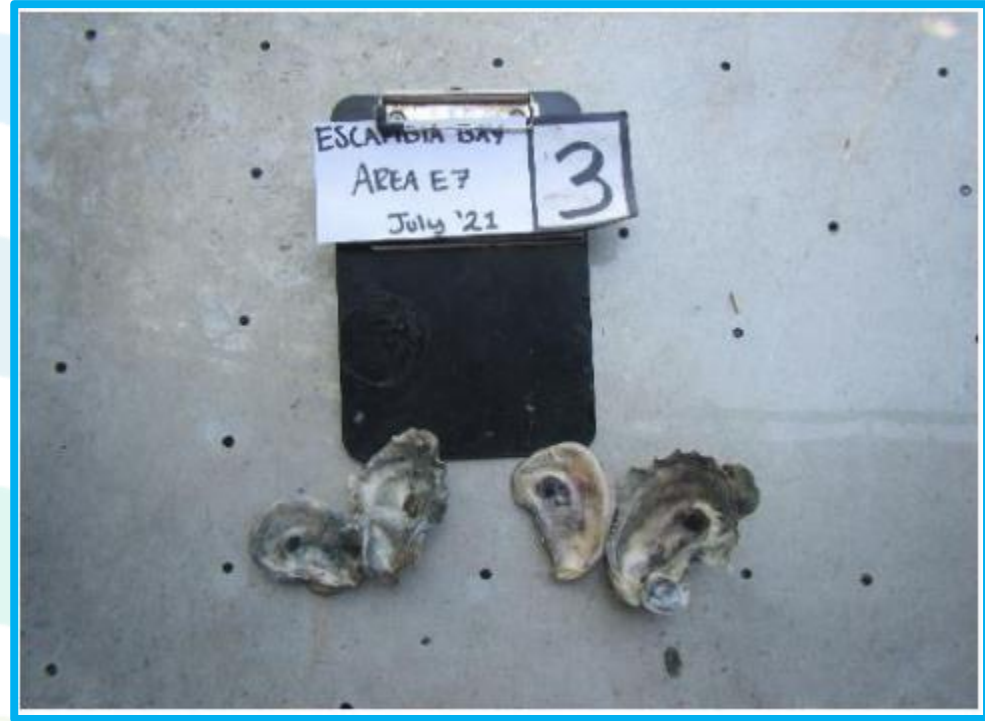
Oyster Condition

- Good distribution of sizes found at a few areas along east Escambia Bay
- Reef organisms: barnacles, oyster drills, hermit & mud crabs, mussels
