Florida Trustee Implementation Group

# Refining Suncoast Seagrass Maps to Identify Oyster Reefs 2024

**Report Date: September 9<sup>th</sup>, 2024**

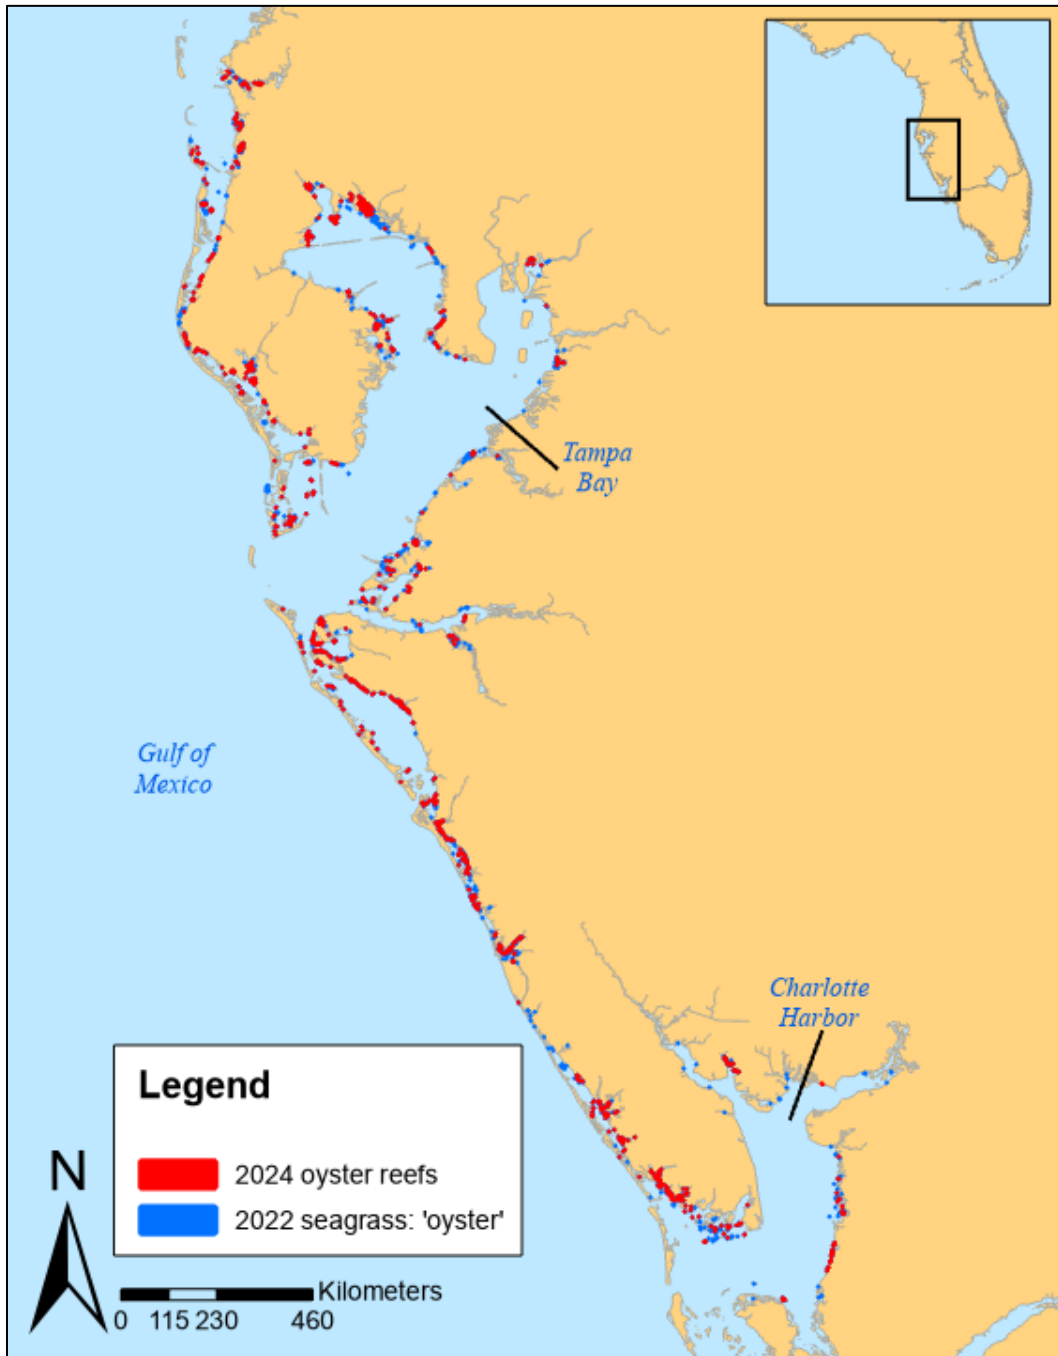
**Figure 1.** Areas classified as 6540 ‘oyster bars’ in SWFWMD (2023) maps (blue), and those that were confirmed as live oyster reefs in this study (red). Oyster reefs are not represented to scale.

Through this mapping revision, 2,618 oyster reefs were reviewed and 183 were ground-truthed. Following reclassification based upon remote imagery and ground-truthing, the final map consisted of 1,356 live oyster reefs for the region (Fig. 1). Only polygons that were confirmed reef or had a high confidence of being a live oyster reef (based on their appearance in aerial images) were included in updated maps. Ground-truthing data determined that 77% and 47% of high- and low-confidence reefs were confirmed oyster reefs, respectively (Table 1). Of the 88 ground-truthed polygons that were unlikely to be reefs and recommended for removal, 88% were confirmed not to be oyster reef (Fig. 2, Table 1). Separating potential reefs into high-confidence and low-confidence strata for ground-truthing enabled focus on areas that have the potential to be reefs, but lack the distinctive visual cues of oyster reefs, enhancing ground-truthing efficiency and improving overall accuracy of oyster maps. Because ground-truthing focused on including many low-confidence reefs with ambiguous appearance and those recommended for removal, overall ground-truthing accuracy was 74.9%. Potential reefs that were determined during ground-truthing to be misclassified were most commonly composed of scattered, live oyster and sand/mud (both representing 26.3% of polygons ground-truthed) followed by oyster shell/shell hash (7.4%; Table 1).

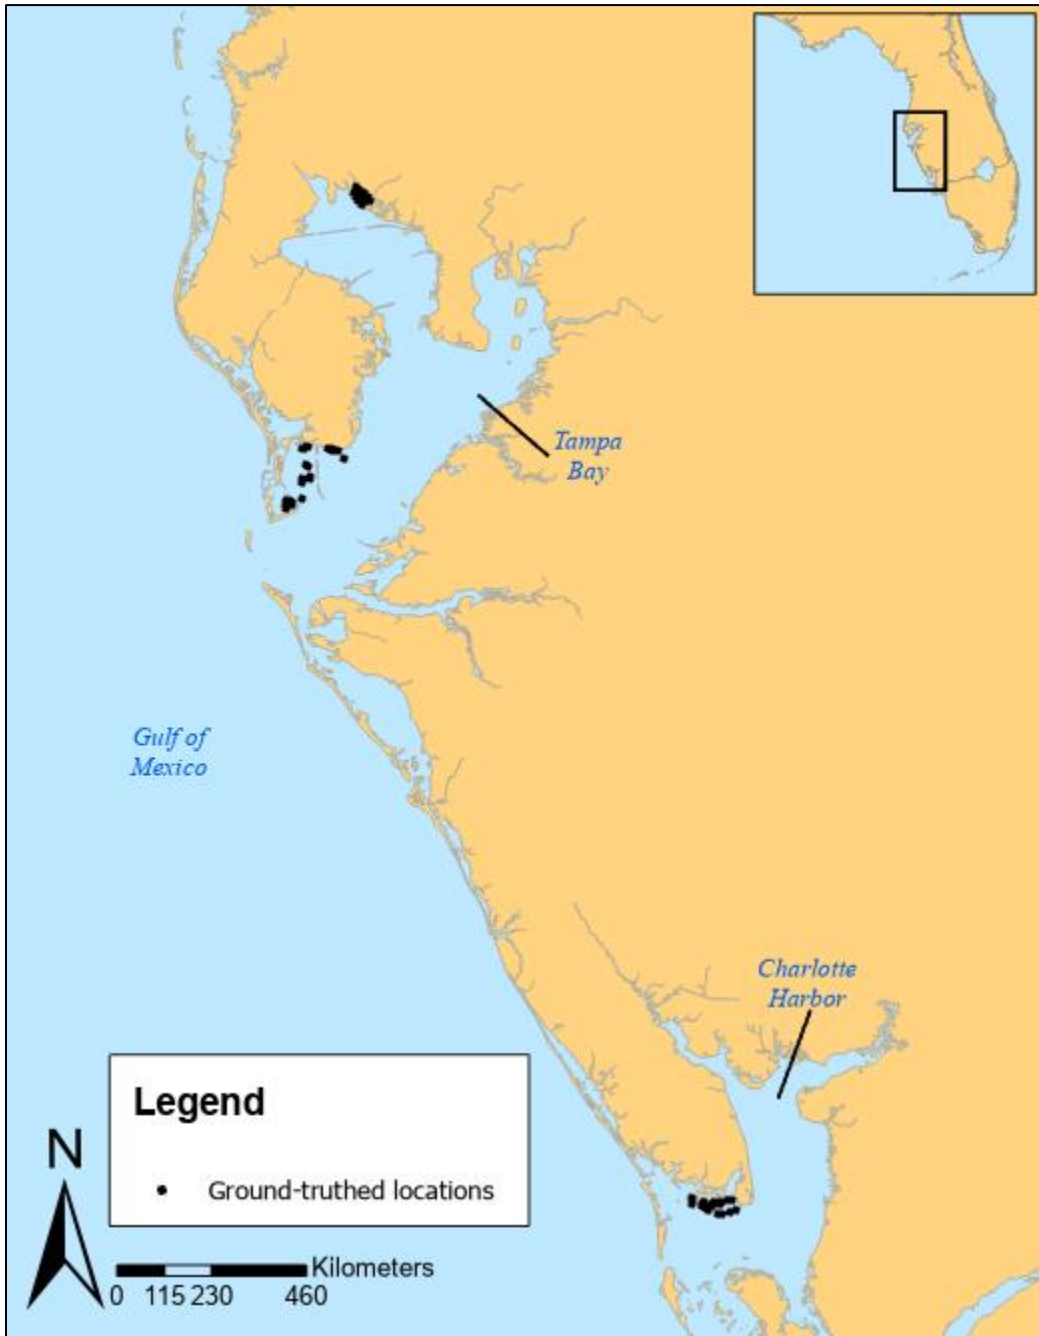
**Figure 2.** Map of ground-truthed locations used to refine SWFWMD (2023) maps.

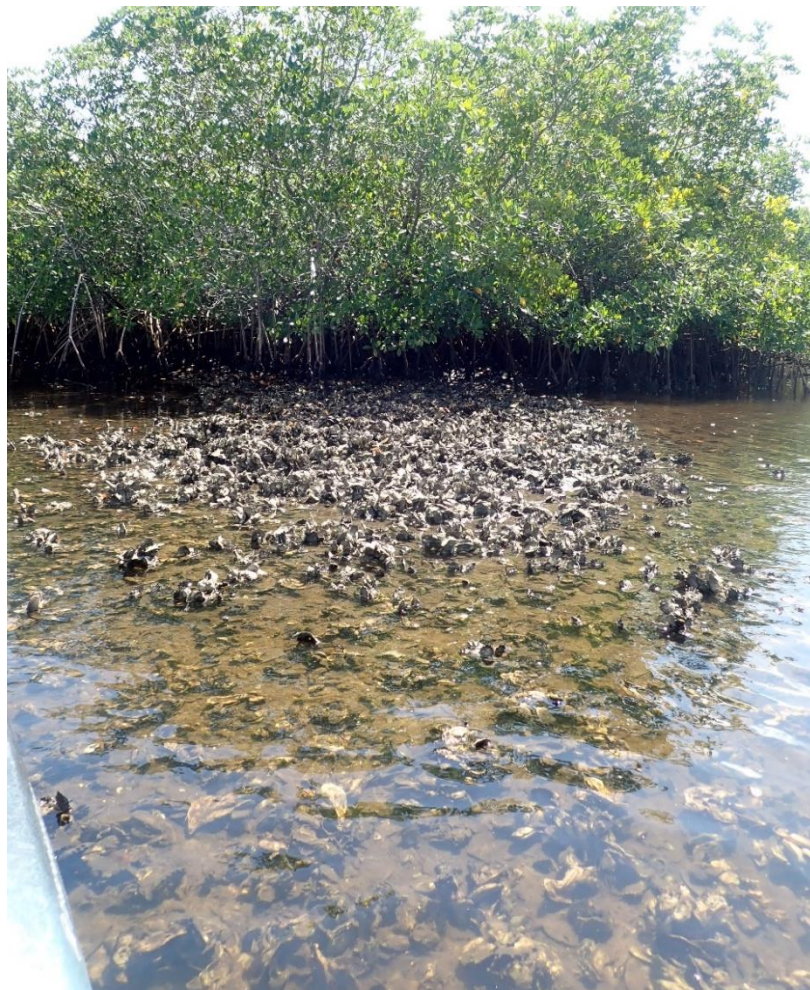
**Figure 3.** An oyster reef fringing a mangrove stand in Cape Haze, FL.

- Many potential oyster reefs were coupled with mangrove habitat - either through an oyster reef fringing mangroves (Fig. 3) or, in some cases, an entire polygon was colonized by a mature mangrove stand (Fig. 4).

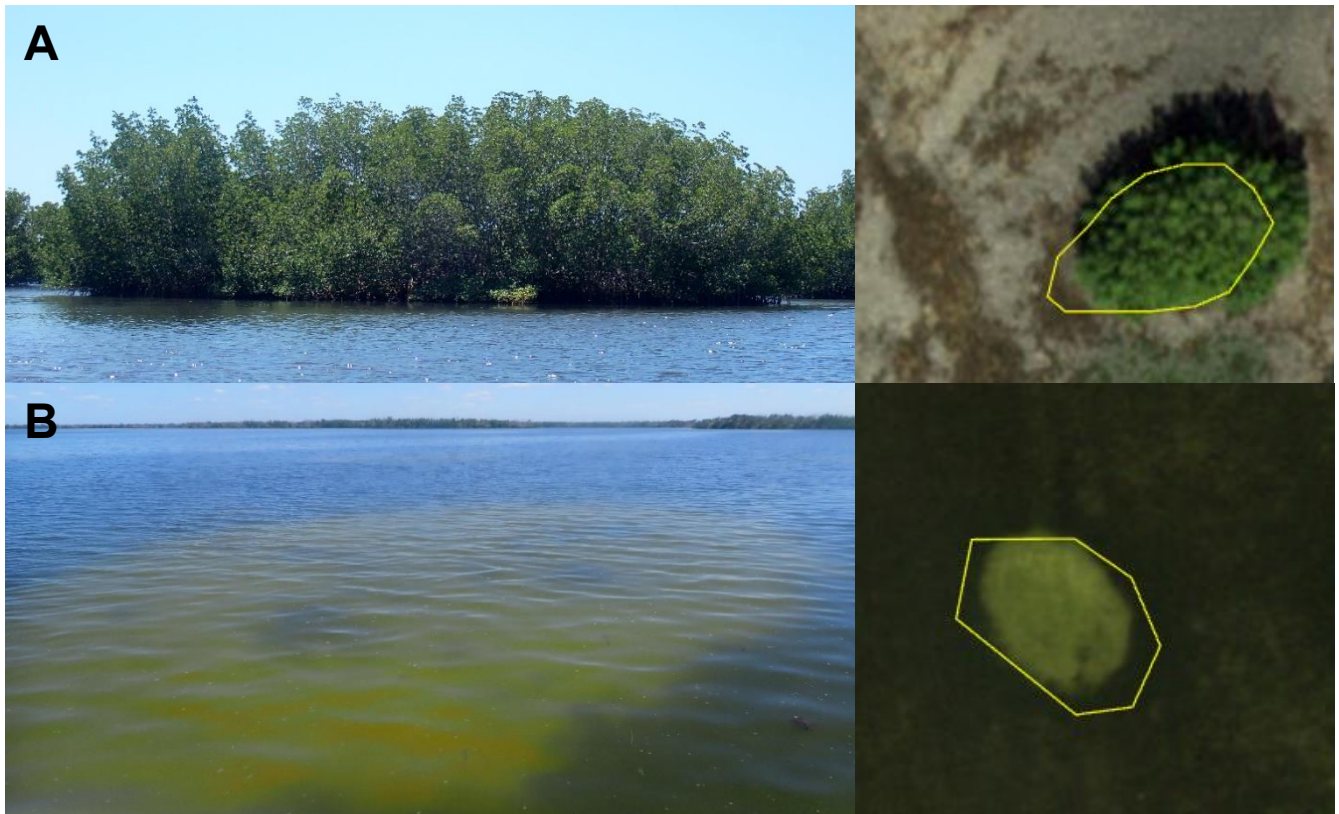
**Figure 4.** Two misclassified substrate types were mangrove (A) and sand/mud (B), as seen in-person (left) and in imagery (right). Note many mangrove islands were former oyster reefs that had been colonized by mangroves in recent years.

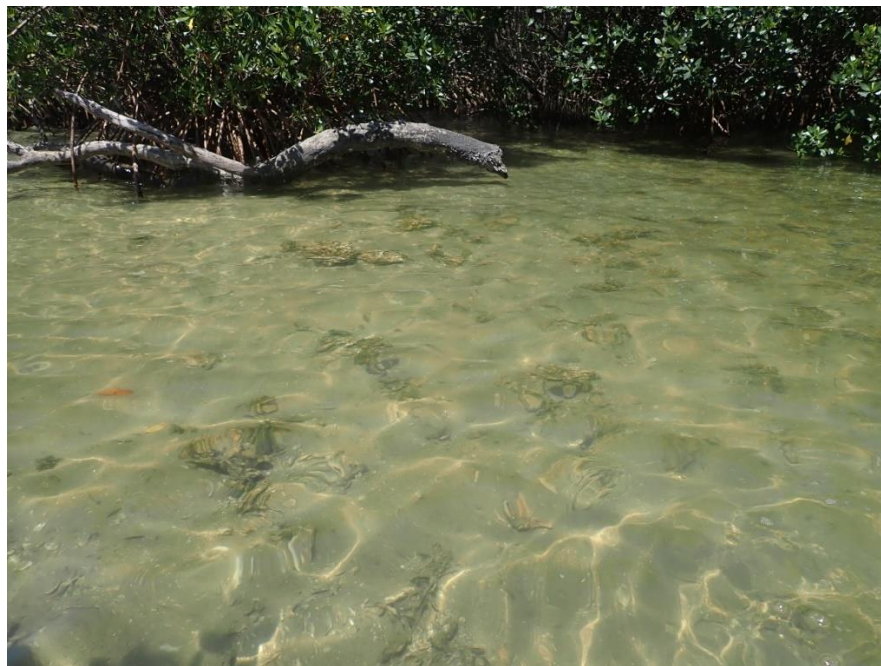
**Figure 5.** Scattered, live oyster with less than 20% live oyster extent.

- More than half of ground-truthed polygons had substrate characterized as scattered, live oyster or sand/mud (Fig. 5). A moderate number of scattered, live oyster polygons were expected due to the inclusive nature of the 6540 'oyster bar' designation used in FLUCCS classification (NV5 Geospatial 2023a). While these areas support some scattered live oyster clusters, they fall below this study's threshold of a live oyster reef and are less likely to sustain a biogenic oyster reef into the future relative to their higher-density counterparts. Sand/mud polygons did not contain oysters or shell; while they mimicked the color and shape of typical patch oyster reefs, they lacked the texture seen on oyster reefs or shell substrate and were frequently surrounded by macroalgae and seagrass (Fig. 5).
