# 2024 St. Andrew Bay Subtidal Oyster Mapping

Final Report completed June 30, 2025

Deliverable 1.2 for Florida Fish and Wildlife Conservation Commission (FWC) Contract #PR241565:  
St. Andrew Bay and Suwannee Sound Subtidal Oyster Reef Mapping 2023-2025

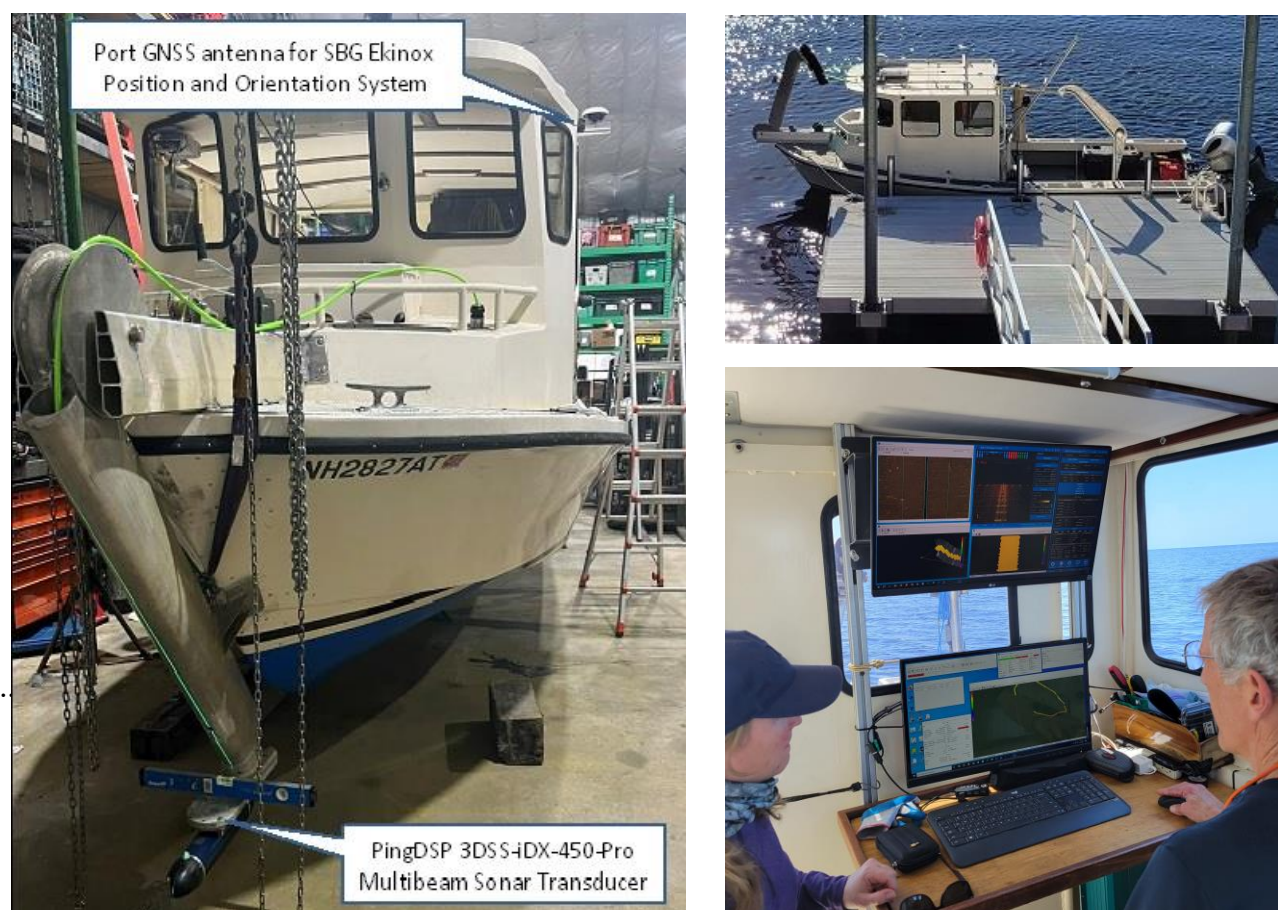
**Figure 3.** Left: Acoustic gear on Substructure's *Diversity* with bow-mount and towfish in deployment position. Top: *Diversity* dockside with bow-mount in raised position for transport. Lower: Sonar monitors in Wheelhouse.

All surveys were conducted aboard Substructure's *Diversity*, a 26-ft Privateer (**Figure 3**). The sonar equipment consisted of a Ping DSP 3DSS-iDX-450-Pro multibeam echosounder, an SBG Systems Navsight Ekinox vessel position and motion reference unit (integrated in the 3DSS), an AML Oceanographic MicroX sound velocity sensor (SVS) mounted near the 3DSS, a YSI Castaway conductivity-temperature-depth (CTD) speed of sound profiler, and Hypack/Hysweep hydrographic data acquisition and processing software (see **Appendix B** for details on all acoustic equipment).

The Ping unit provides simultaneous side-scan and bathymetric data outputs. It is a multibeam echosounder operating at 450 kHz with a nominal beamwidth of 0.4°. The system includes motion reference units (MRU) that are fully integrated into the sonar transducer package. It also includes a patented signal processing methodology that extends the single angle-of-arrival principle used in interferometric systems to accommodate multiple simultaneous backscatter arrivals (e.g., the seabed, sea surface, water-column, and multipath), resulting in improved wide-swath bathymetry, and both 2D and 3D imagery. The Ping towfish was mounted on a rigid bow-mount fairing about 50 cm below the water surface with known offsets to the SBG Navsight navigation reference point (**Figure 3**).

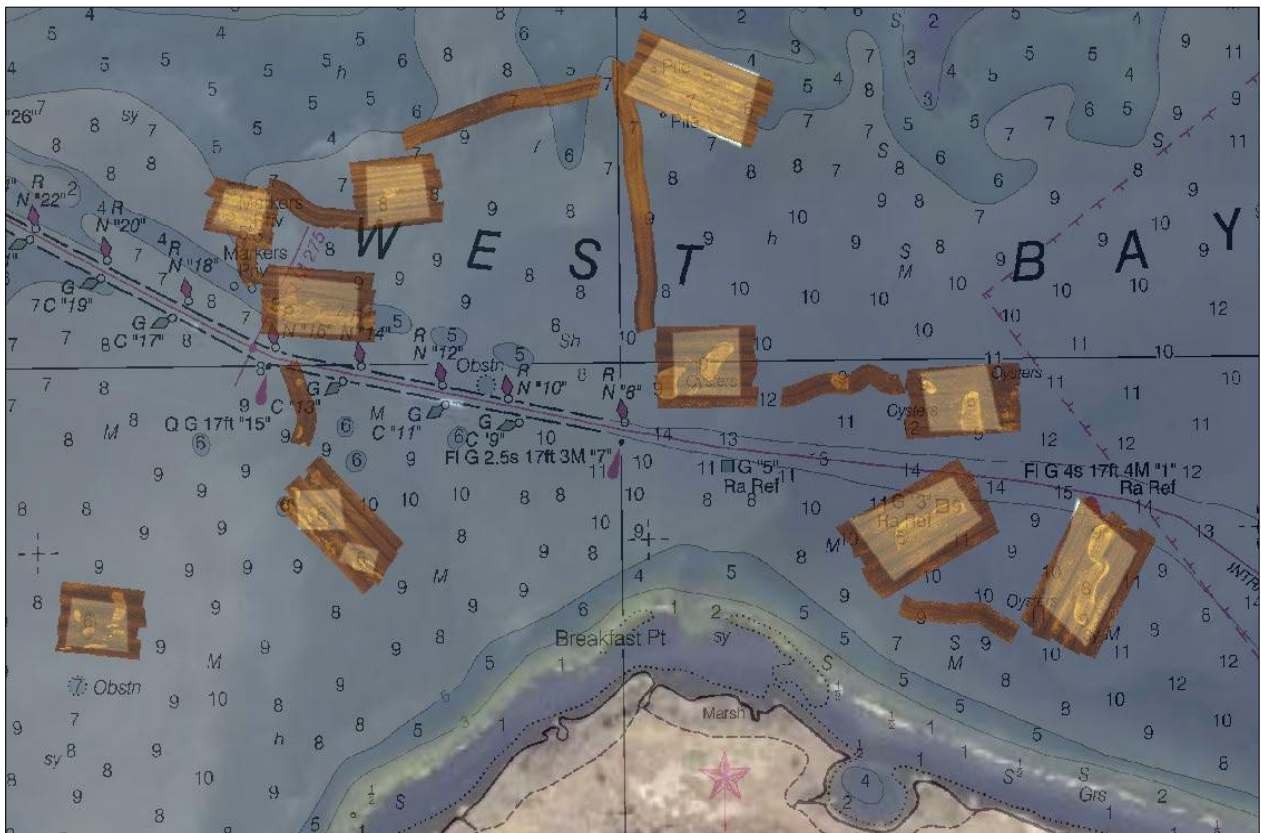
**Figure 7.** A view of the western parts of West Bay provides a representative example of how the initial acoustic imagery coverage was focused on obtaining at least 100% imagery coverage over all of the defined “oyster” polygons. In this figure, the imagery mosaics are partially transparent so the underlying polygons are visible. Additional acoustic data were also acquired during transits between the primary areas.

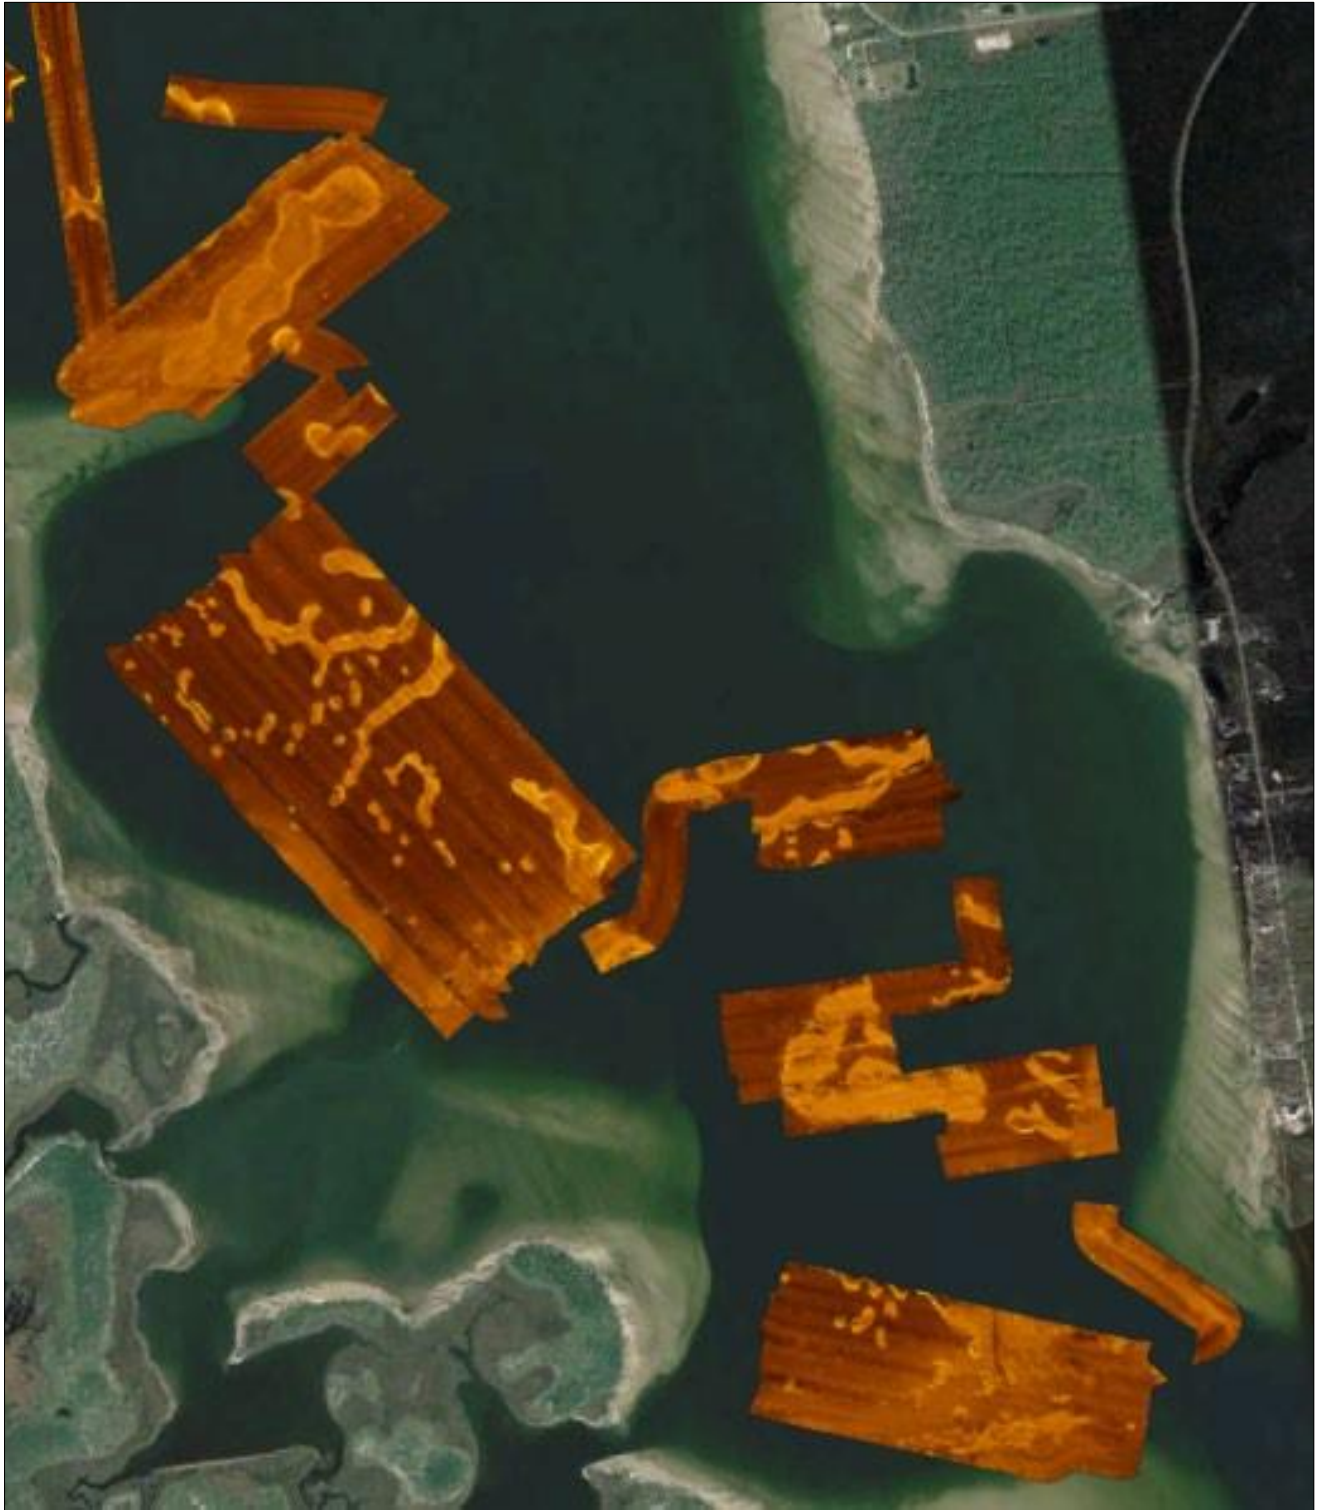
**Figure 8.** Examples of exported 1-m resolution 2D (side-scan) imagery mosaics from several of the target polygons in East Bay as viewed in GoogleEarth. The hard bottom (light brown) areas showing high-reflectance of the sonar signal clearly contrast in most areas with the darker brown muddy sediments. The GoogleEarth interface was helpful to step through images from different time periods to best characterize the shallow nearshore areas. This aerial image from 2019 provided the best view of the immediate nearshore areas showing extensive sand bar features that sometimes extended into the survey areas.

After application of the SBET file if necessary, initial processing of the multibeam imagery data included reviewing the raw sensor and navigation data, reviewing and updating the bottom-tracking, clipping any data as needed, applying a variety of gain adjustments, and creating preliminary imagery mosaic data products to assess data coverage. All of the acoustic imagery data processing was conducted in Chesapeake Technology SonarWiz. For these operations, the 50-m imagery range setting was used during all data acquisition, primarily because there were definitive survey goals that enabled the application of a systematic survey plan designed to provide at least 100% imagery coverage over all of the identified “oyster” polygons (**Figure 7**). Preliminary imagery mosaics for the different survey areas were initially exported as geoTIFs and KMZs at a 1-meter resolution. The geoTIFs were then used within Hypack during the physical sampling operations to help plan and select specific target locations. The acoustic imagery KMZs were viewed in GoogleEarth to help assess the overall coverage and also to compare the acoustic imagery results against the aerial imagery, particularly in the nearshore areas (**Figure 8**).

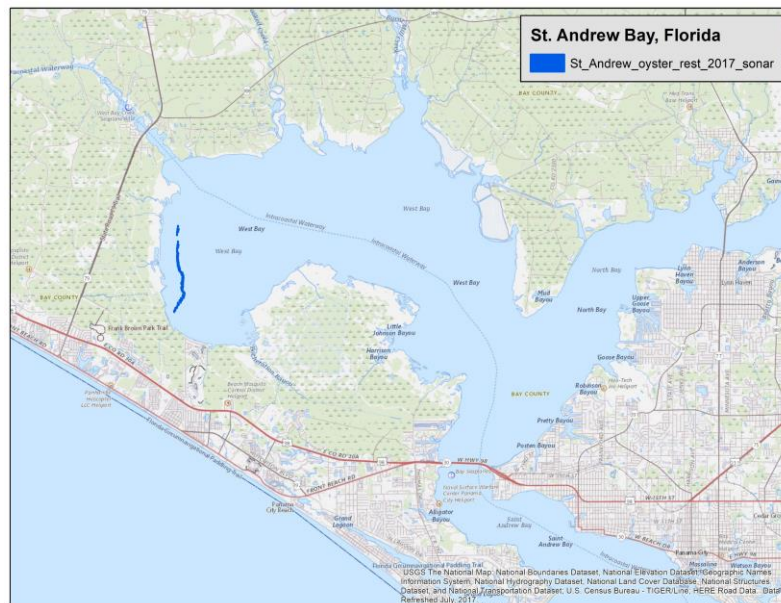
**FWC (2017), from 2017 side-scan-sonar  
SHAPEFILES**

FWC (Florida Fish and Wildlife Conservation Commission). 2017. Side scan sonar of oyster reef habitat restoration in St. Andrew Bay, FL

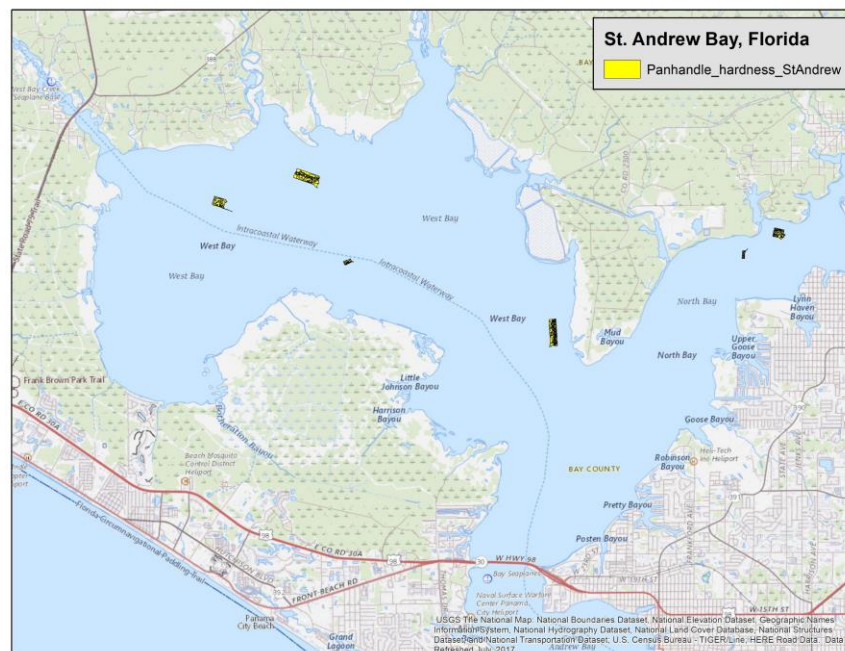
[https://services2.arcgis.com/z6TmTIyYXEYhuNM0/arcgis/rest/services/hardness\\_StAndrew\\_FDEP\\_2021/FeatureServer](https://services2.arcgis.com/z6TmTIyYXEYhuNM0/arcgis/rest/services/hardness_StAndrew_FDEP_2021/FeatureServer)  
Panhandle\_hardness\_StAndrew

Hardness maps of cultivated areas in St. Andrew Bay from side scan sonar. Not included in FWC's Oyster Beds in Florida layer. For layer file, contact [GISLibrarian@MyFWC.com](mailto:GISLibrarian@MyFWC.com)
