FKNMS

Benthic Habitat Monitoring Program

Canal Restoration in Monroe County

Benthic Monitoring Report

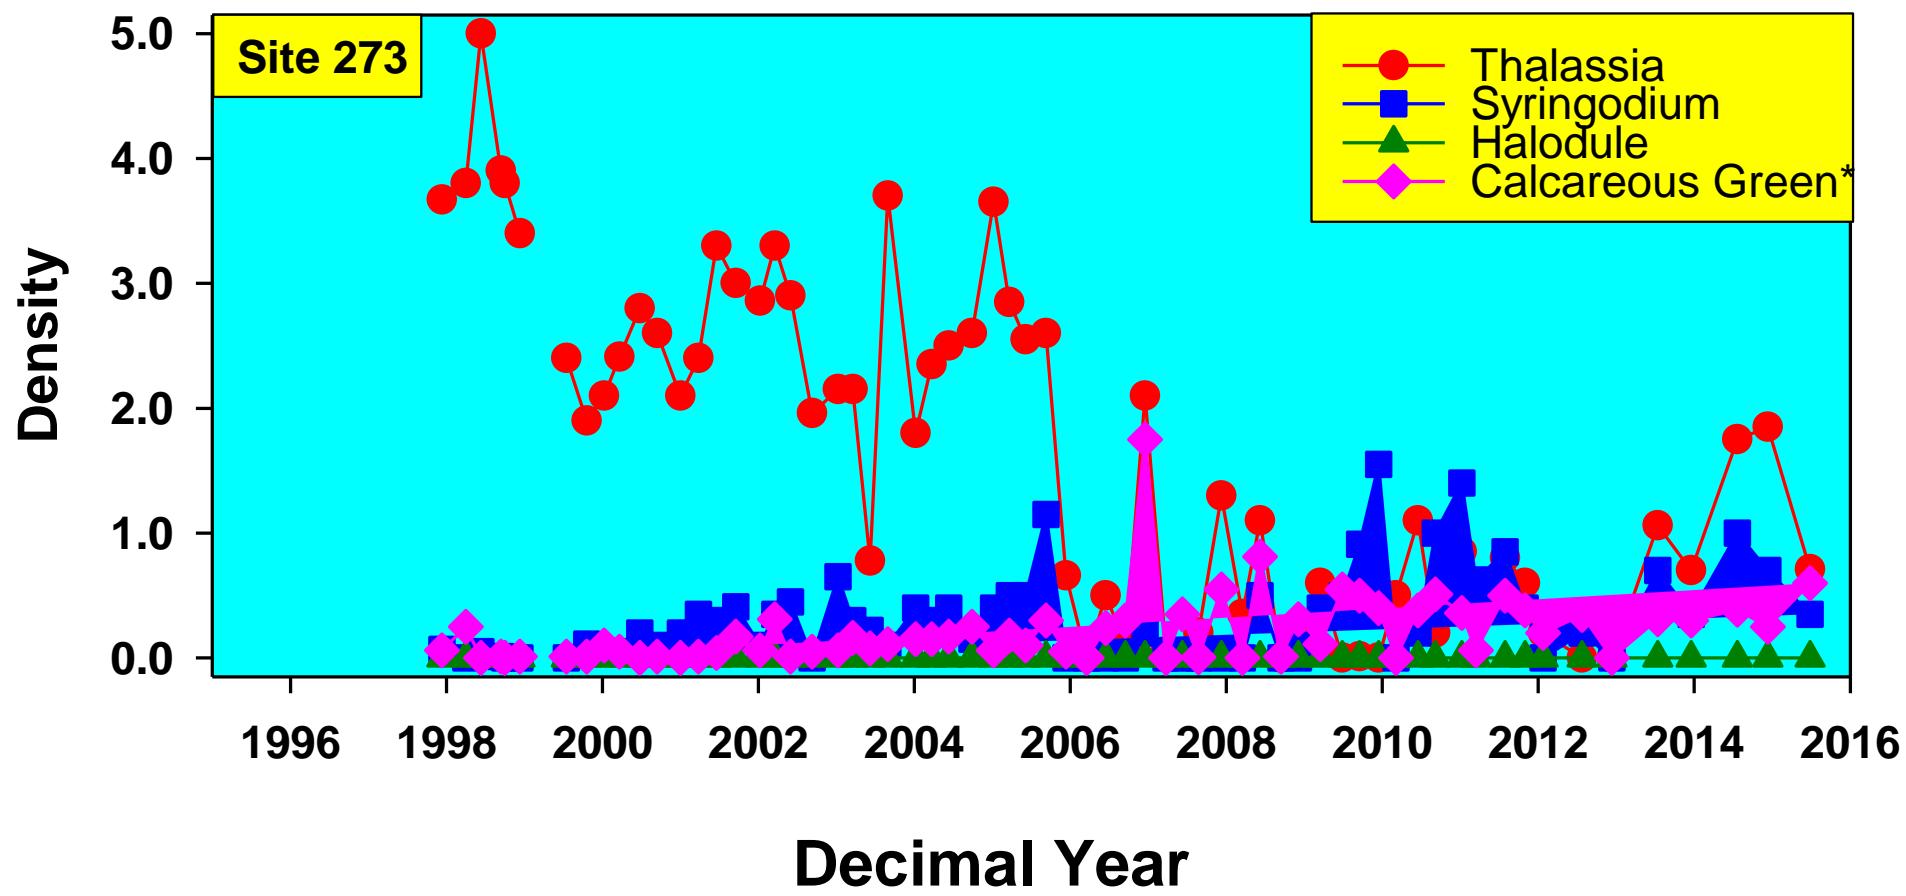
Changes in relative abundance of primary producers

Nutrient pollution will lead to changes in relative abundances of primary producers in a predictable way.

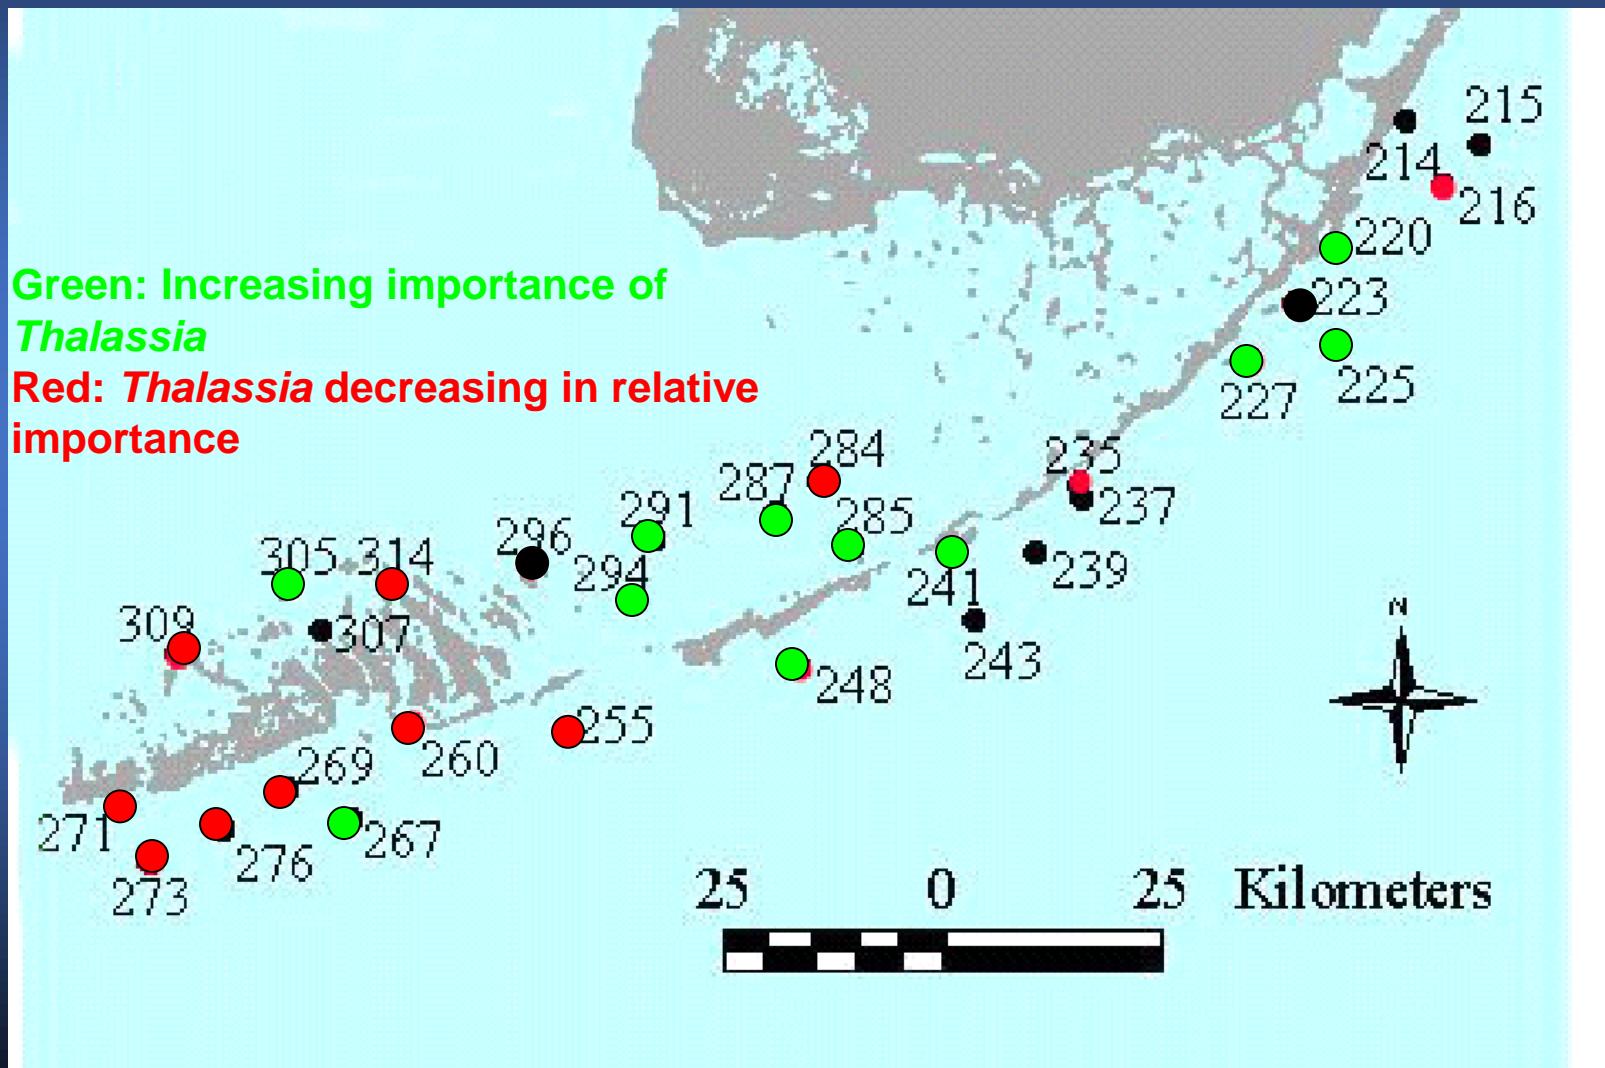
Changes in relative abundance of primary producers

At 22 of 30 sites, species composition has shifted in a manner consistent with increased nutrient availability

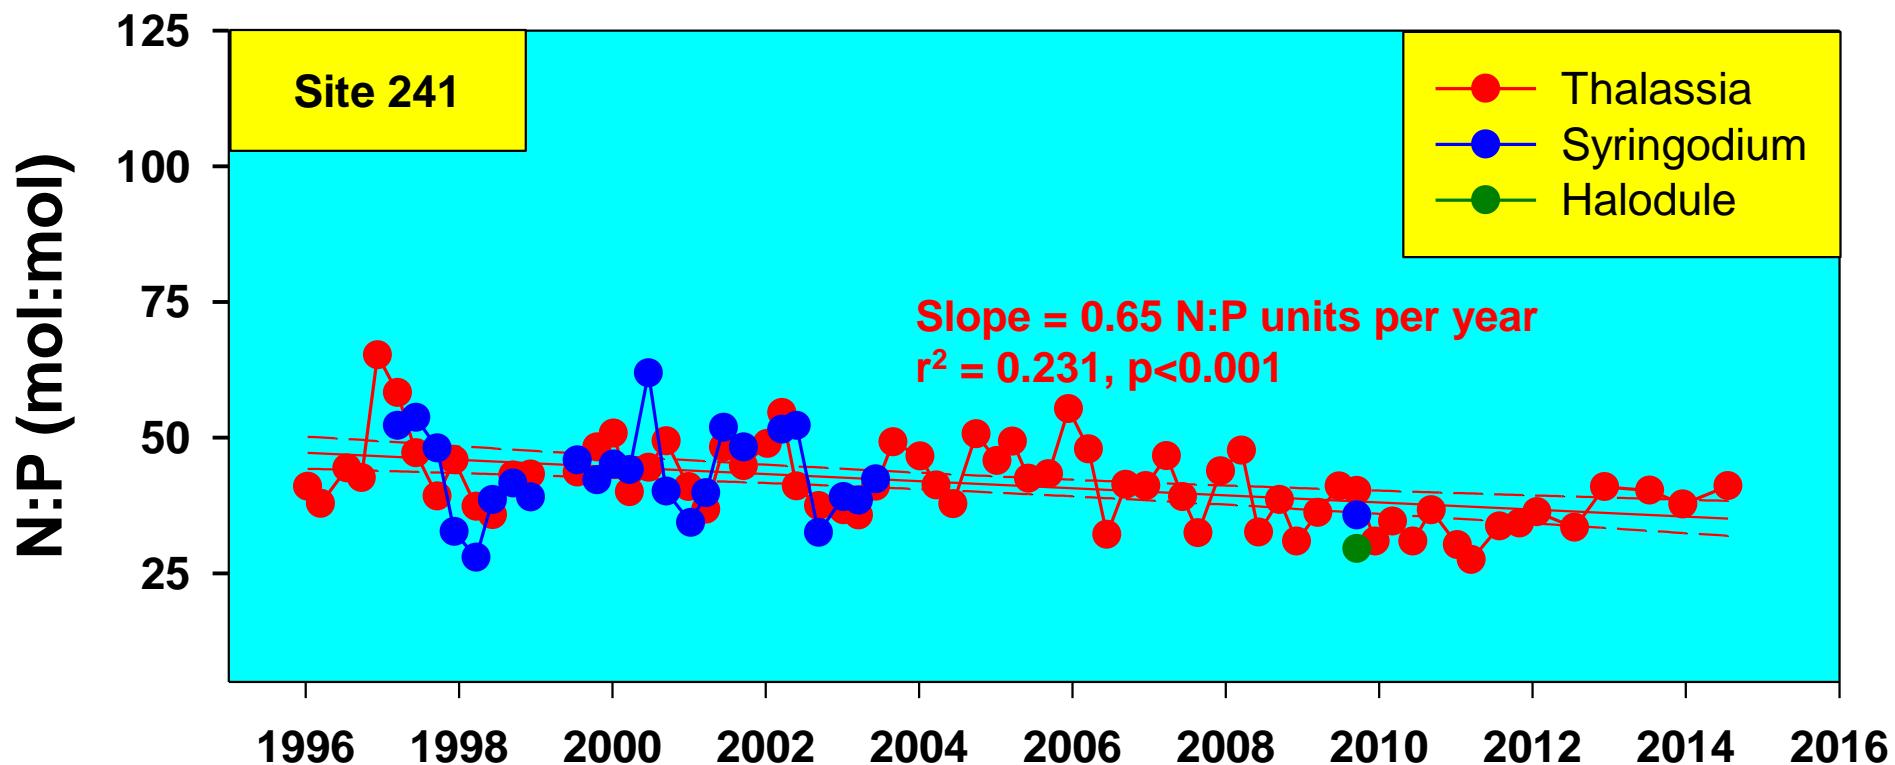
Changes in N:P of primary producers

At 10 of 30 sites, N:P is trending towards “seagrass Redfield ratio”

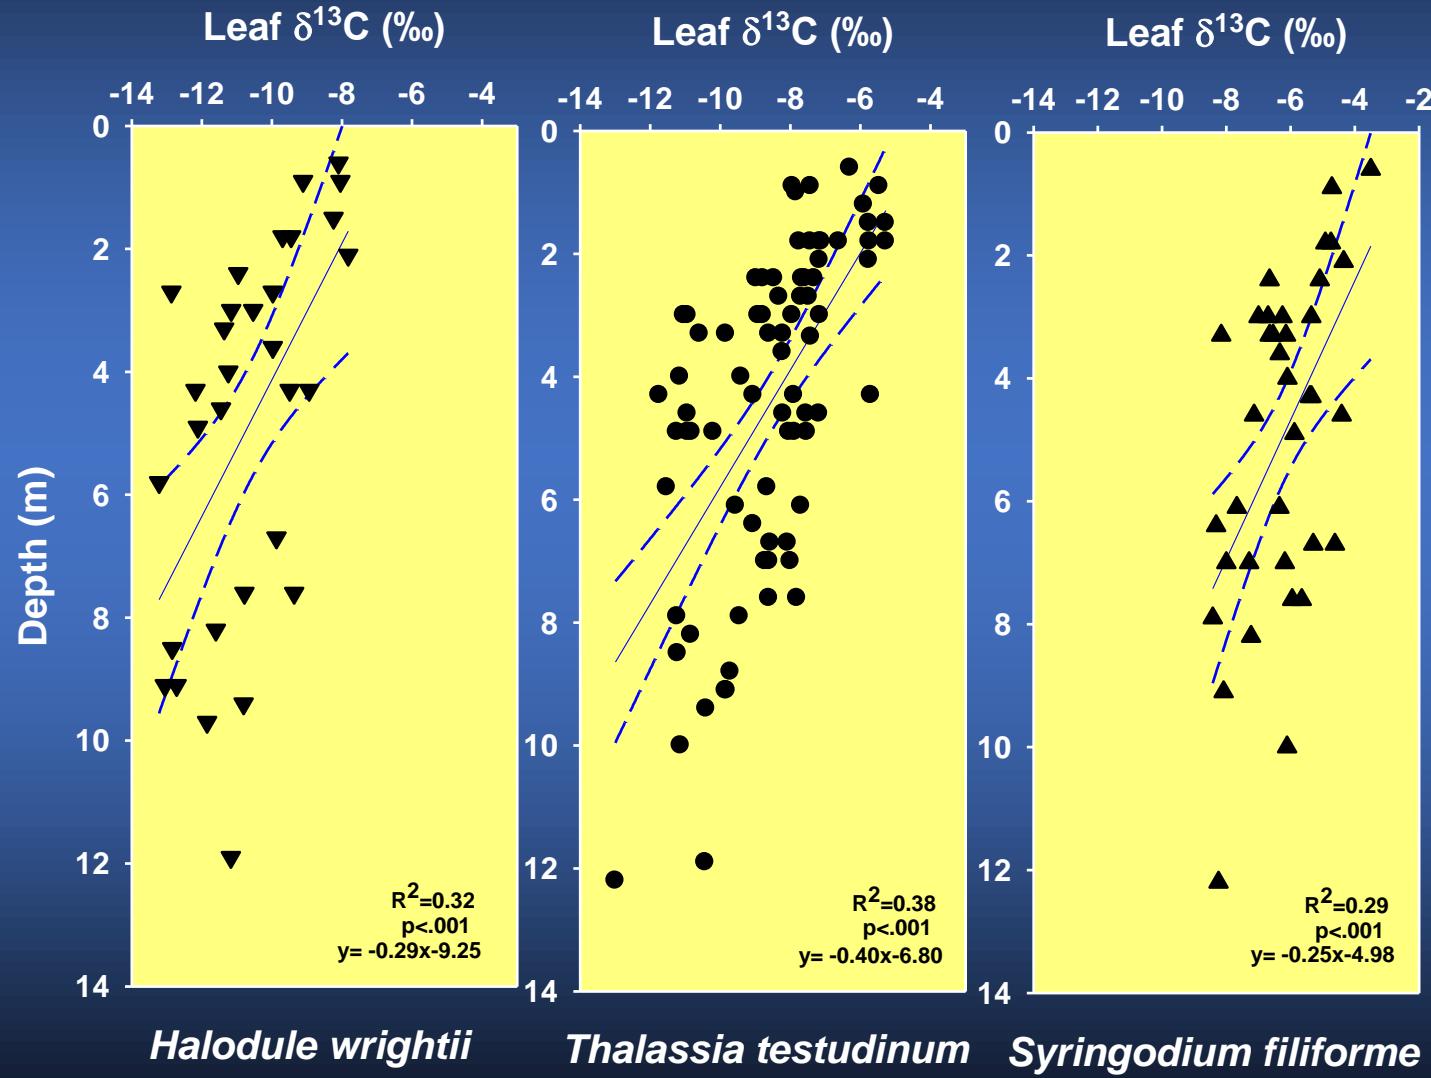
As light decreases with depth, $\delta^{13}\text{C}$ decreases

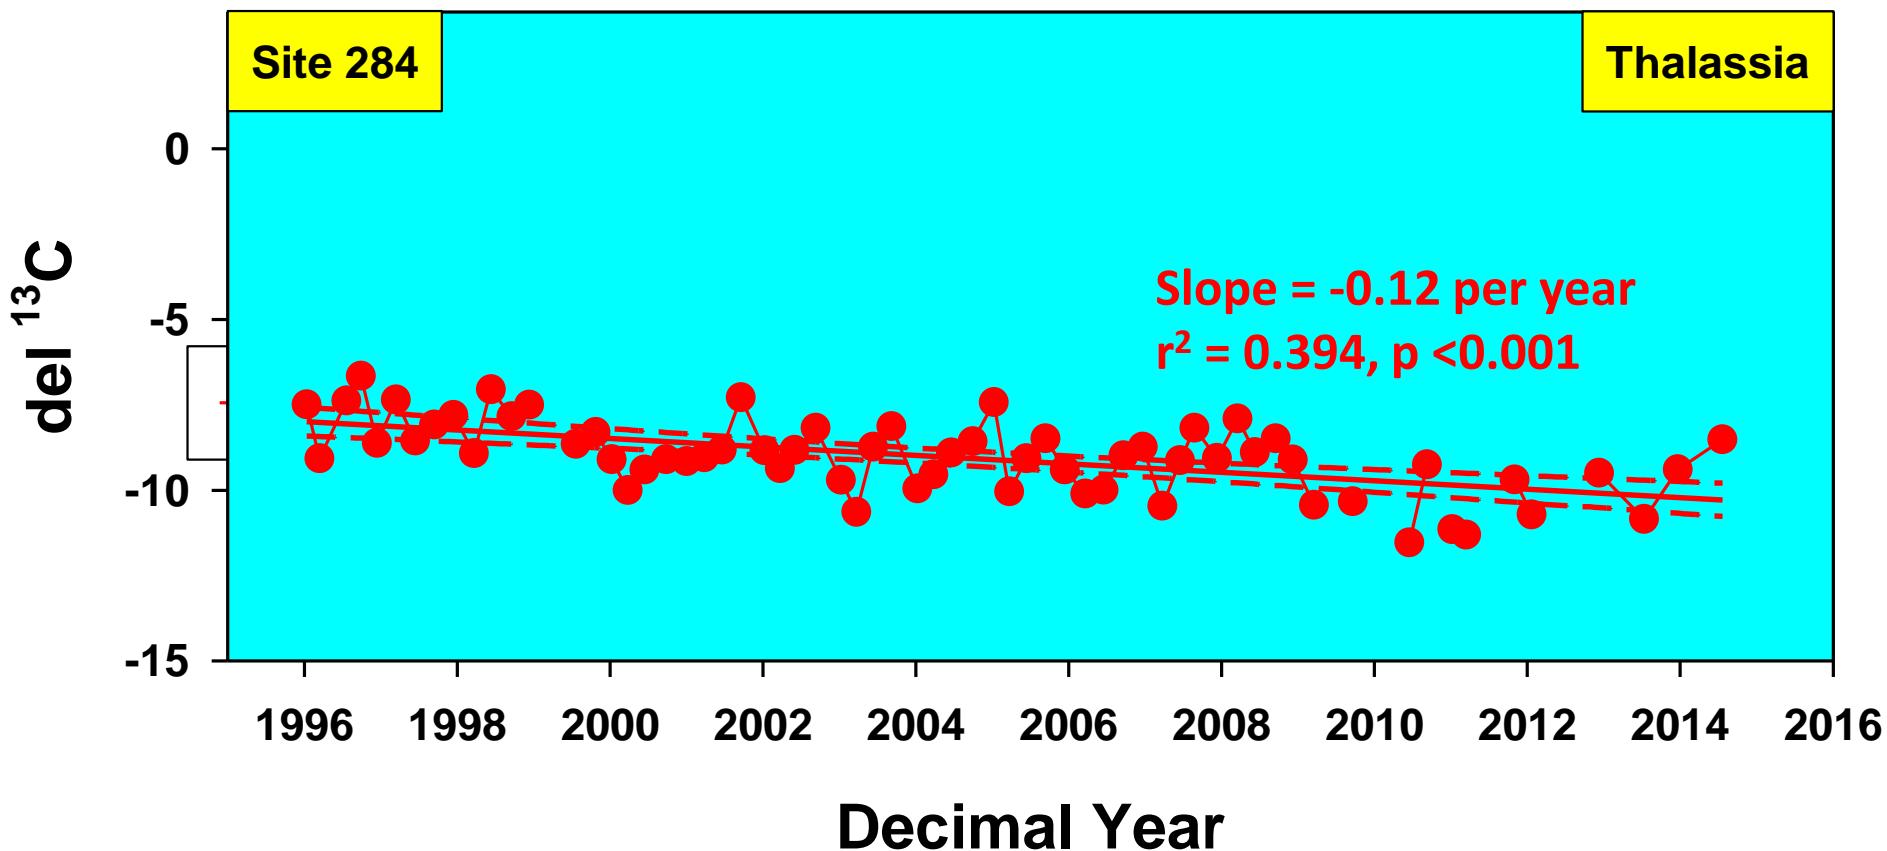
Changes in $\delta^{13}\text{C}$ of primary producers

At 7 of 30 sites, significant $\delta^{13}\text{C}$ trends consistent with eutrophication (7 of 30 last year)
