Florida Keys National Marine Sanctuary Steering Committee
December 6, 2017

**WATER QUALITY MONITORING PROJECT FOR
DEMONSTRATION OF CANAL REMEDIATION METHODS
FLORIDA KEYS
Report of activities**

Dr. Henry O. Briceño

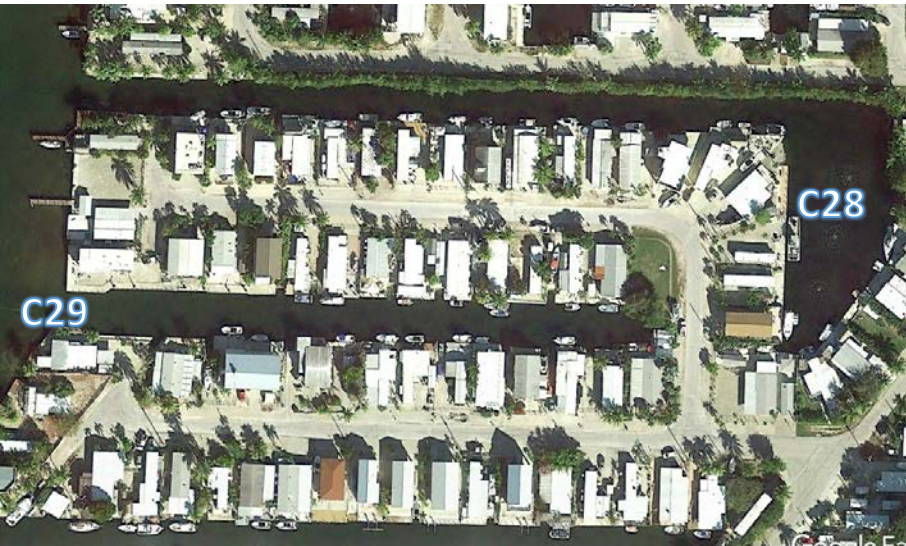
Canal 29

Backfilling

**26,000 cy of fill to raise
canal bottom**

**Before = -35 feet MLW
After = -7.7 feet MLW**

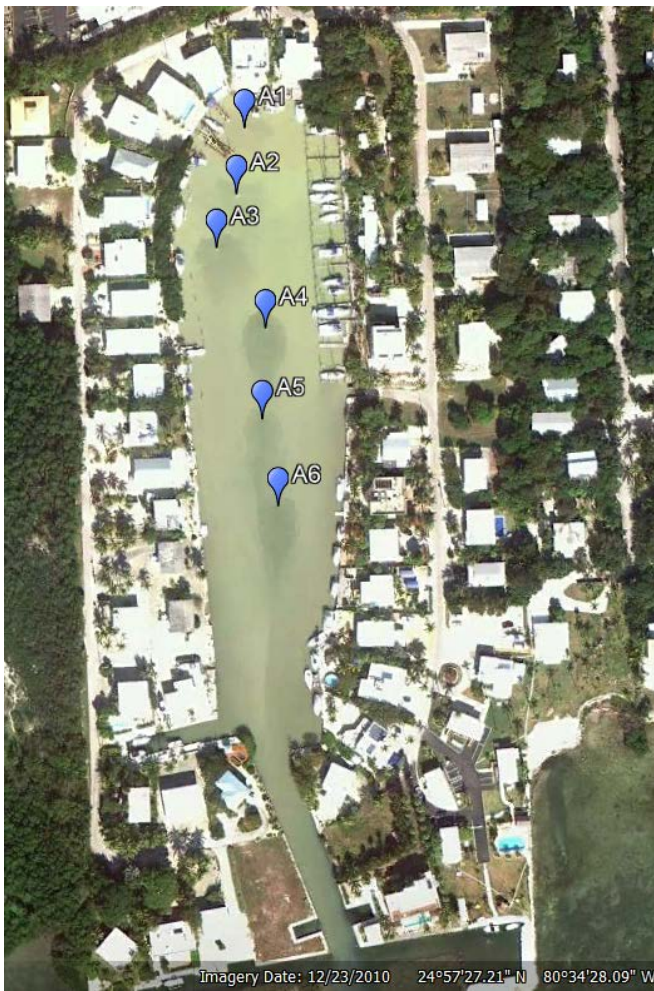
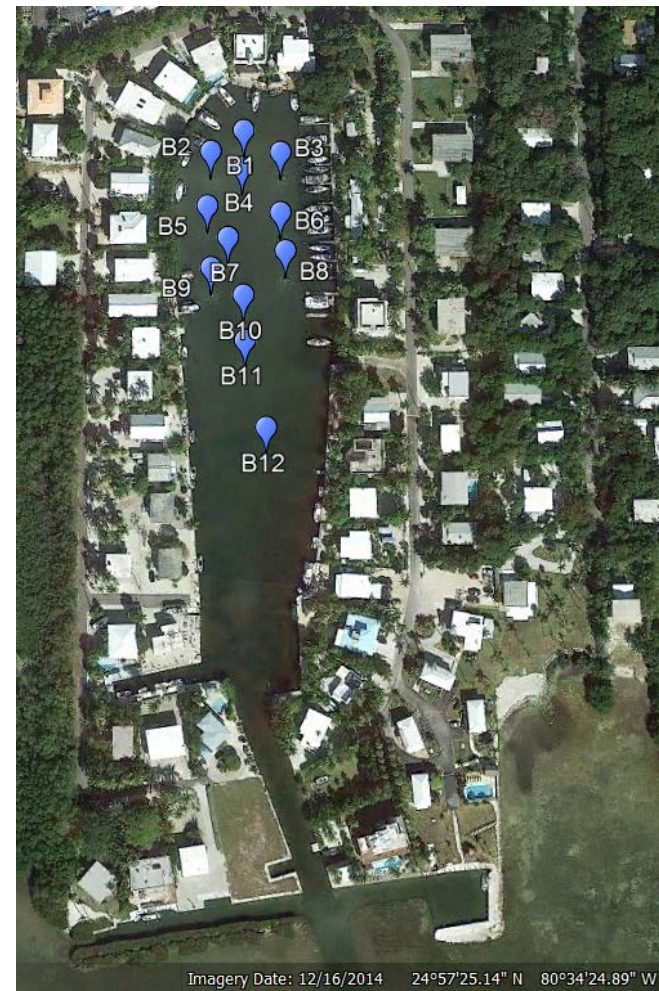
Canal 137

Weed barrier & Aerators

Before
(Dec 2010)

After
(Dec 2014)

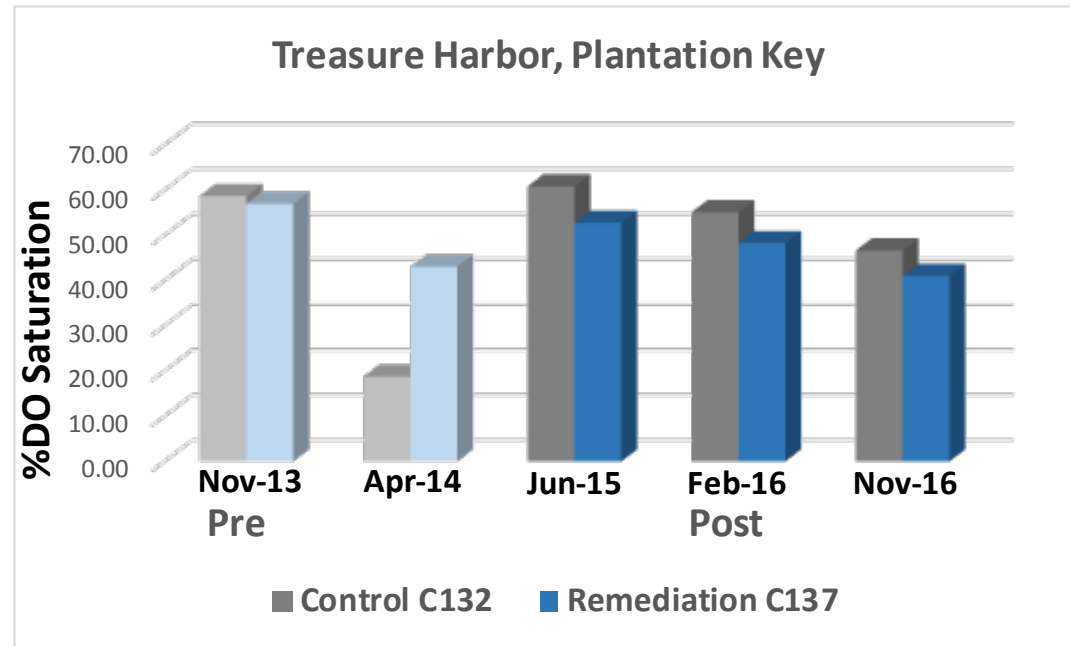
Treasure Harbor, Plantation Key

- No significant improvement wrt control
- Close coupling to Control canal in profiles

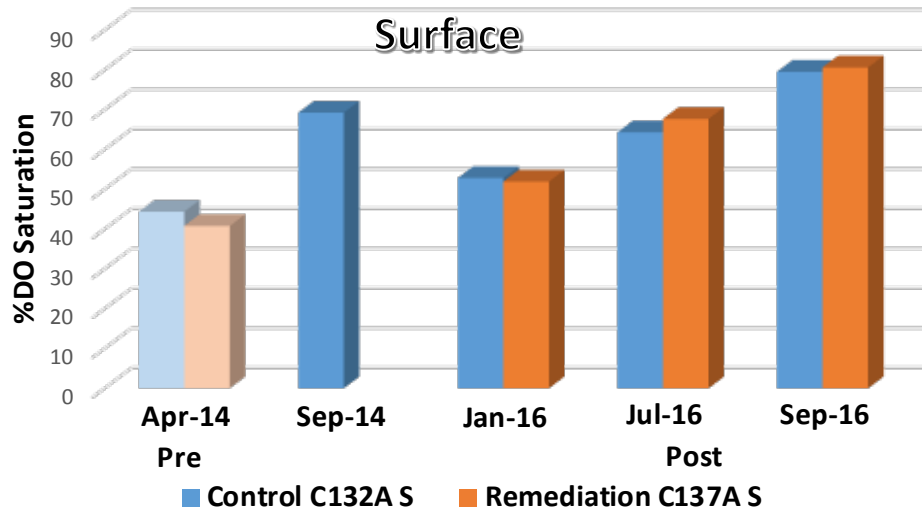
Surface

- Some improvement wrt control in Diels
- Close coupling to Control canal in surface but bottom improves

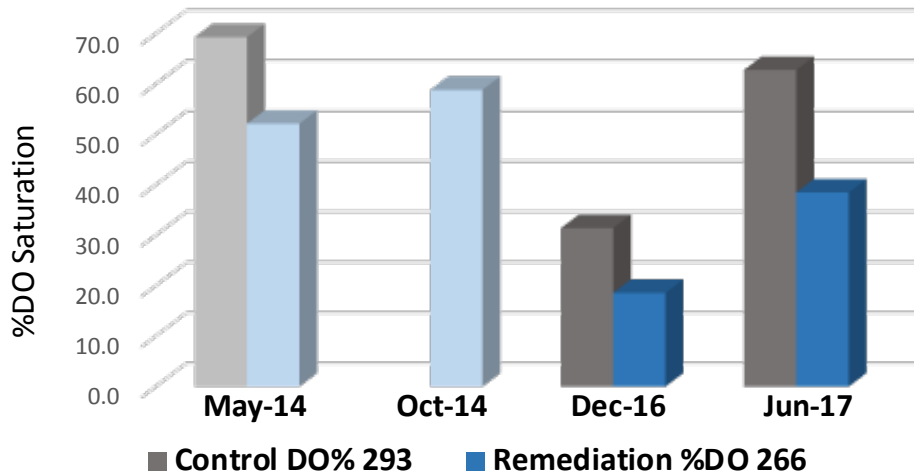
Dr Arm Subdivision. Big Pine

- No significant improvement wrt control or remediation
- Slight coupling to Control canal

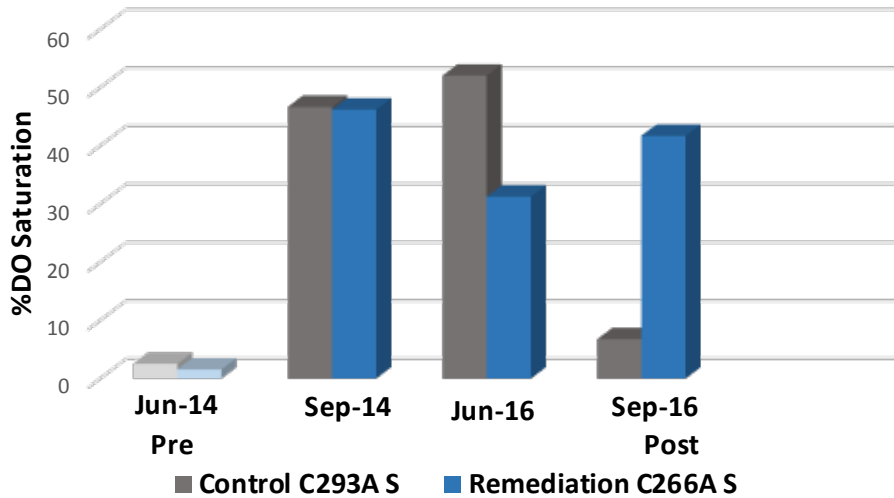
Dr Arm. Big Pine Key

- Slight improvement in surface waters but still with many readings <42% DO Sat

- Significant improvement wrt remediation. Values higher than control and approaching compliance.

- Decoupling with Control canal

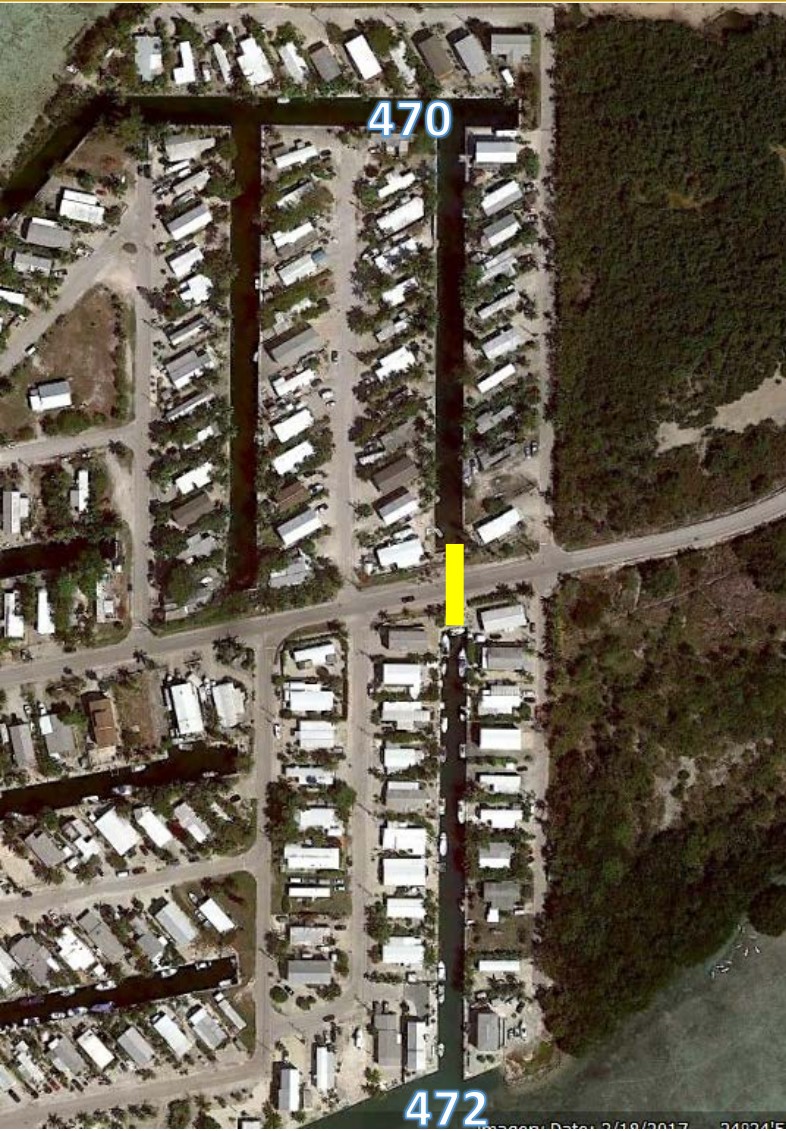
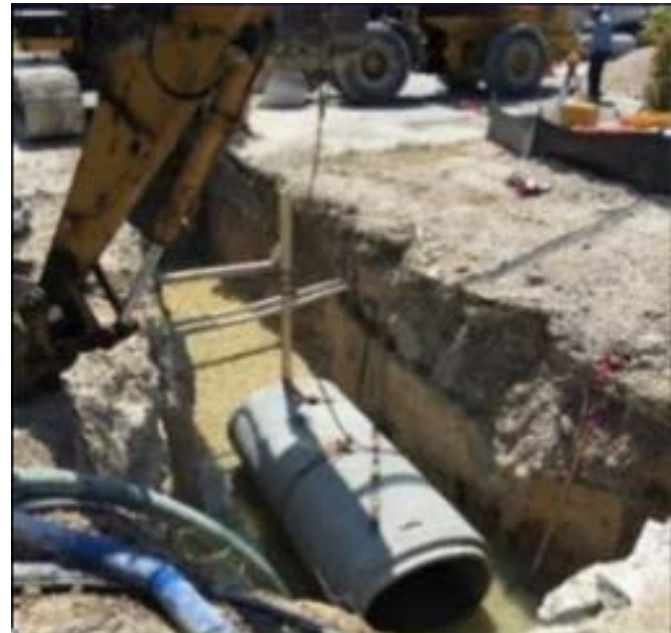
Canal 472

Installation of 112 foot 24" by 38" concrete culvert

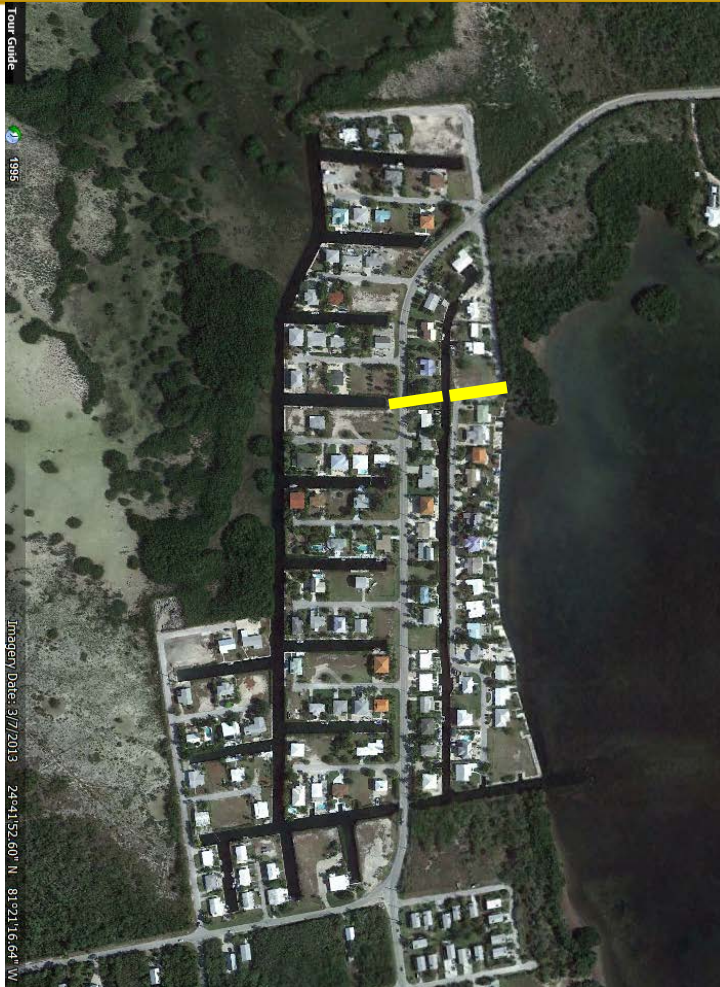
Culvert Installation Tropical Bay, Big Pine Key Canal 277

Installation of a 200 foot 60" concrete culvert
