# Tidal Inlet Protection Strategies for Oil-Spill Response

## U.S. Coast Guard Sector St. Petersburg

October 2011

Prepared by Miles O. Hayes, Jeffrey Dahlin, and Joseph Holmes,  
Research Planning, Inc.

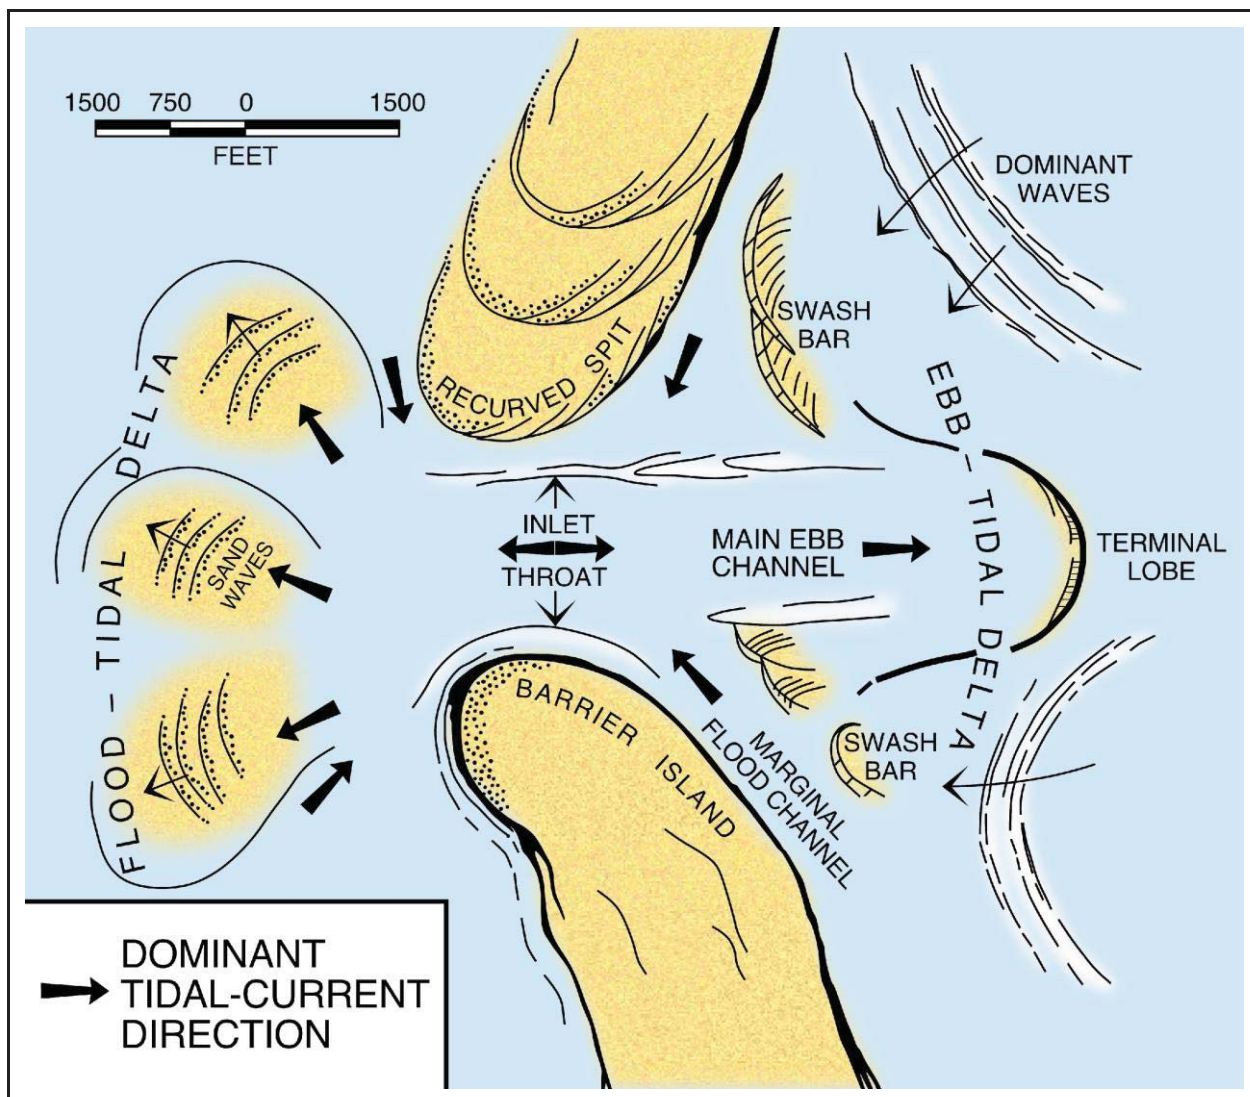
**FIGURE 3.** General model showing the morphological components of a typical tidal inlet.

As shown in Figure 3, a typical tidal inlet in a barrier island setting consists of a deep channel between the adjacent sand spits, called the inlet throat, and lobate-shaped sand bodies on either side of the inlet, called tidal deltas. The sand deposit on the landward side of the inlet, the flood-tidal delta, is typically composed of sheet-like lobes of sand with seaward-sloping ramps on their seaward sides covered by landward migrating waves of sand. The sand deposit on the seaward side of the inlet, the ebb-tidal delta, is built seaward by ebb-tidal currents, but waves mould the outer margins into an arcuate shape and build landward migrating intertidal bars (swash bars) on the delta surface. The tidal flow on the ebb-tidal delta is horizontally segregated, with the main ebb channel, which usually projects perpendicular to shore off the inlet throat, being dominated by ebb-tidal currents. Shallower, flood-dominant channels (marginal flood channels) flank both sides of the ebb-tidal delta (Figure 3). The marginal flood channels are important in oil-spill response because the first waters to enter the inlet during the rising tide flow along these channels, even as residual ebb-tidal currents are flowing out of the main ebb channel. This allows for a period of time (one hour or so) when any oil heading landward would be moving only through the marginal flood channels, during which time it could possibly be diverted to the adjacent sand beach, rather than allowing it to enter the inlet and the highly sensitive bay/estuary behind it.

Because of complexities related to their drainage networks, tidal inlets in this USCG Sector can be ebb-dominated, flood-dominated, or neutral with respect to the sediment transport capacities of the inlets. Ebb-dominated inlets have larger ebb-tidal deltas (Figure 3) than flood-tidal deltas, and vice versa. Neutral inlets, which are fairly rare, have equal sized flood- and ebb-tidal deltas. Based on an examination of the geomorphology of the inlets of this USCG Sector (carried out in 1995), 21 of the 35 open inlets were ebb dominant, 10 were flood dominant, 3 were neutral, and one could not be interpreted. The prevalence of ebb dominance in these inlets probably results from the excessive tidal prisms created by the large bays in the area, plus other as yet unstudied factors.

**Ebb-tidal delta.** Lobate accumulation of sand at the seaward margin of the primary entrance channel to a tidal inlet. Formed as a result of deceleration of ebb-tidal currents. Modified by waves (see Figure 3).

**Flood-tidal delta.** Lobate accumulation of sand at the seaward margin of the primary entrance channel to a tidal inlet. Formed as a result of deceleration of flood-tidal currents (see Figure 3).

**Main ebb channel.** Deep channel through ebb-tidal delta, scoured by ebb-tidal currents, that projects seaward directly away from the inlet throat (see Figure 3).

**Marginal flood channel.** Component of ebb-tidal delta resulting from horizontal segregation of tidal current flow. An ebb-tidal delta usually has two marginal flood channels which are oriented obliquely to the main ebb channel and roughly parallel to the adjacent beaches (see Figure 3).

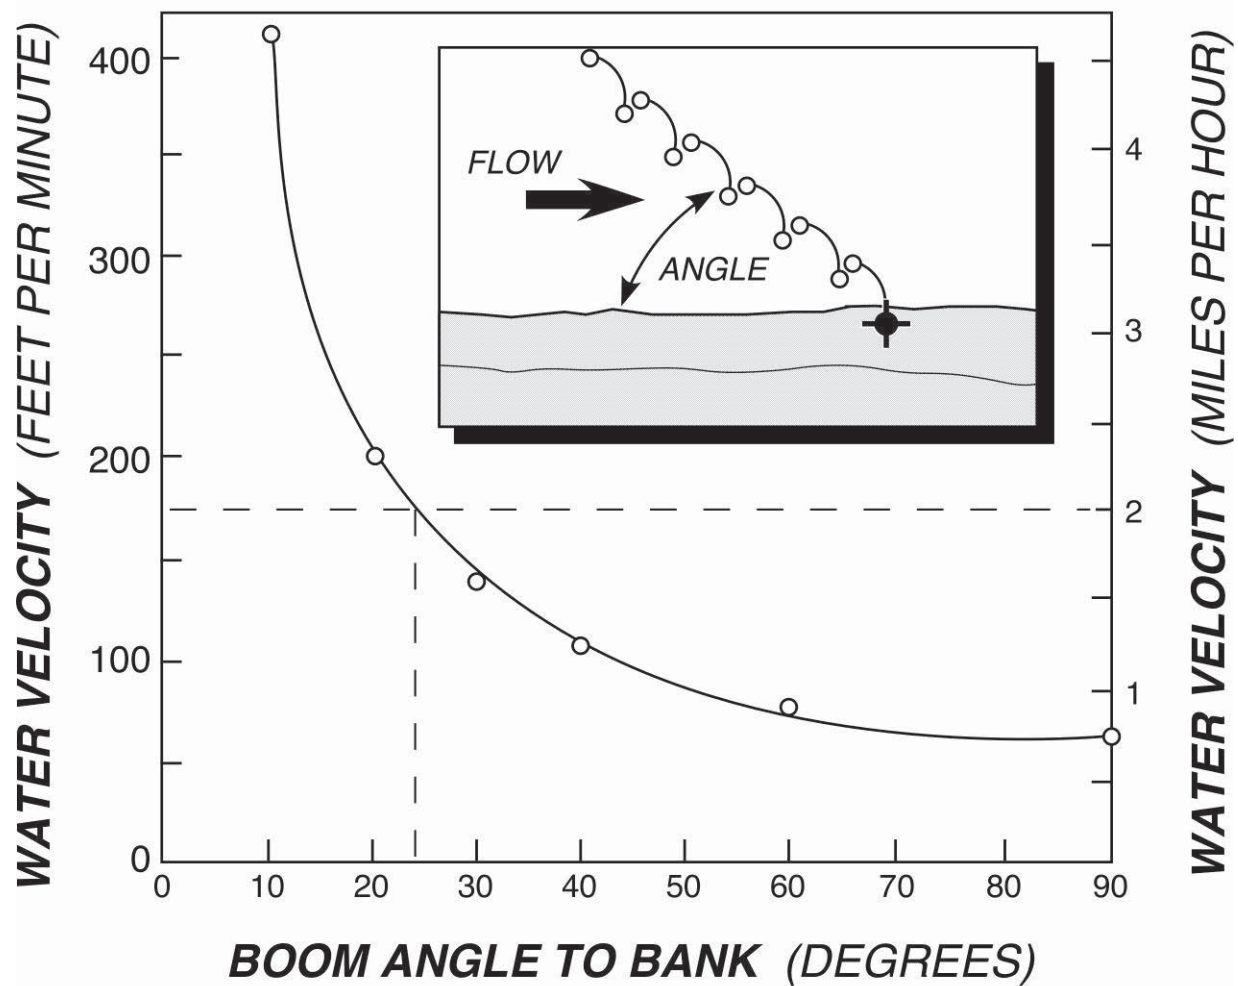
## BOOM ANGLES FOR VARIOUS CURRENTS

- When oil is on the water, the first priority is containment and the second is recovery.
- Following guidelines established by the U.S. Coast Guard Strike Team, we conclude that deflection booms are the best means of controlling oil in the vicinity of tidal inlets because of the common occurrence of tidal currents greater than 0.7 knots, the threshold velocity for entrainment of oil past a boom set at 90° to the current (see diagram in Figure 5).

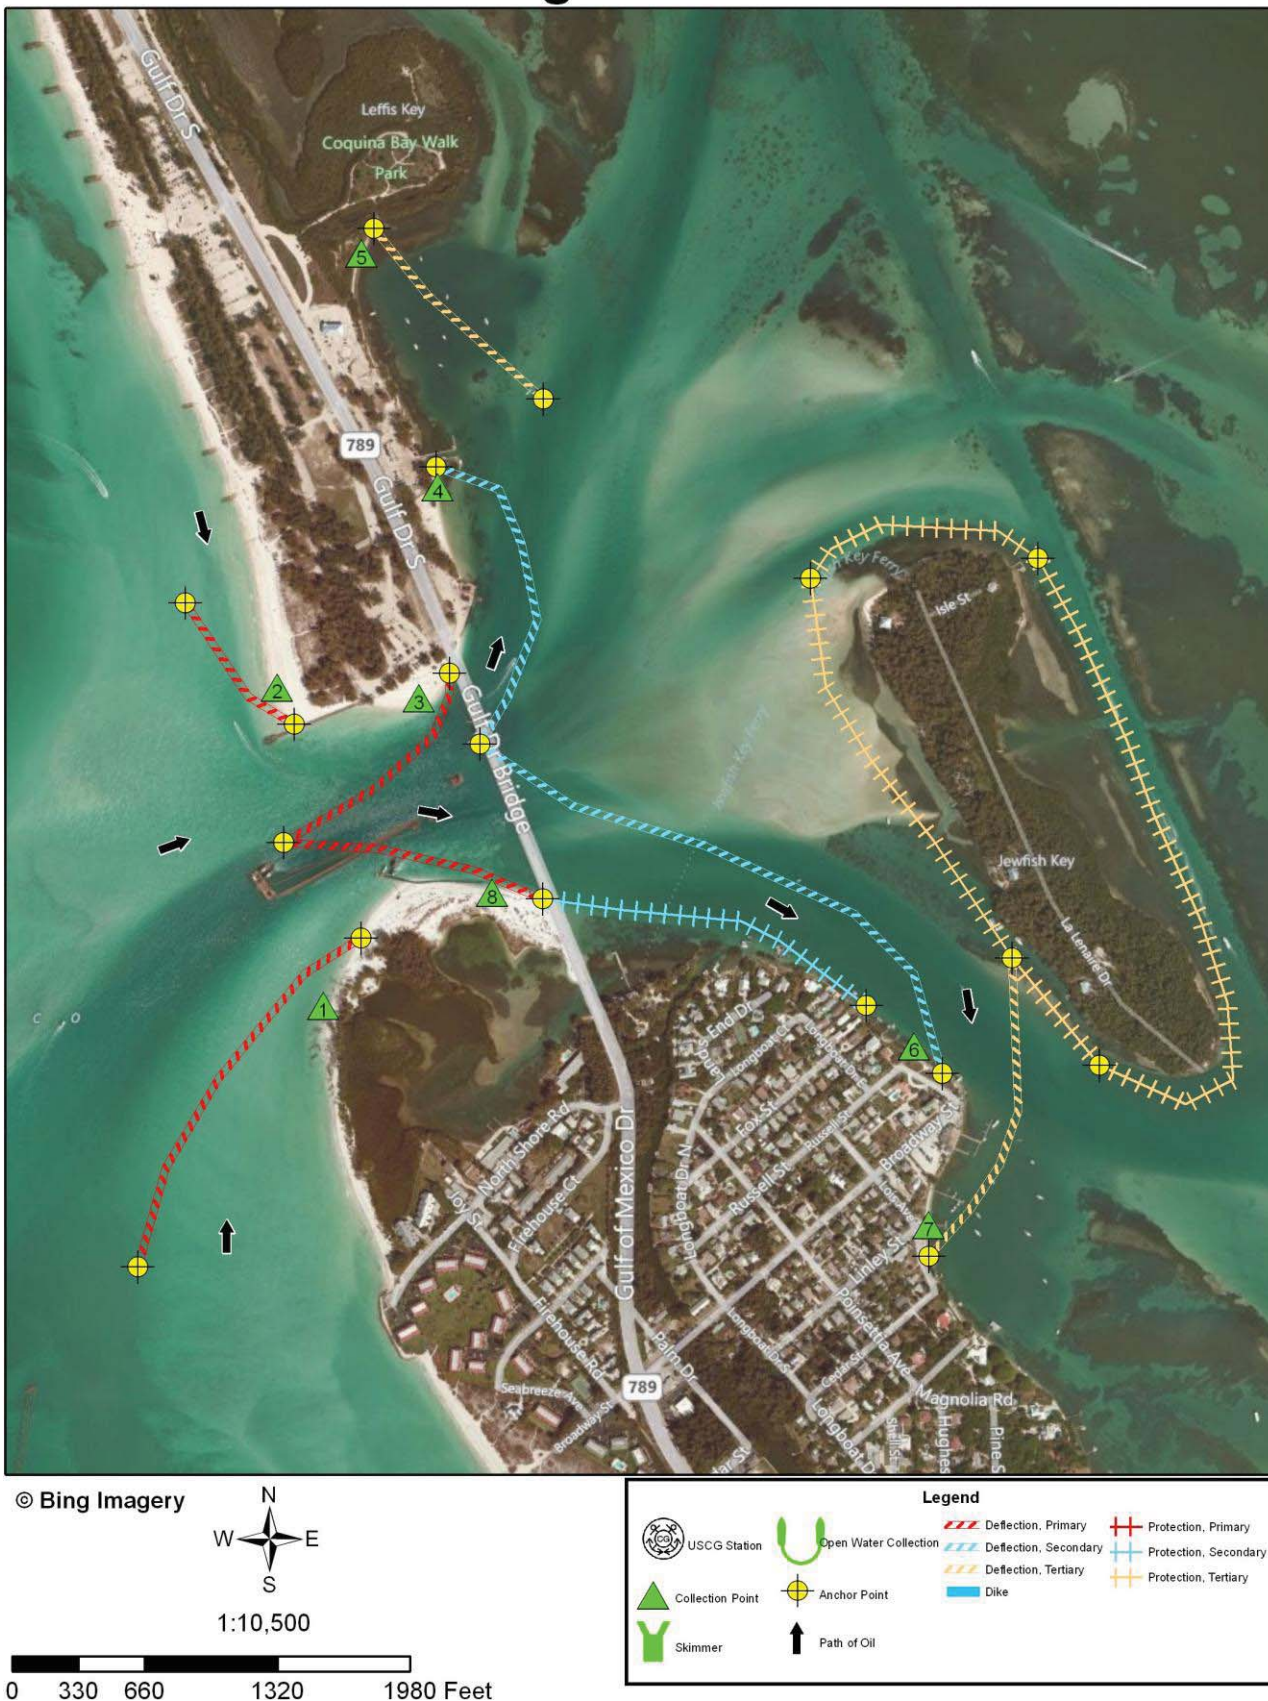
**FIGURE 6.** Flood-tide protection strategy recommended for Longboat Pass.

An example of how one of the protection strategies completed in October 2011, Longboat Pass, is presented graphically in Figure 6. The first step recommended is to divert oil entering the inlet through the marginal flood channels to collection points along the outer beaches (collection points 1 and 2). Next, erect a Christmas tree configuration of deflection boom with the lead anchor point being in the main inlet channel parallel with the outer beach shoreline. The north limb of this Christmas tree would divert oil to the sand beach on the south end of Anna Maria Island (collection point 3), and the south limb would divert oil to the sand beach on the north end of Longboat Key (just west of where the Route 789 Bridge across Longboat Pass meets the shore; collection point 8). Position the lead anchor point of another Christmas tree of deflection boom at the Route 789 Bridge that is designed to prevent oil from reaching the large and well-defined flood-tidal delta and the mangroves on Jewfish Key. The north limb of this Christmas tree would divert oil to a sand beach on the east shore of Anna Maria Island (collection point 4), and the south limb would divert oil to another sand beach on the northeast end of Longboat Key (collection point 6). About 400 yards north of collection point 4, extend a line of deflection boom out into the channel that would divert oil to the sand beach at collection point 5. About 300 yards south of collection point 6, extend a line of deflection boom all the way across the adjoining channel to Jewfish Key that would divert oil to the sand beach at collection point 7. Place a line of protection boom around the north end of Longboat Key east of collection point 8 in order to keep oil out of that zone of tidal flats and mangroves (in a side channel). Also place protection boom all the way around Jewfish Key to keep oil out of the abundant mangroves on that island

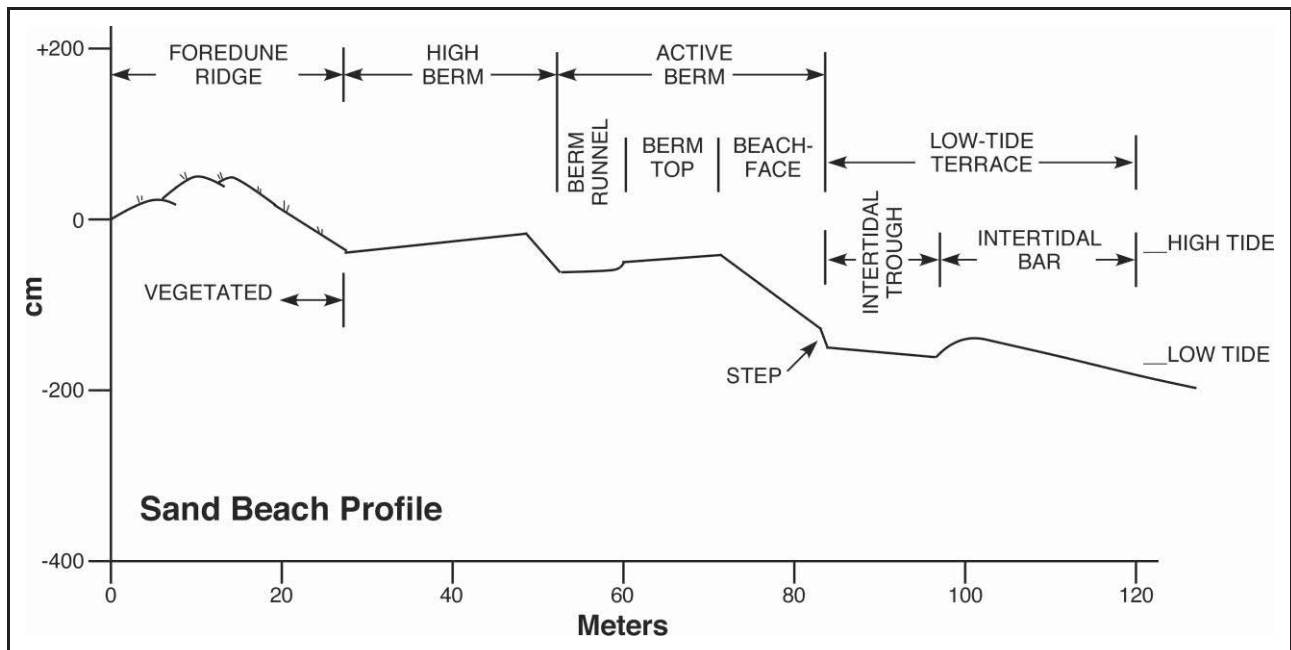
FIGURE 7. Nomenclature used for the sand beaches of Florida.

The typical sand beach morphology found in much of the Florida shoreline is illustrated in Figure 7. Sand beaches are normally planed off flat during storms.

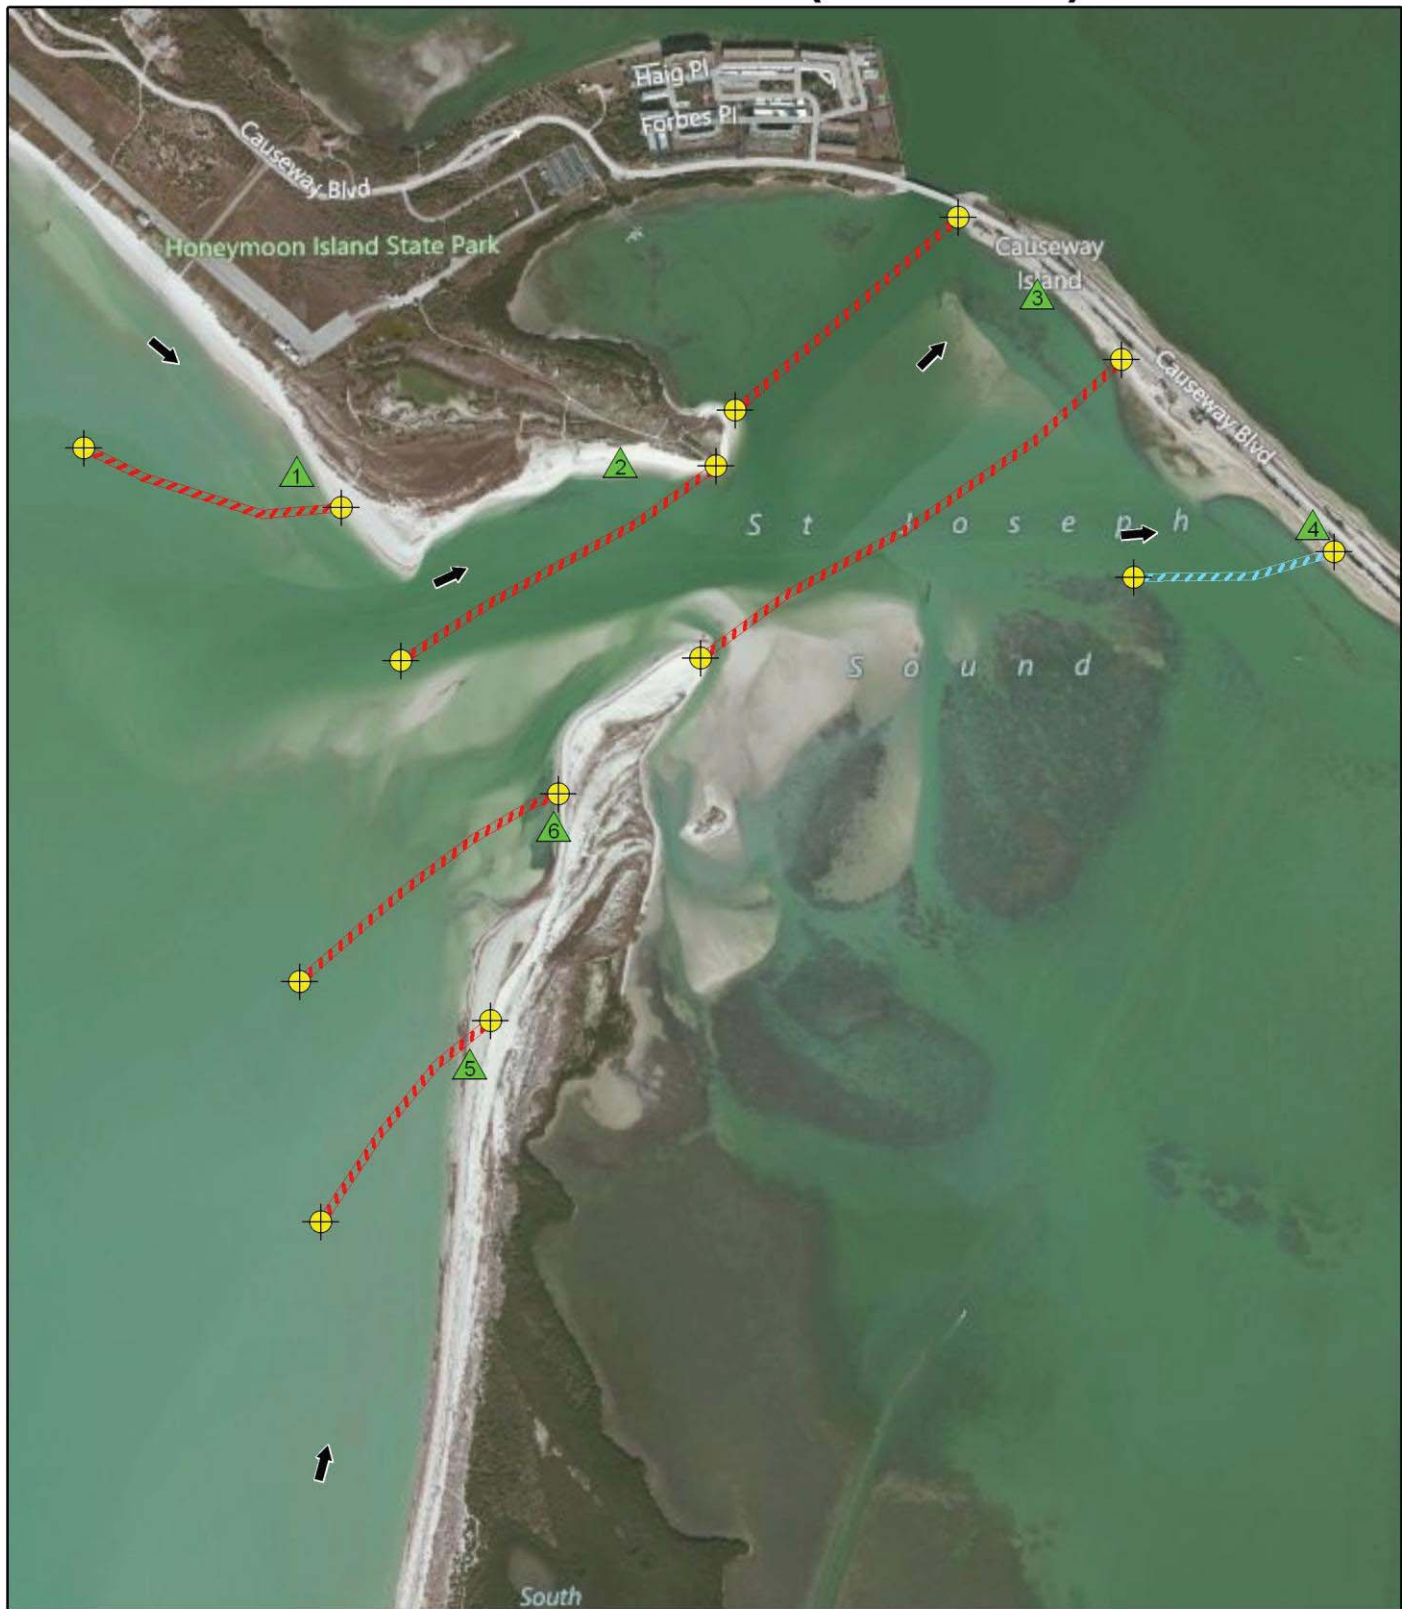
# Hurricane Pass (Pinellas)

Divert oil entering the inlet through the two marginal flood channels to collection points along the outer sand beaches (CPs 1, 5, and 6). Extend a line of deflection boom obliquely across the inlet entrance to divert oil to the beach on the north side of the inlet (CP2). Place two lines of deflection boom straight parallel with the main inlet channel to the fine-grained sand beach on Causeway Island (CP3). Place another line of deflection boom across the channel southeast of CP3 to also divert oil to the fine-grained sand beach on Causeway Island (CP4).

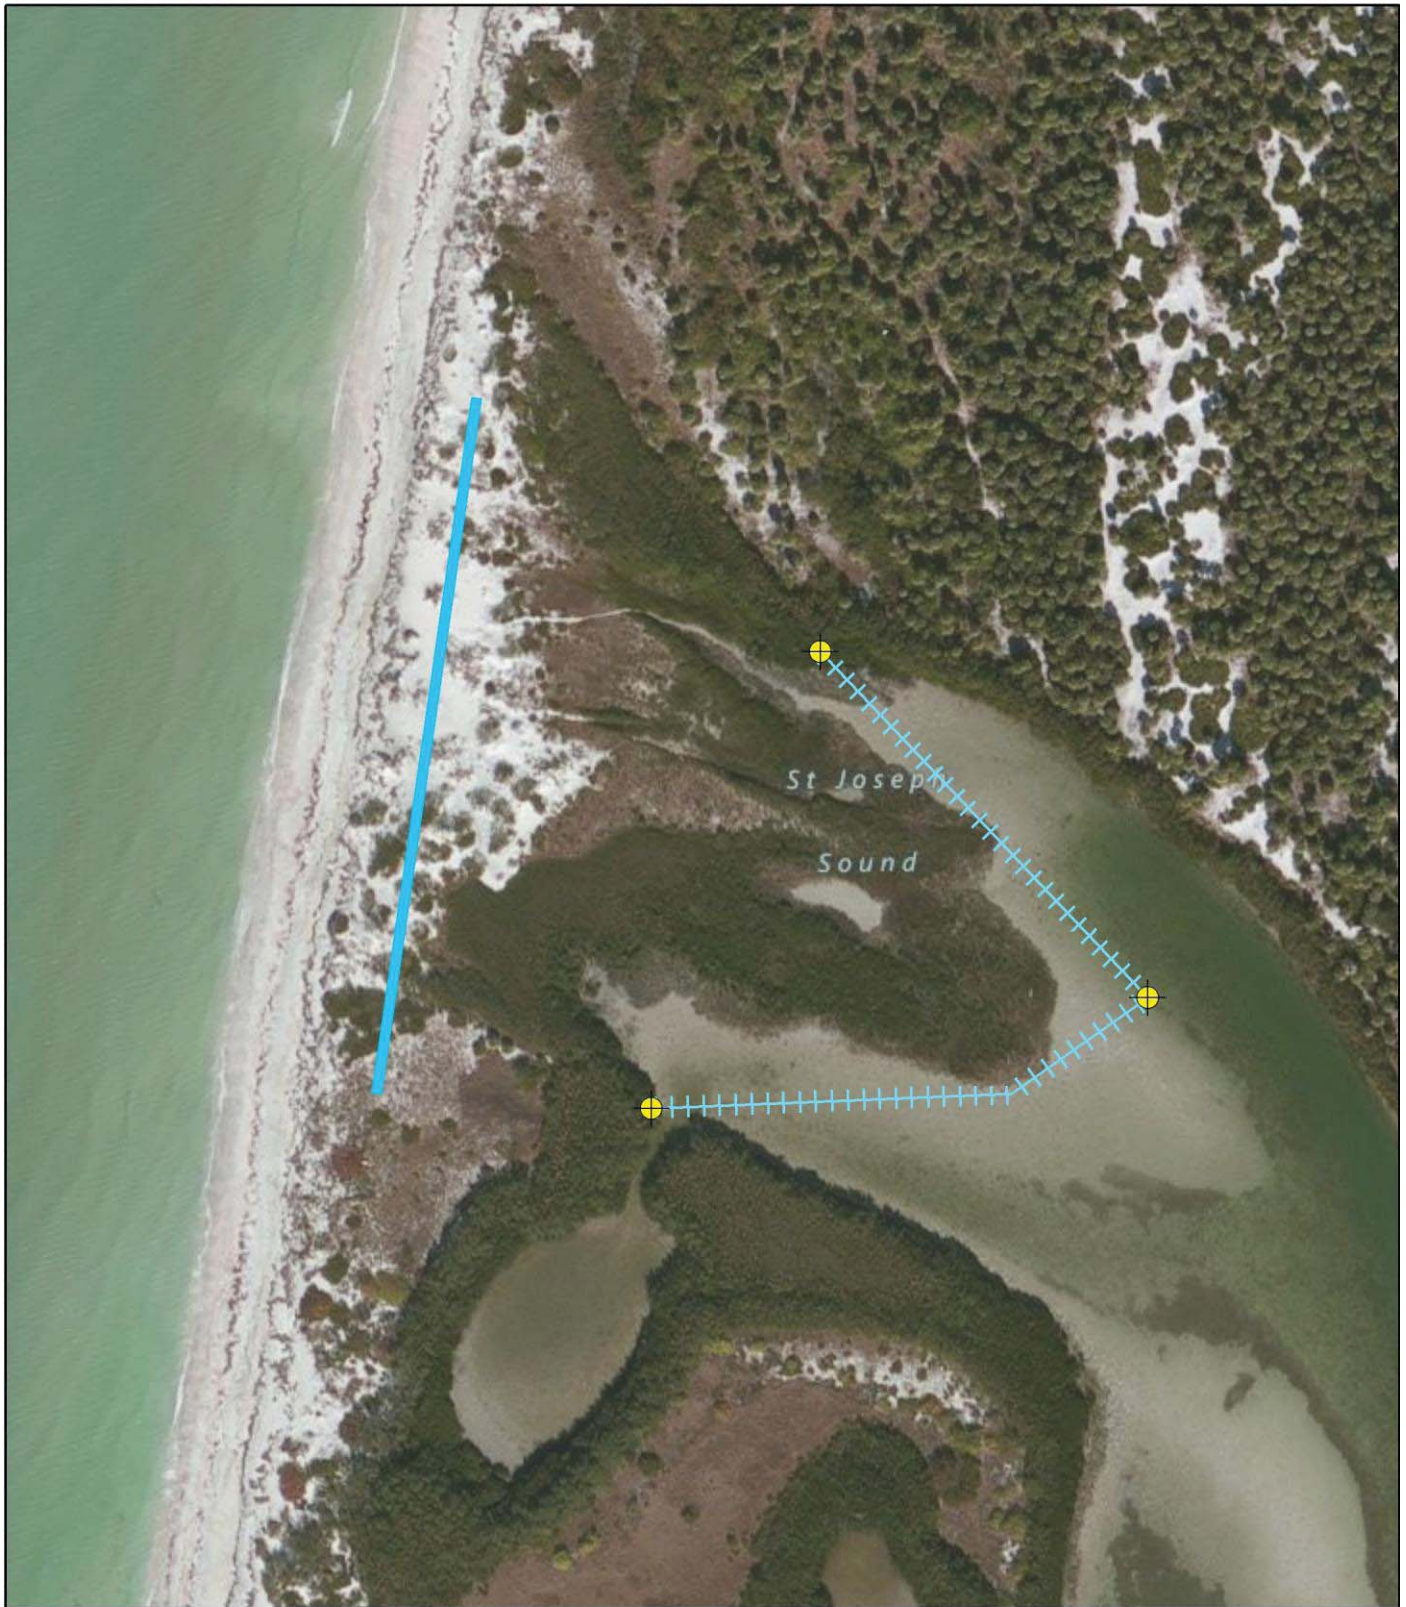
# Dunedin Pass

During the original survey, this inlet was closed (as it was during the later survey). Build a sediment dike on top of the washover terrace to prevent overwash that may occur during high spring tides that coincide with adverse conditions (strong winds and large waves). Boom off the landward side of the washover terrace to back up the dike.

The dike we are recommending is about 500 feet long.

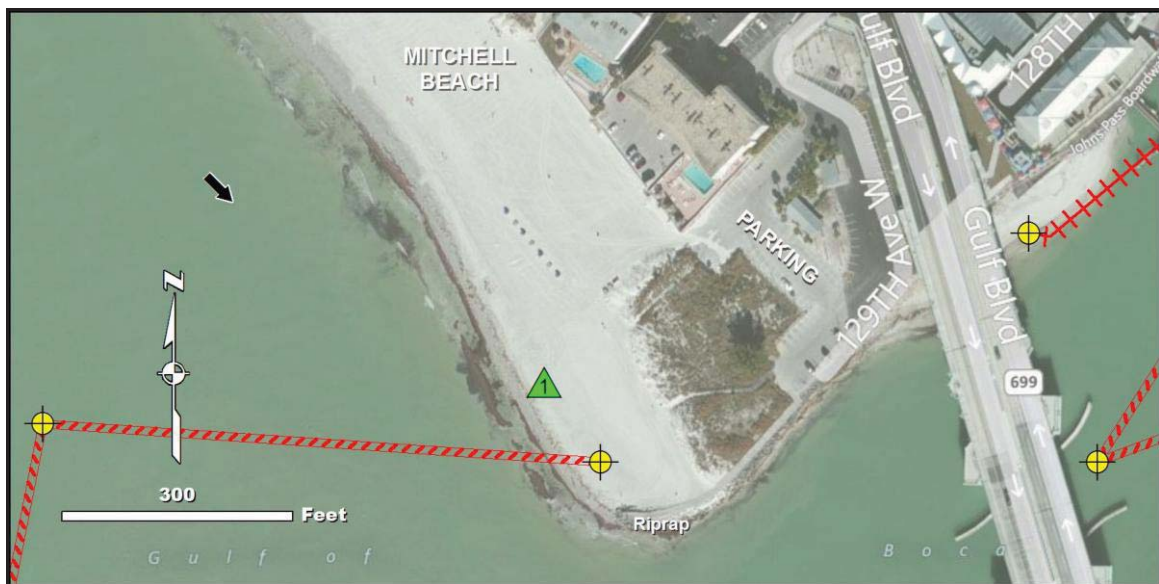
Shoreline Description: Sand beach. The deflection boom extends across the northern marginal flood channel of the very well defined ebb-tidal delta.

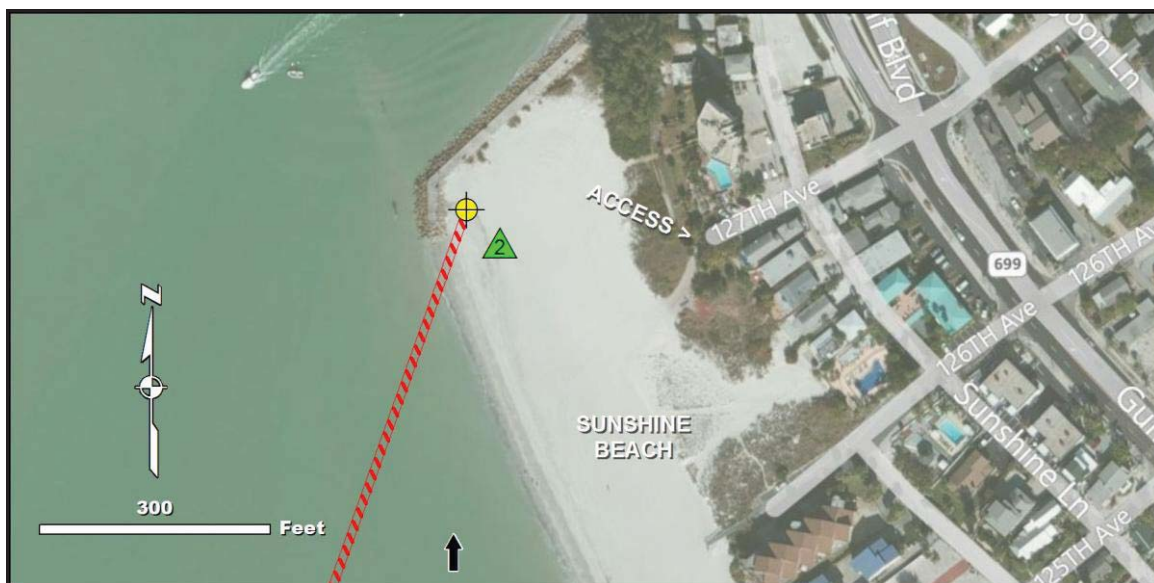
Shoreline Description: Sand beach. The deflection boom extends across the southern marginal flood channel of the very well defined ebb-tidal delta.

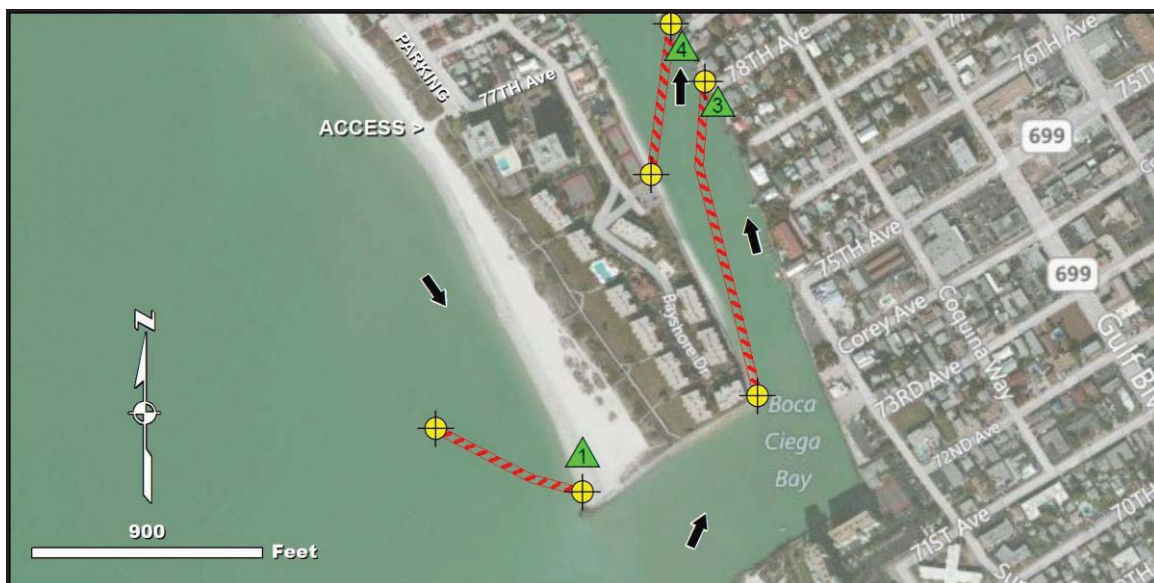
Shoreline Description: Sand beach.

Access: It looks as if you may be able to drive on this beach or possibly right behind it. A parking lot and access road is located 0.3 miles north of the jetty. Otherwise, you may have to use watercraft with access from the main inlet channel.

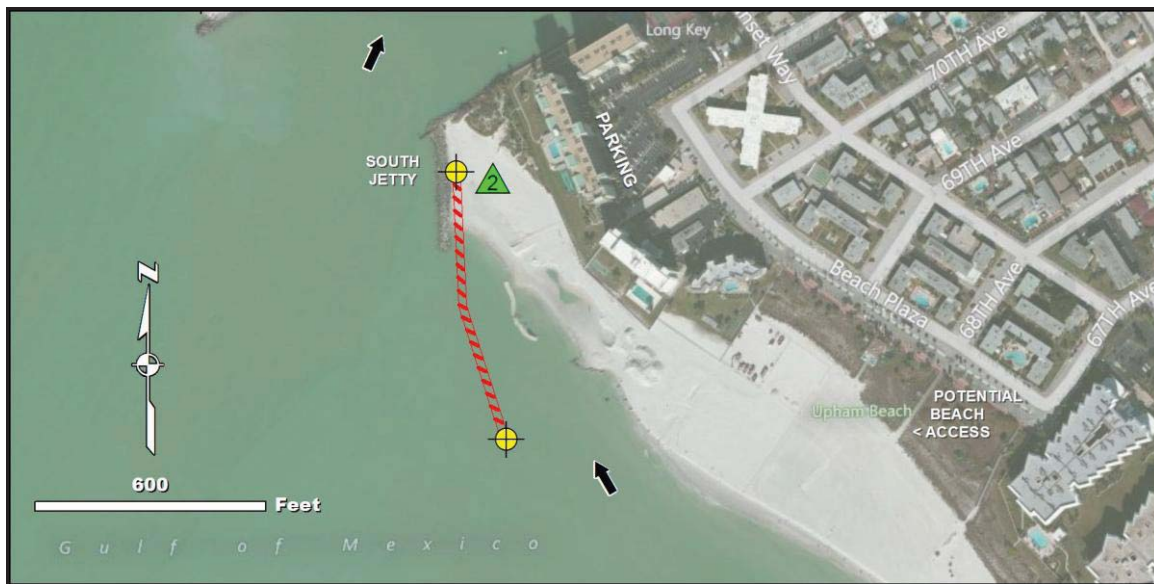
Shoreline Description: Sand beach with some riprap to the south and in the groin to the north, There is a seawall behind beach to the south.

Access: You would have to go across a grass lawn in between two condos. There is a large parking area nearby. In that case, you could drive to the seawall. However, if permission to cross this private property is not granted, you may have to use a watercraft, which would be difficult (across the riprap in the jetty??).

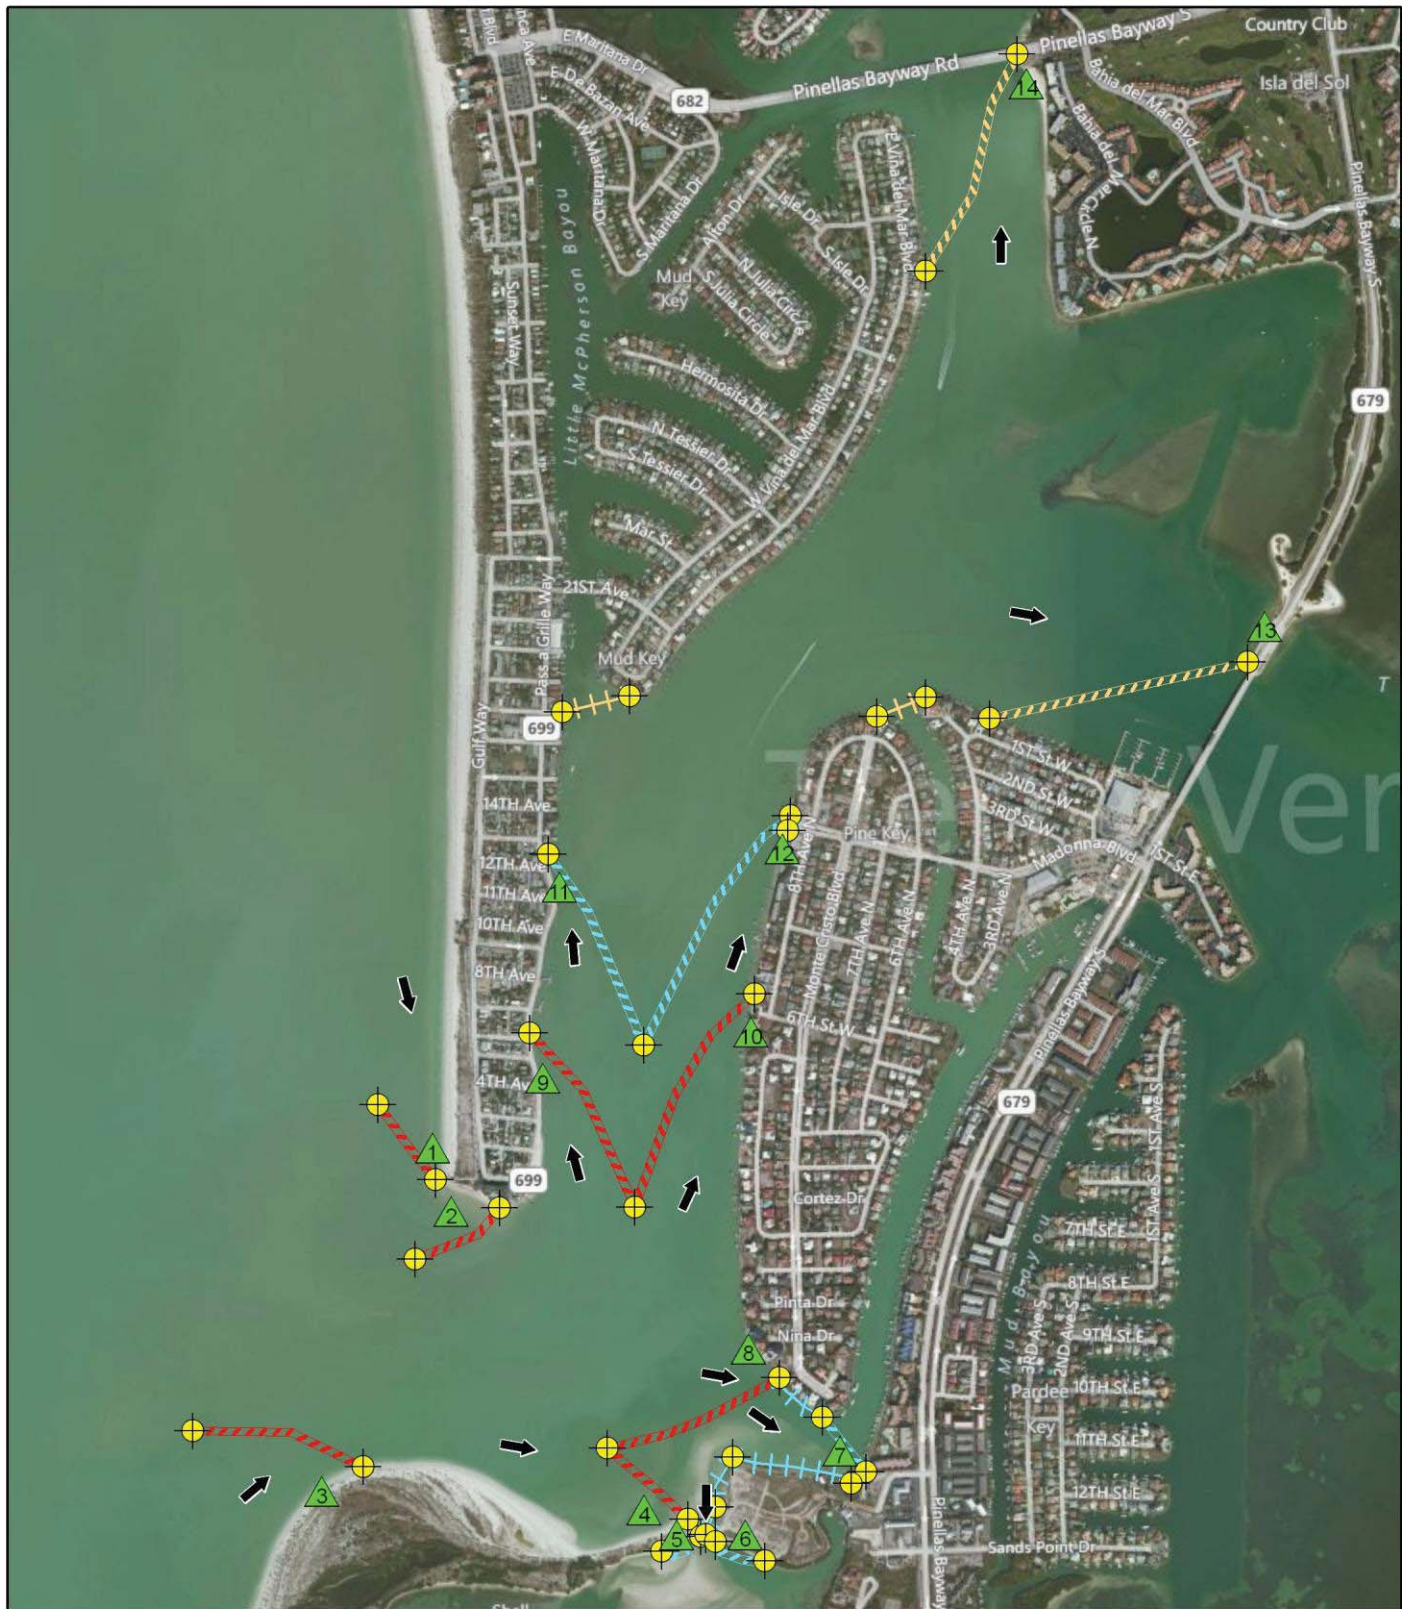
# North Channel and Passe-A-Grille

Although we do not have measured data, we suspect that there are some very strong tidal currents in this inlet based on the geomorphology.

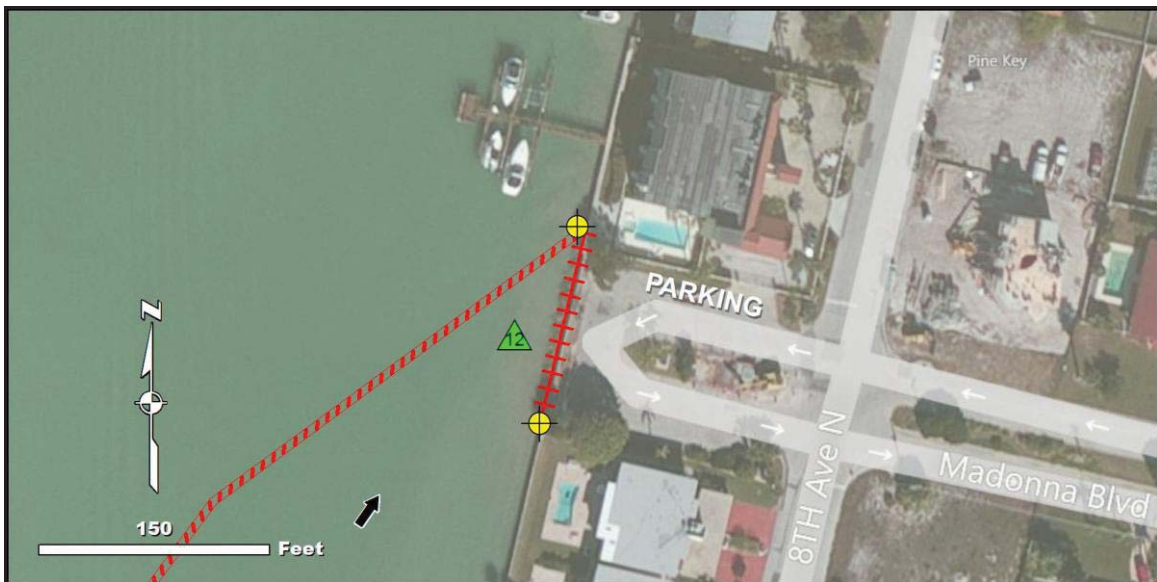
Shoreline Description: Seawall with riprap in front of it. Place protection boom along the riprap for the oil to accumulate on.

Access: Excellent. Parking area right by the seawall.

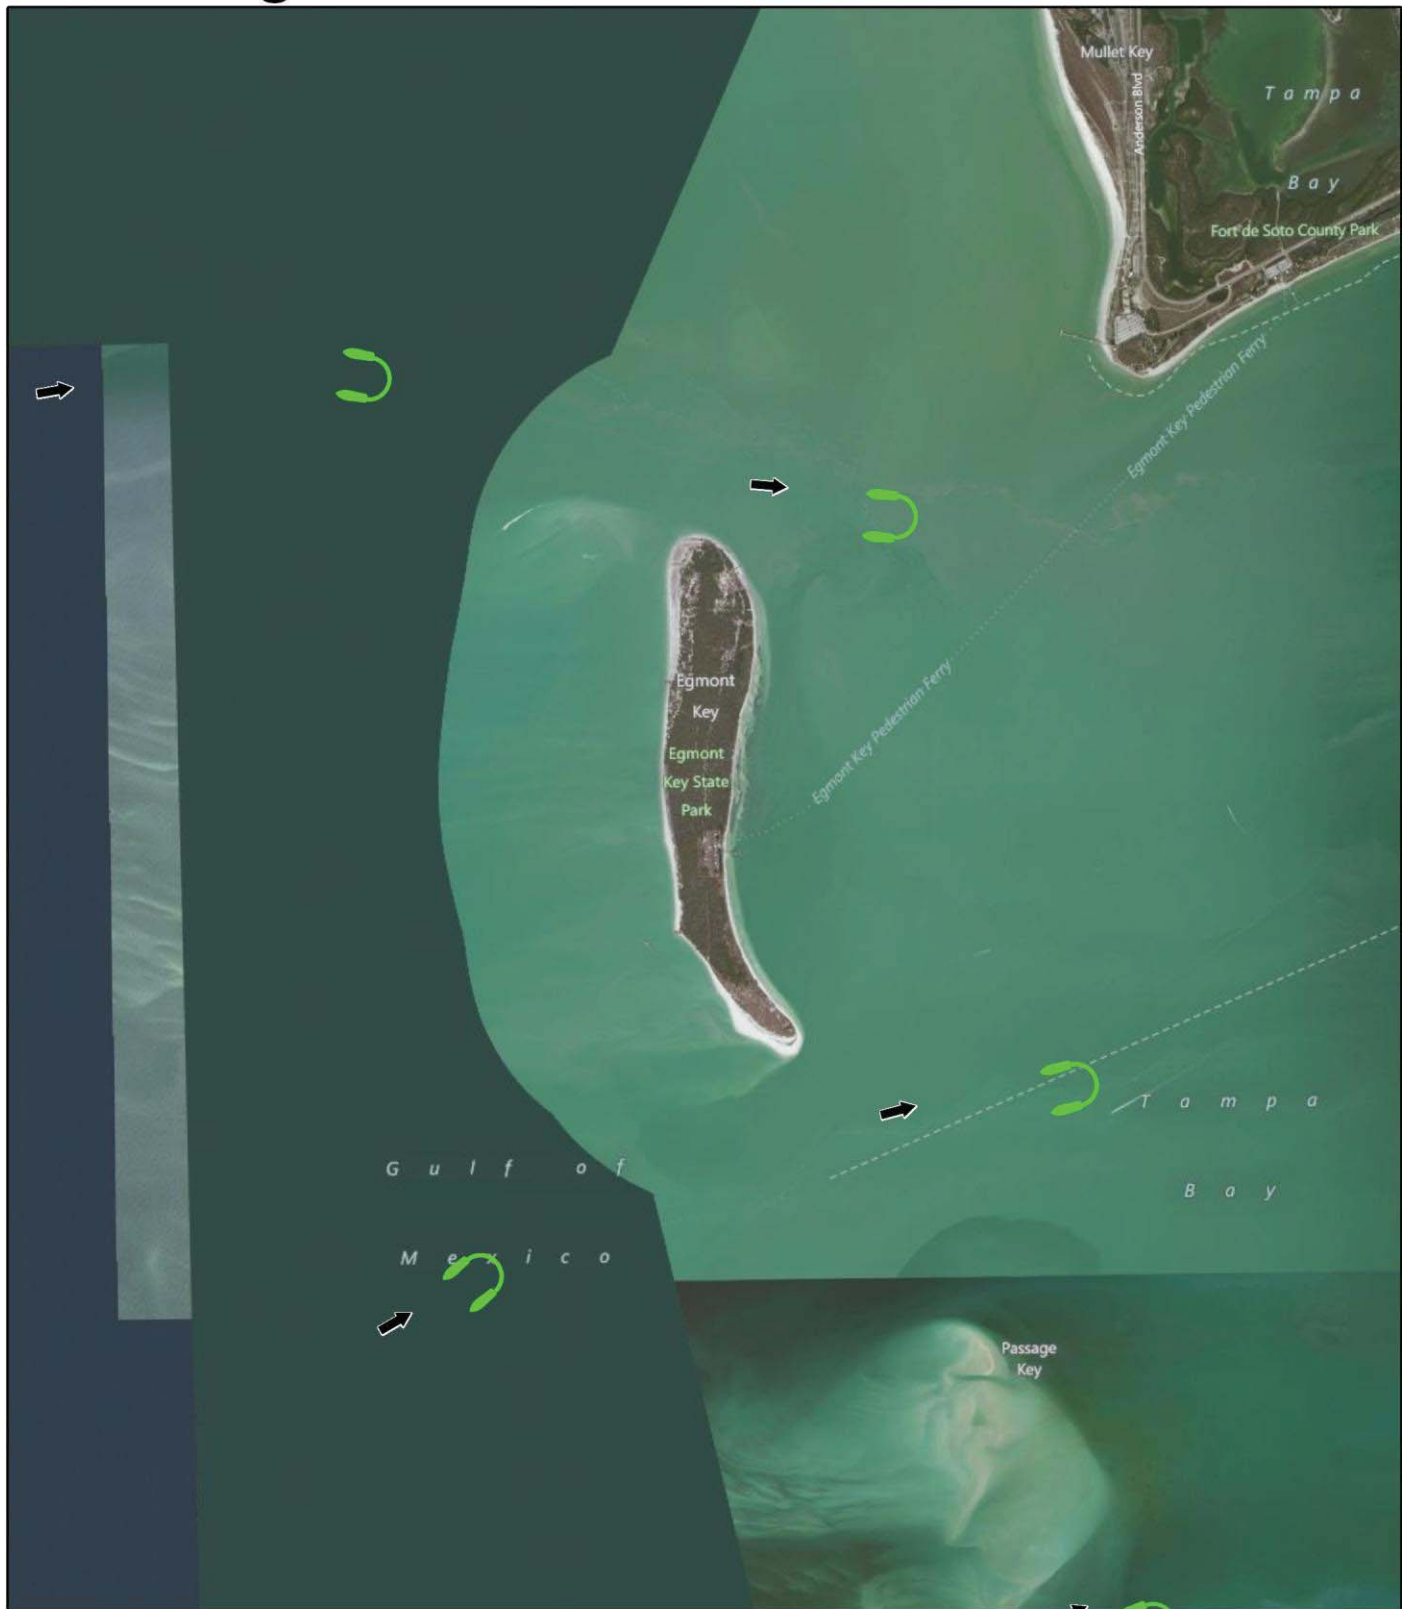
# Egmont and Southwest Channel

The 1995 NOAA Tidal Current Tables reported currents in Egmont Channel to be 1.3 knots at maximum flood and 1.3 knots at maximum ebb, and currents in Southwest Channel to be 0.8 knots at maximum flood and 1.2 knots at maximum ebb.
