# Tidal Inlet Protection Strategies for Oil-Spill Response

## U.S. Coast Guard Sector St. Petersburg

October 2011

Prepared by Miles O. Hayes, Jeffrey Dahlin, and Joseph Holmes,  
Research Planning, Inc.

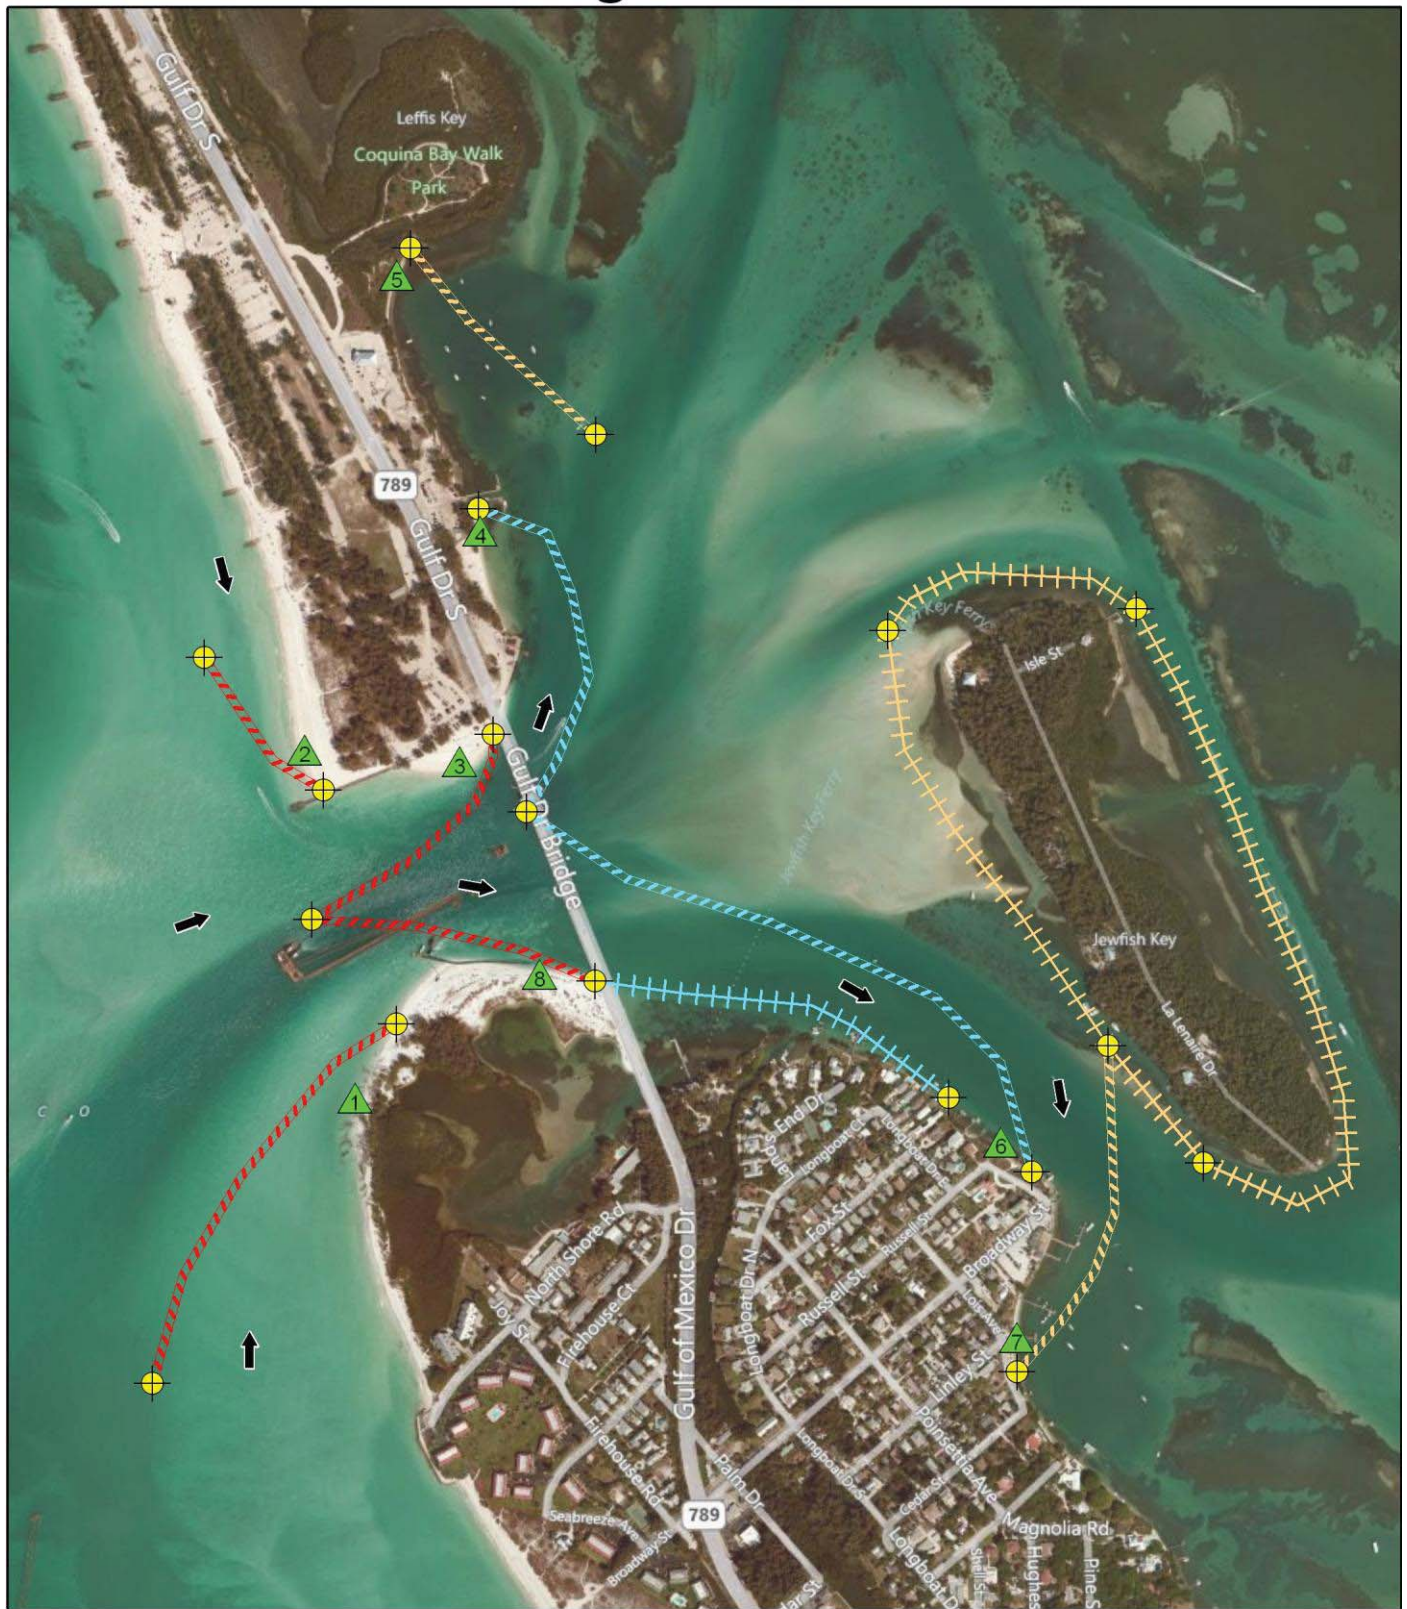
# Longboat Pass

The 1995 NOAA Tidal Current Tables reported currents in Longboat Pass to be 1.8 knots at maximum flood and 1.6 knots at maximum ebb.

An example of how one of the protection strategies completed in October 2011, Longboat Pass, is presented graphically in Figure 6. The first step recommended is to divert oil entering the inlet through the marginal flood channels to collection points along the outer beaches (collection points 1 and 2). Next, erect a Christmas tree configuration of deflection boom with the lead anchor point being in the main inlet channel parallel with the outer beach shoreline. The north limb of this Christmas tree would divert oil to the sand beach on the south end of Anna Maria Island (collection point 3), and the south limb would divert oil to the sand beach on the north end of Longboat Key (just west of where the Route 789 Bridge across Longboat Pass meets the shore; collection point 8). Position the lead anchor point of another Christmas tree of deflection boom at the Route 789 Bridge that is designed to prevent oil from reaching the large and well-defined flood-tidal delta and the mangroves on Jewfish Key. The north limb of this Christmas tree would divert oil to a sand beach on the east shore of Anna Maria Island (collection point 4), and the south limb would divert oil to another sand beach on the northeast end of Longboat Key (collection point 6). About 400 yards north of collection point 4, extend a line of deflection boom out into the channel that would divert oil to the sand beach at collection point 5. About 300 yards south of collection point 6, extend a line of deflection boom all the way across the adjoining channel to Jewfish Key that would divert oil to the sand beach at collection point 7. Place a line of protection boom around the north end of Longboat Key east of collection point 8 in order to keep oil out of that zone of tidal flats and mangroves (in a side channel). Also place protection boom all the way around Jewfish Key to keep oil out of the abundant mangroves on that island

**FIGURE 6.** Flood-tide protection strategy recommended for Longboat Pass.

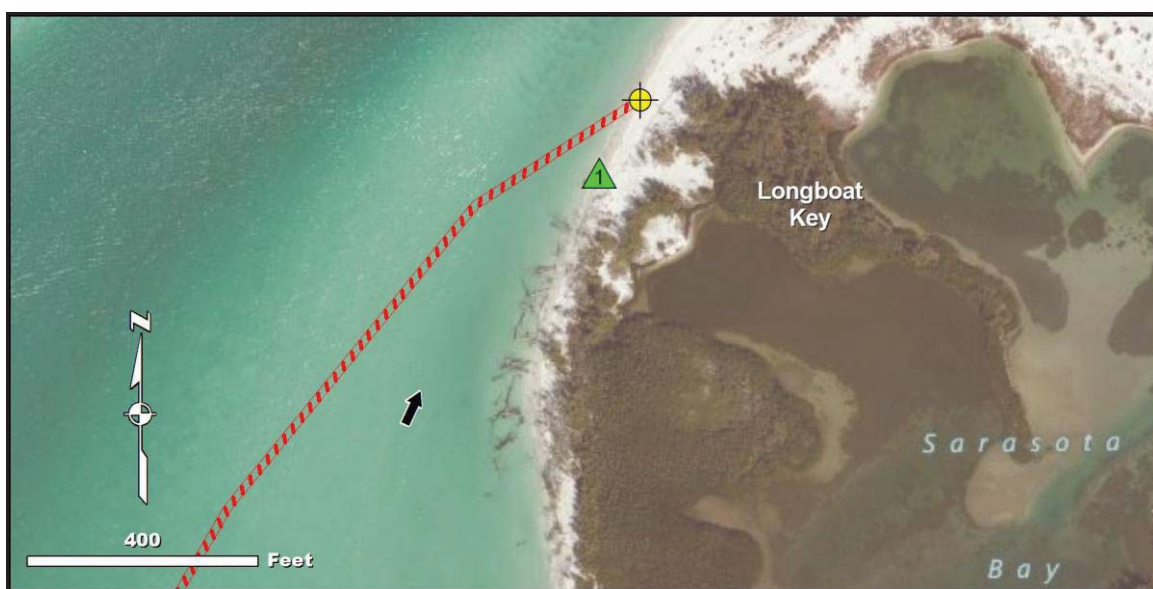
Shoreline Description: Sand beach; eroding with some fallen down trees in the surf; Boom extends offshore into a shallow marginal flood channel (almost into the main ebb channel) of the ebb-tidal delta which is offset markedly to the south.

Access: By watercraft.

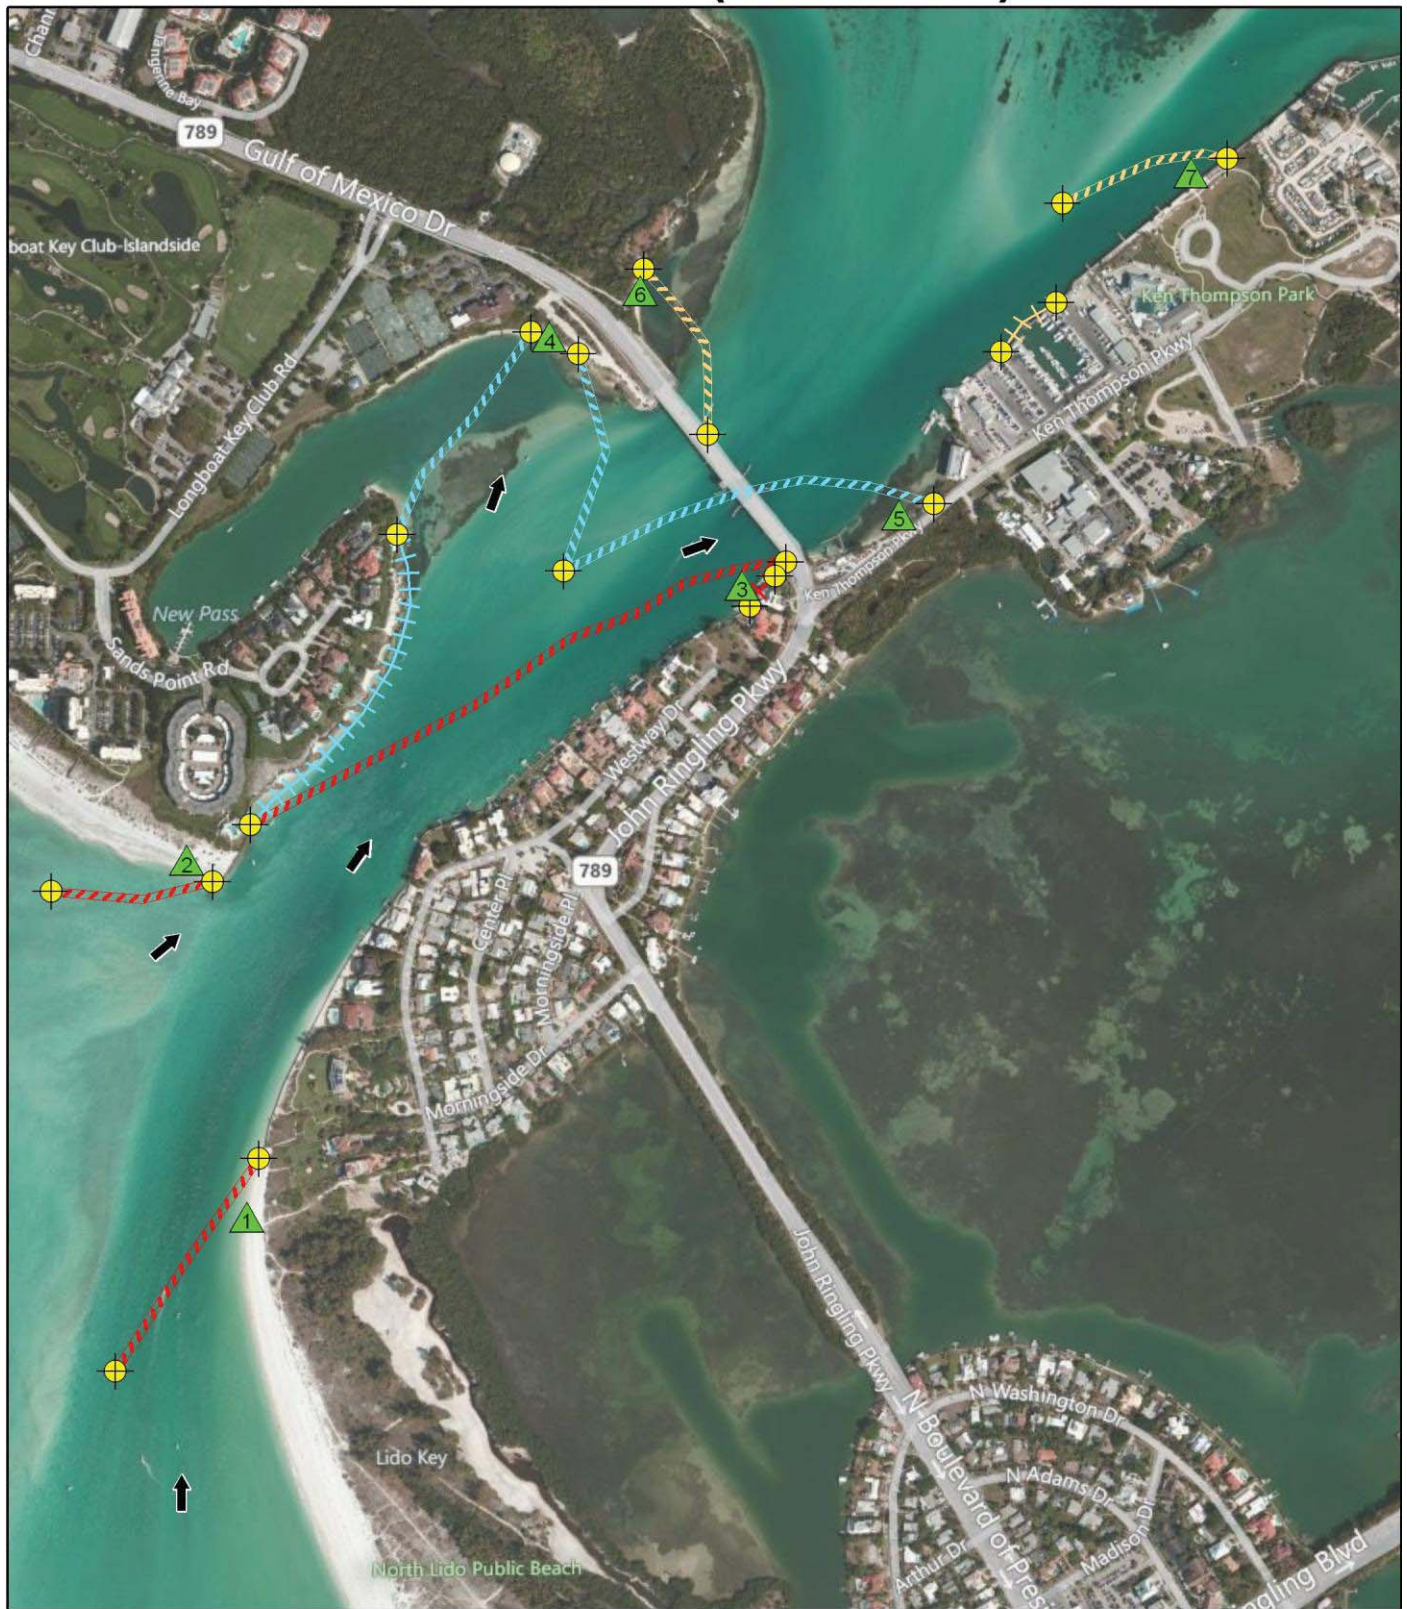
# New Pass (Sarasota)

The 1995 NOAA Tidal Current Tables reported currents in New Pass to be 1.6 knots at maximum flood and 1.0 knots at maximum ebb.

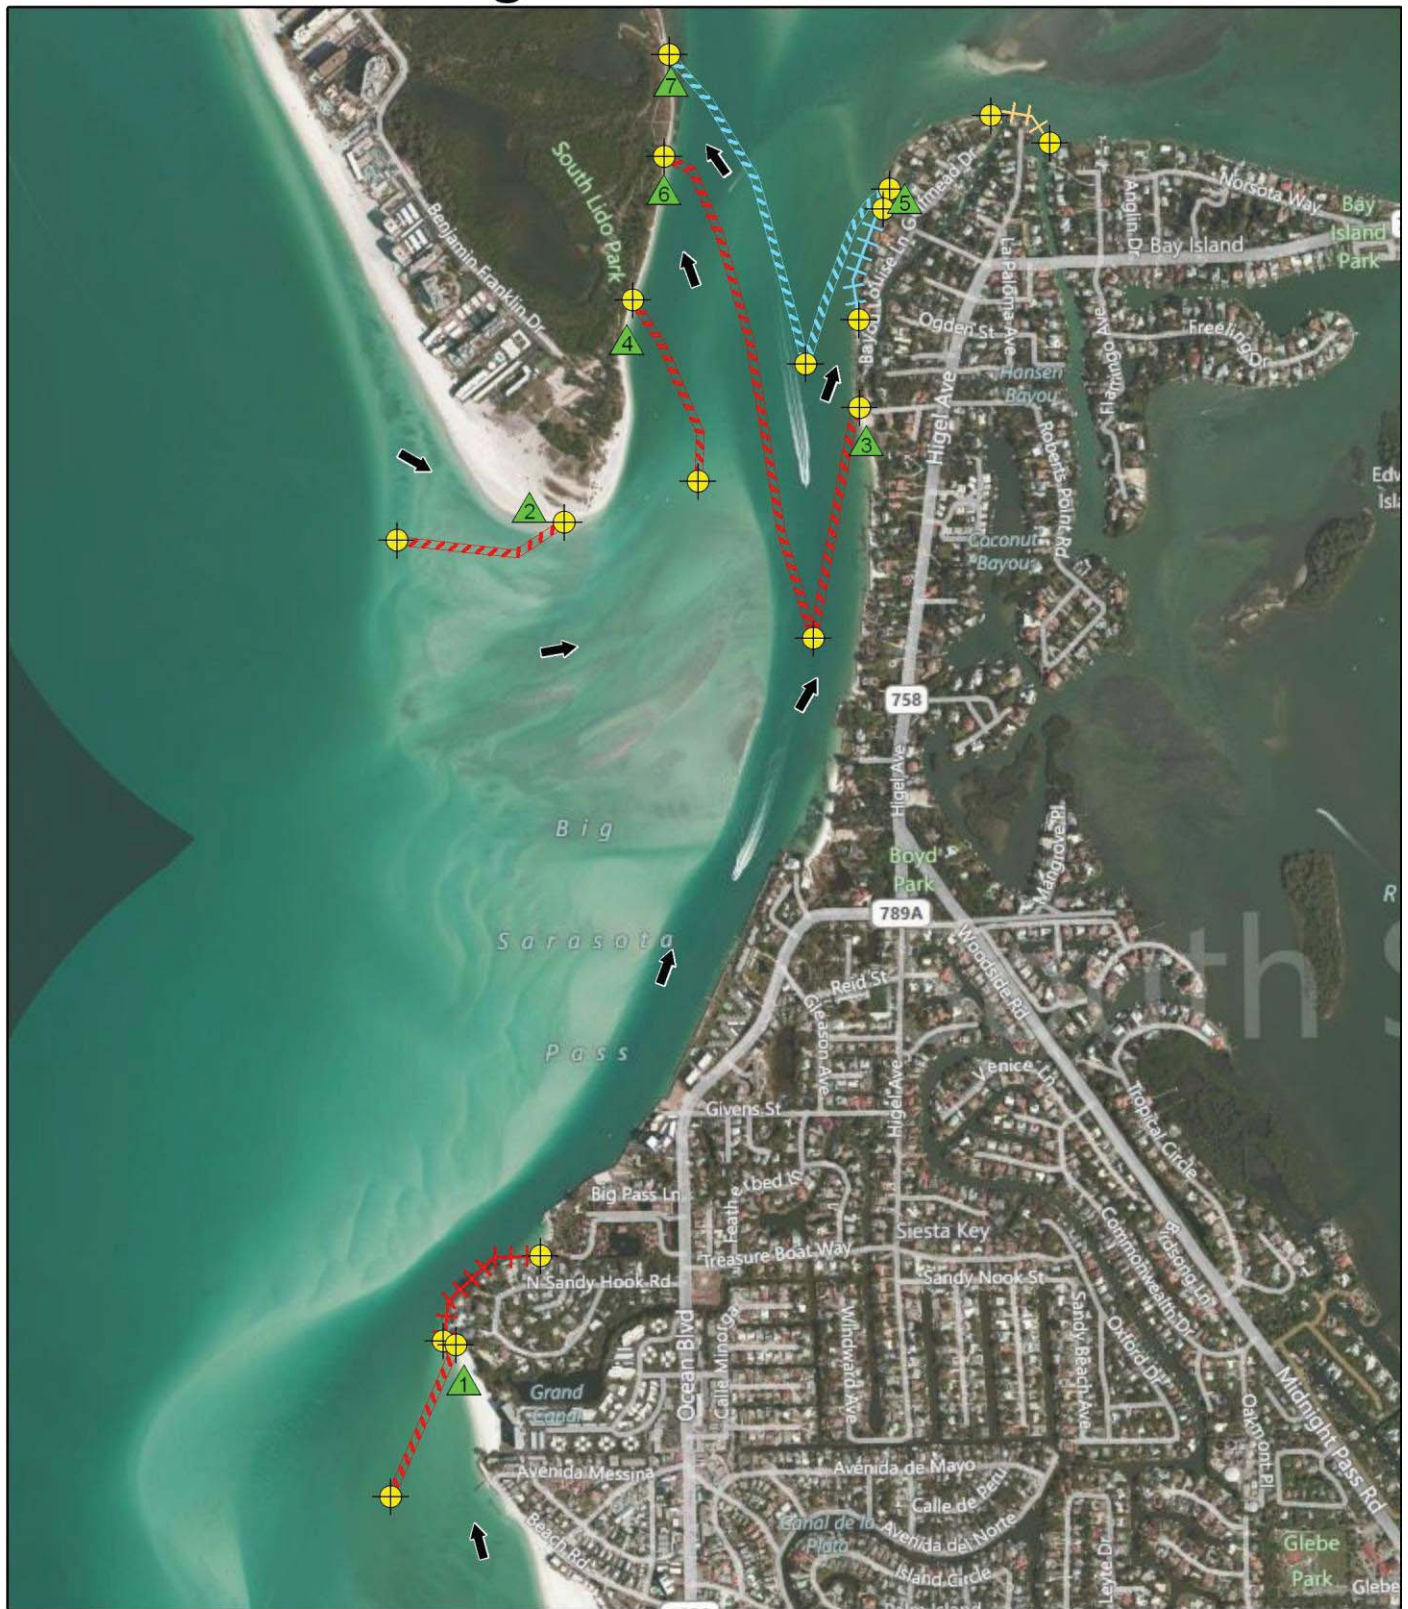
# Big Sarasota Pass

The 1995 NOAA Tidal Current Tables reported currents in Big Sarasota Pass to be 1.5 knots at maximum flood and 1.0 knots at maximum ebb.

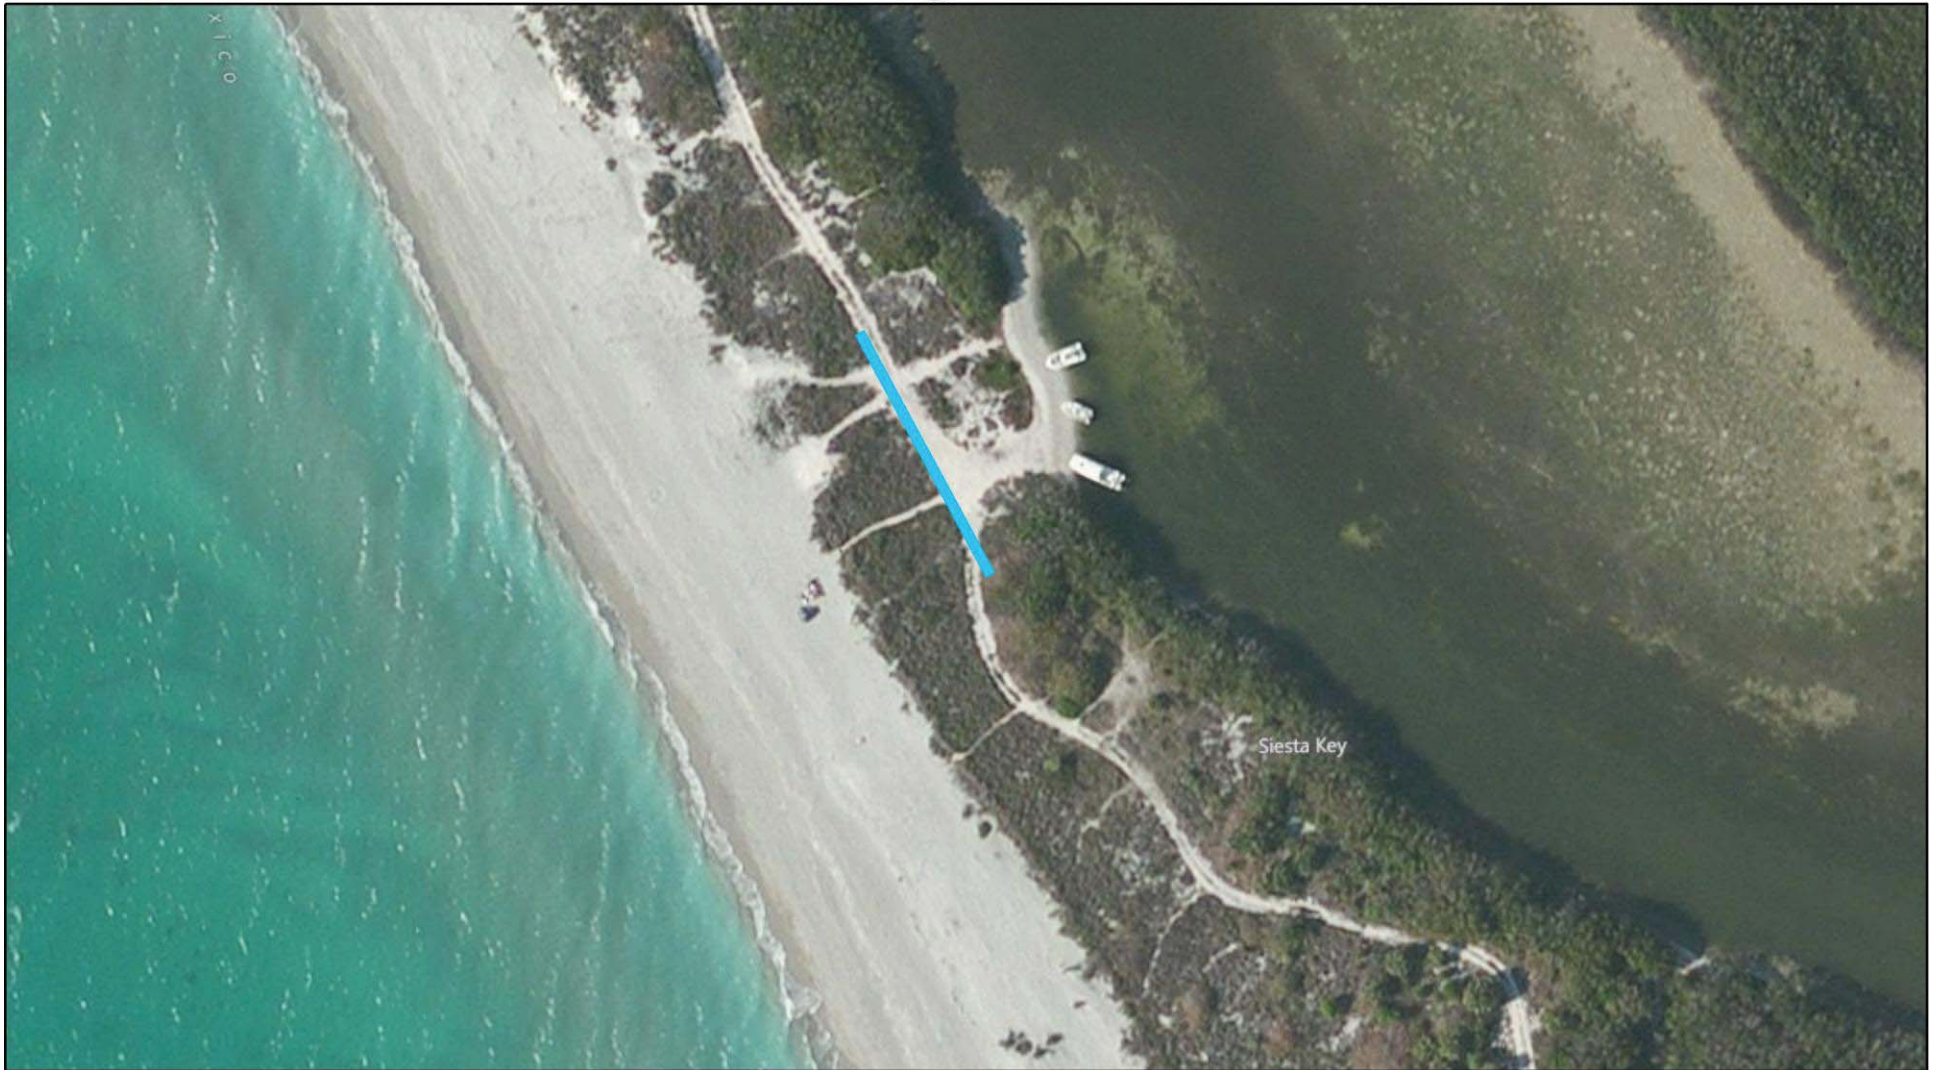
# Midnight Pass

During the original survey in 1995, this inlet was closed. It was also closed during the later survey. Our recommendation is to build a sediment dike about 40 yards long on top of the washover terrace to prevent overwash that may occur during high spring tides that coincide with adverse conditions (strong winds and large waves).

During the survey, the washover terrace was vegetated. When this inlet was open, NOAA Tidal Current Tables reported currents to be 1.8 knots at maximum flood and 1.4 knots at maximum ebb.

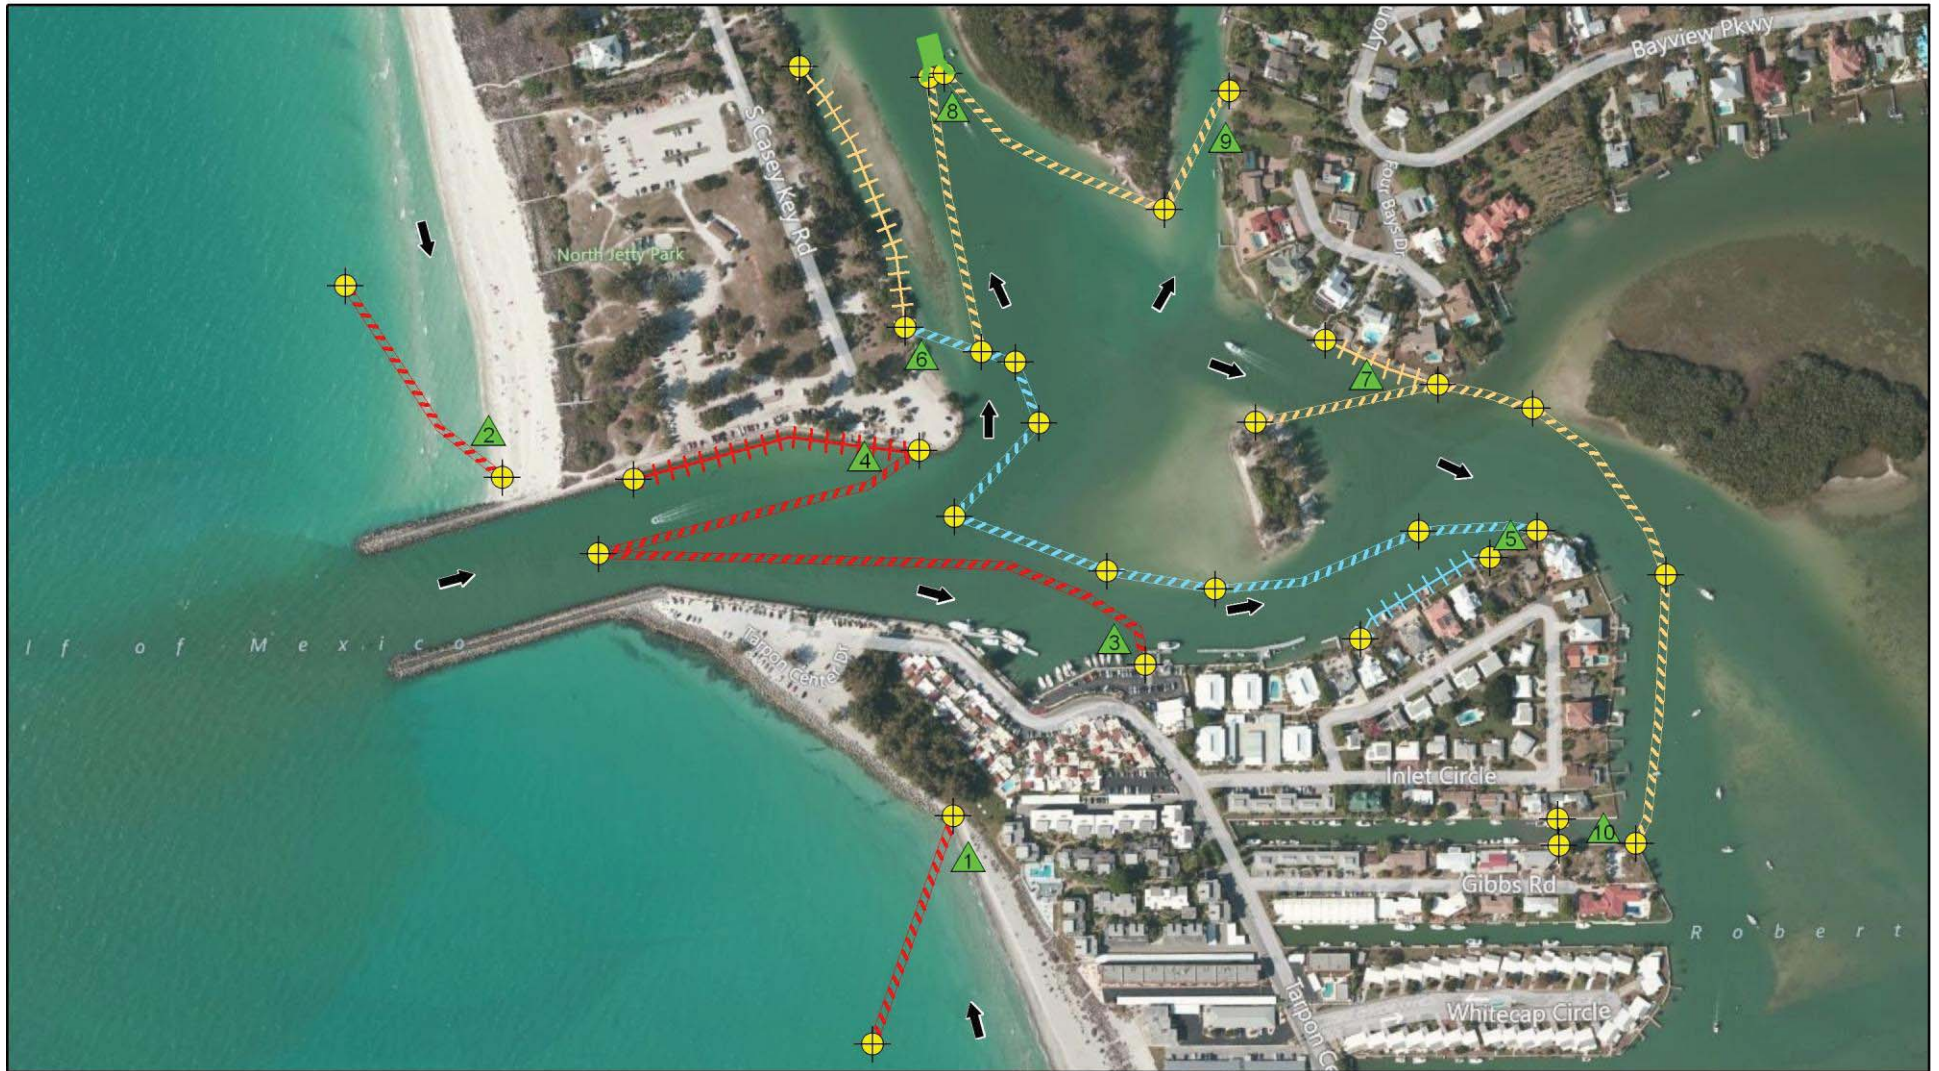
# Venice Inlet

The 1995 NOAA Tidal Current Tables reported currents in Venice Inlet to be 1.1 knots at maximum flood and 0.9 knots at maximum ebb. A 1.5-2.0 knot flood current was measured using a float during the 1995 field survey. A strong wind was blowing onshore at the time that may have augmented the flood current.

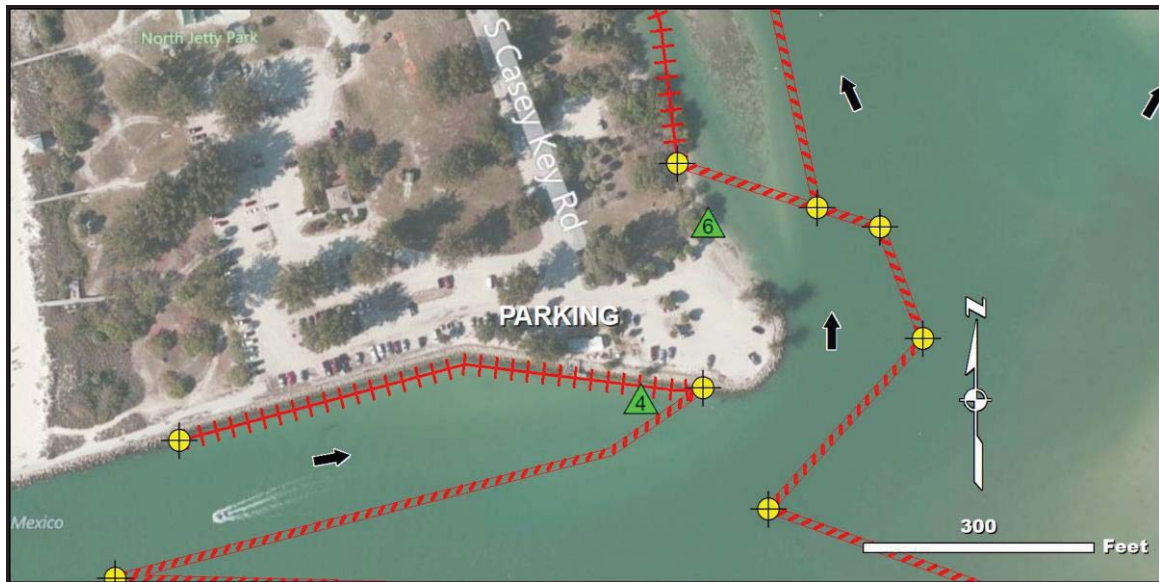
Shoreline Description: Riprap; place protection boom along the riprap for the oil to accumulate on.

Access: This is in North Jetty Park. There is parking right by the riprap.

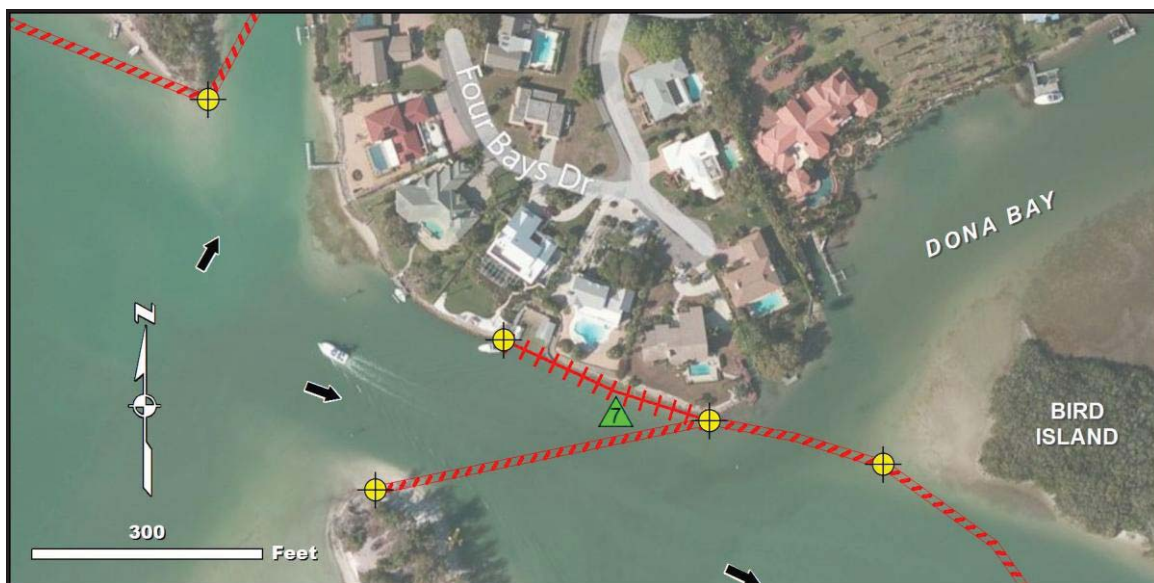
Shoreline Description: Riprap shoreline; Place a line of protection boom along the riprap for the oil to accumulate on.

Access: By watercraft.

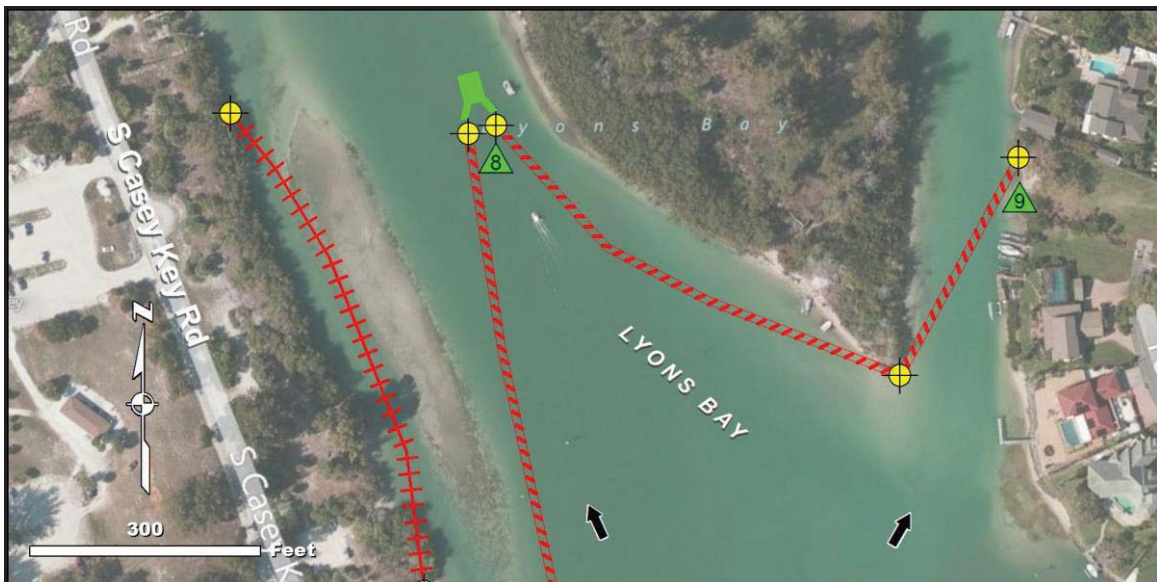
Shoreline Description: Open water skimmer.

Access: By watercraft.

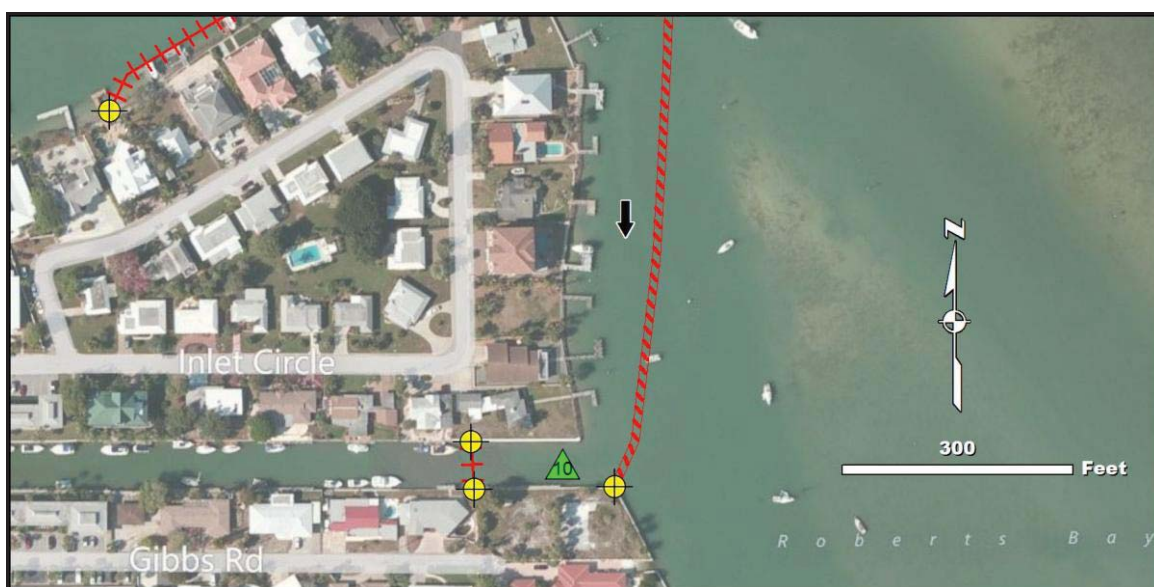
Shoreline Description: Entrance to a canal with seawalls along its sides. Place a line of protection boom across the canal a few hundred feet inside it.

Access: Probably best by watercraft.

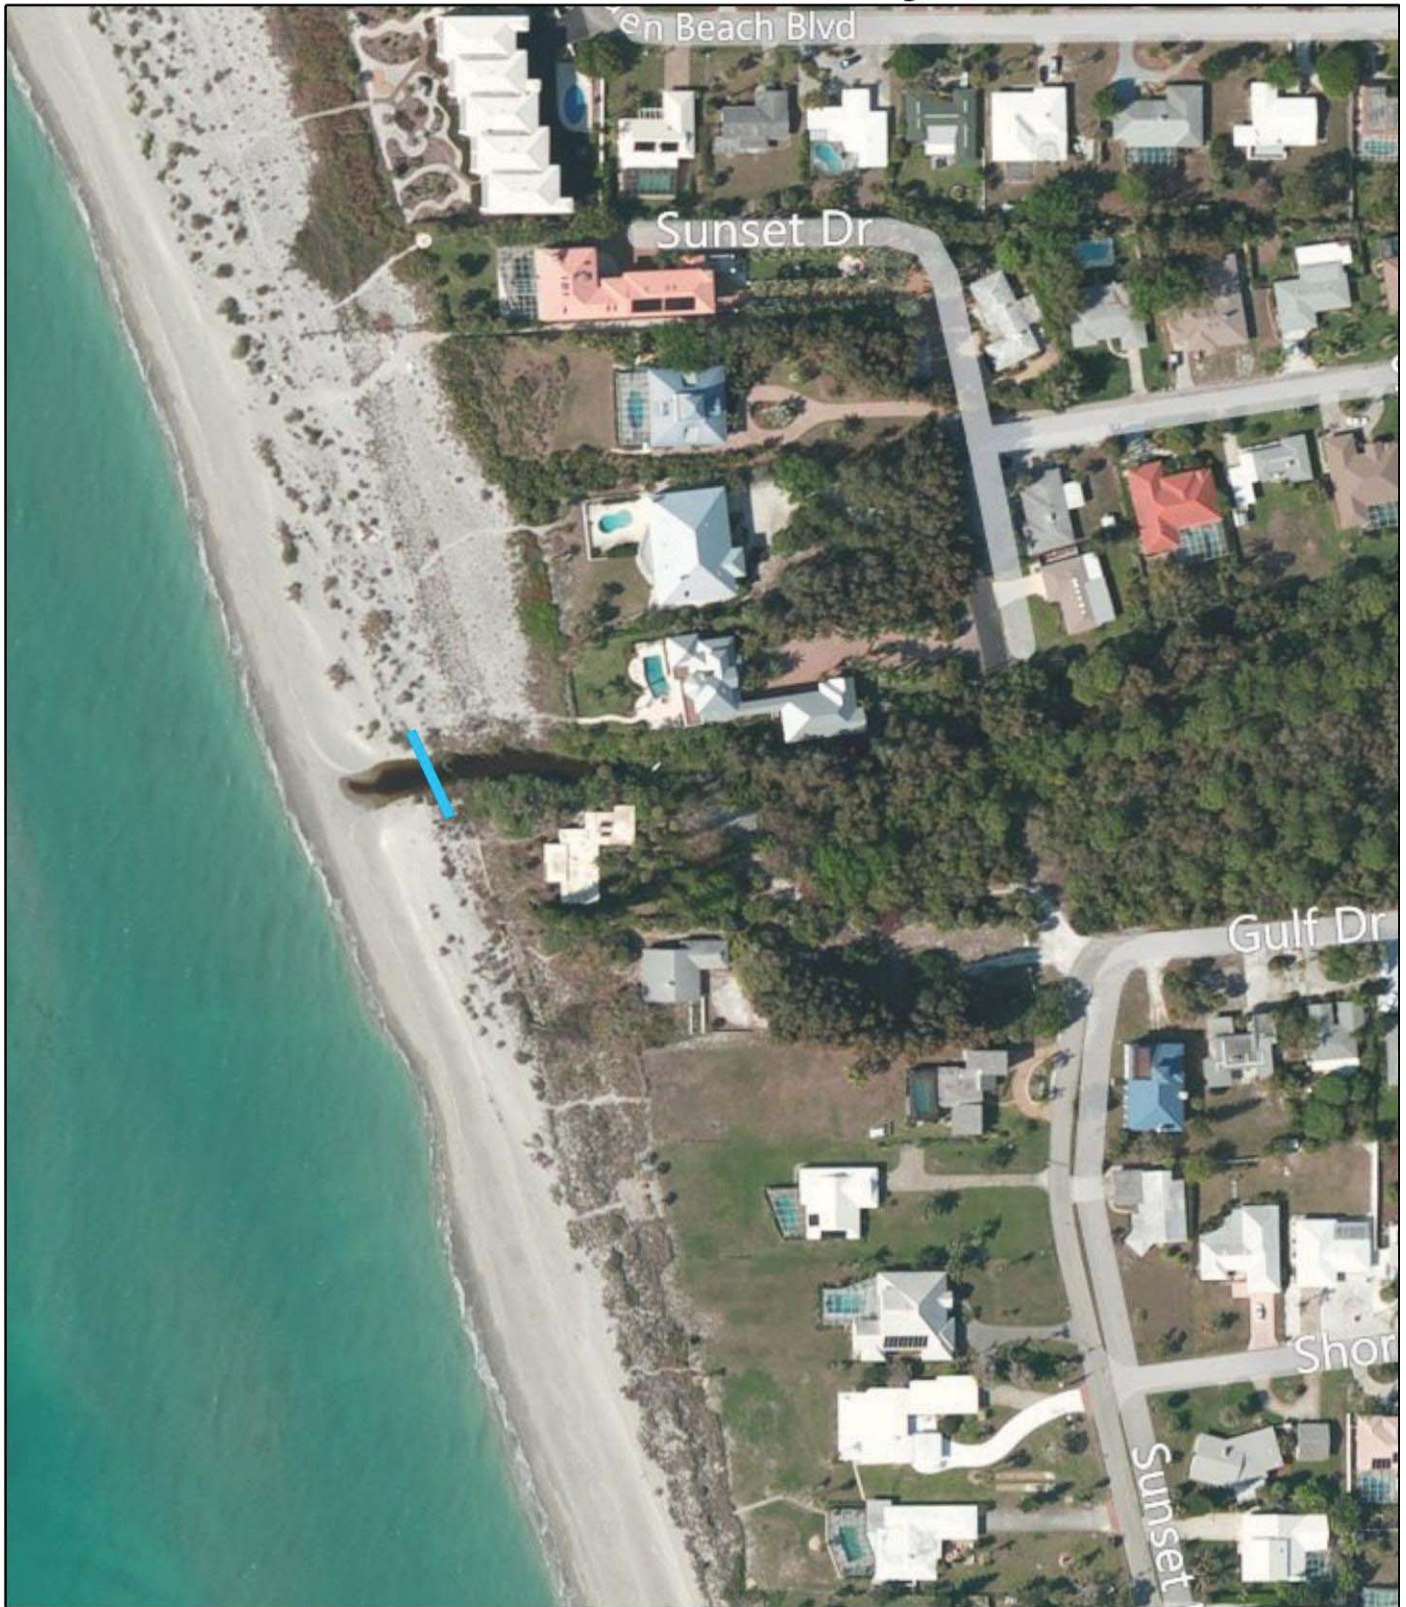
# Deertown Gully

(NOTE: This small inlet/channel is located in the southern section of Venice near Sunset Drive.)  
Place a sand dike about 90 yards long across the entrance to the channel.

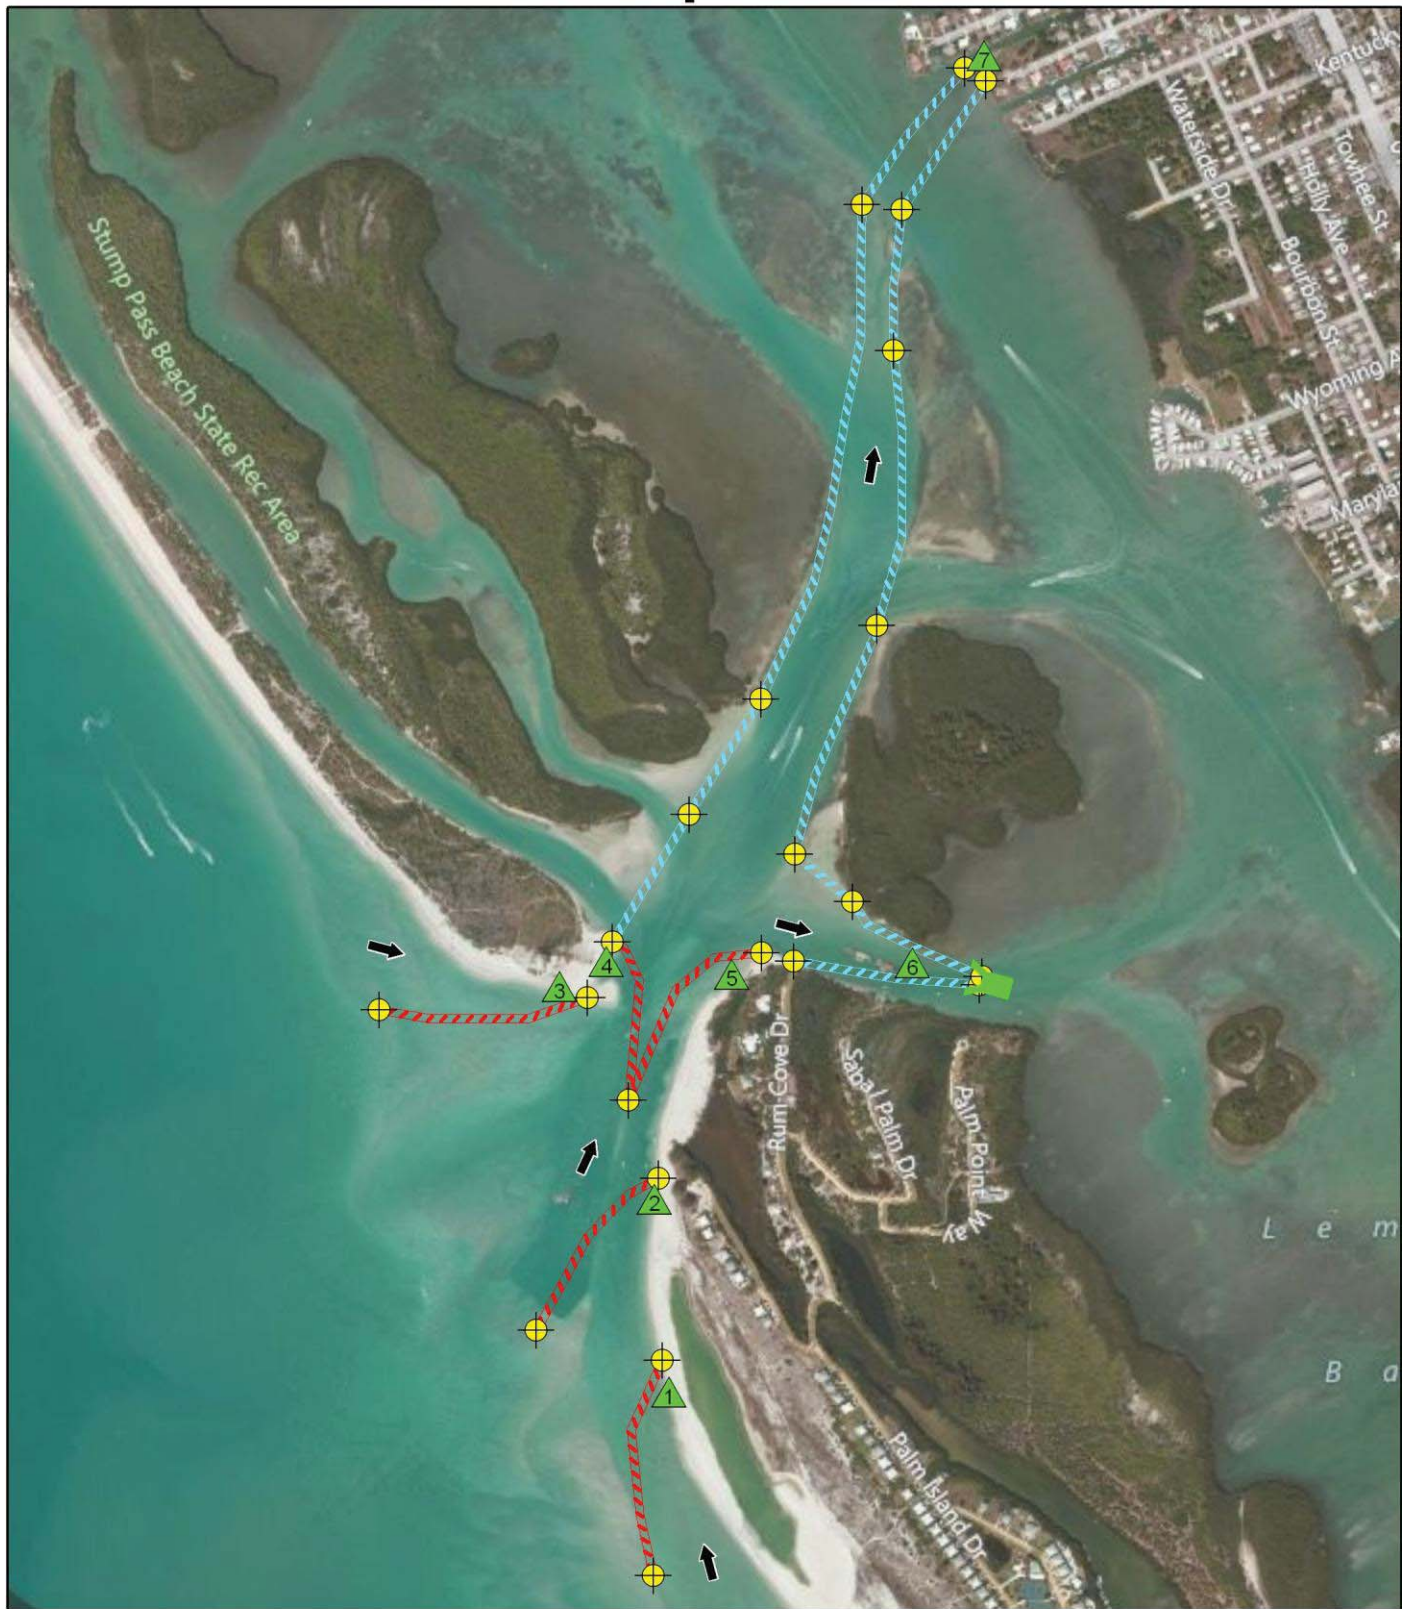
# Stump Pass

Divert oil entering the inlet through marginal flood channels (and a dredged channel) associated with the very complex ebb-tidal delta to collection points along the outer sand beaches (CPs 1, 2, and 3). Just inside the main inlet channel, anchor a Christmas tree configuration of deflection boom that would divert oil to sand beach collection points on the northwest and northeast sides of the channel (CPs 4 and 5). Establish an open water skimmer (CP6) in the channel that runs along the far northeast end of Thornton Key (about 450 yards east of the main inlet channel). Next, place two long lines of deflection boom along both sides of the main inlet channel and beyond to a seawall in Grove City (CP7). The northwest limb of this set of boom extends away from CP4, and the southeast limb extends away from the west end of north limb of deflection boom that leads to the open water skimmer at CP6.

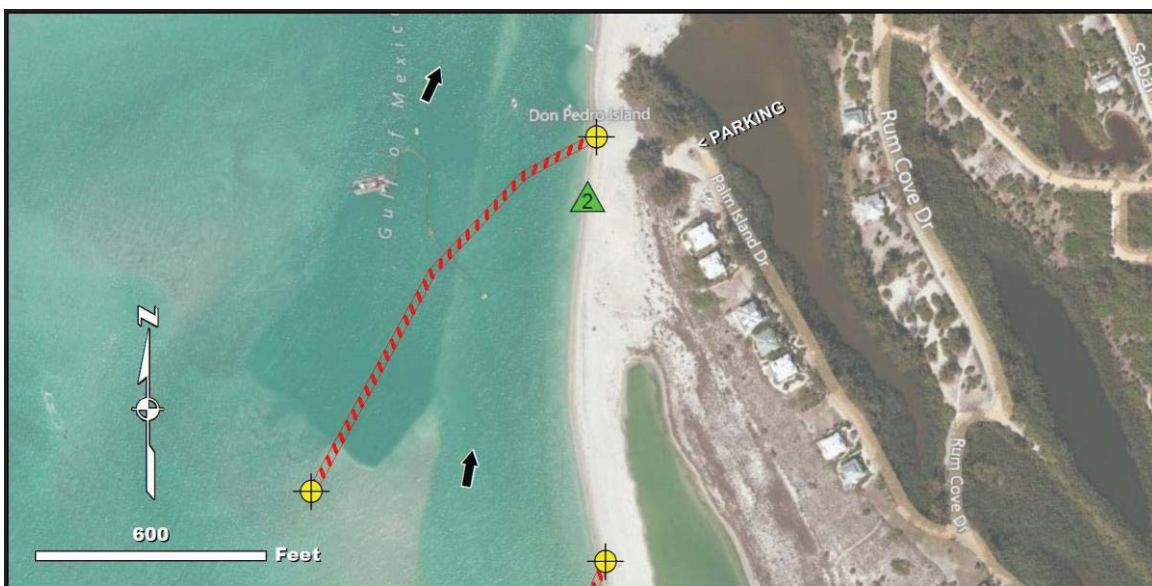
Shoreline Description: Sand beach. Boom extends across what appears to be a dredged channel that probably also functions as the southern marginal flood channel of the complex ebb-tidal delta.

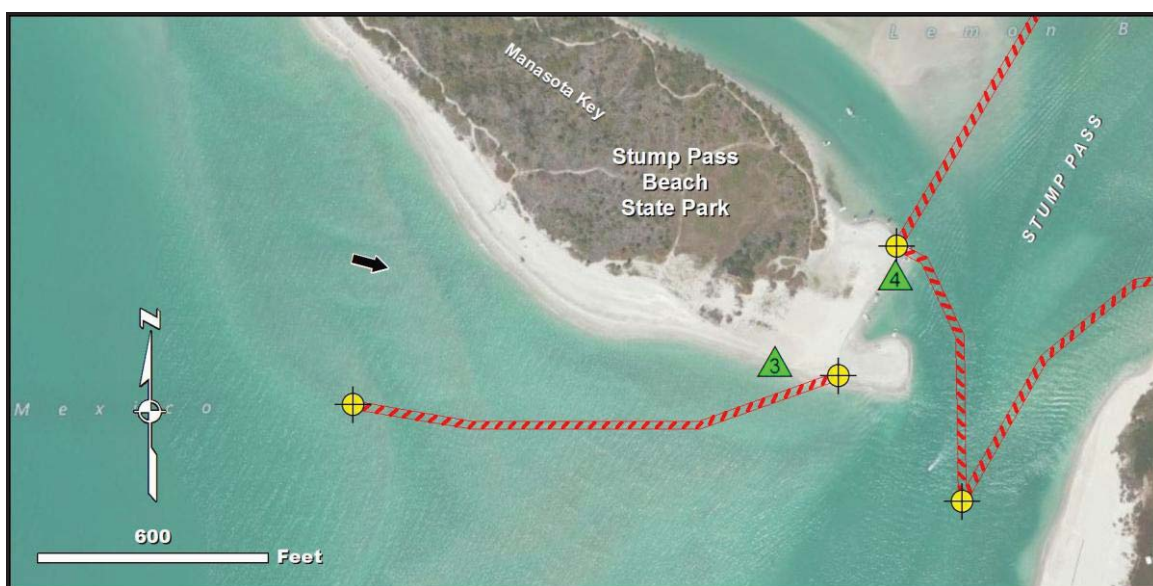
Shoreline Description: Sand beach. The boom extends across the northern marginal flood channel of the complex ebb-tidal delta.

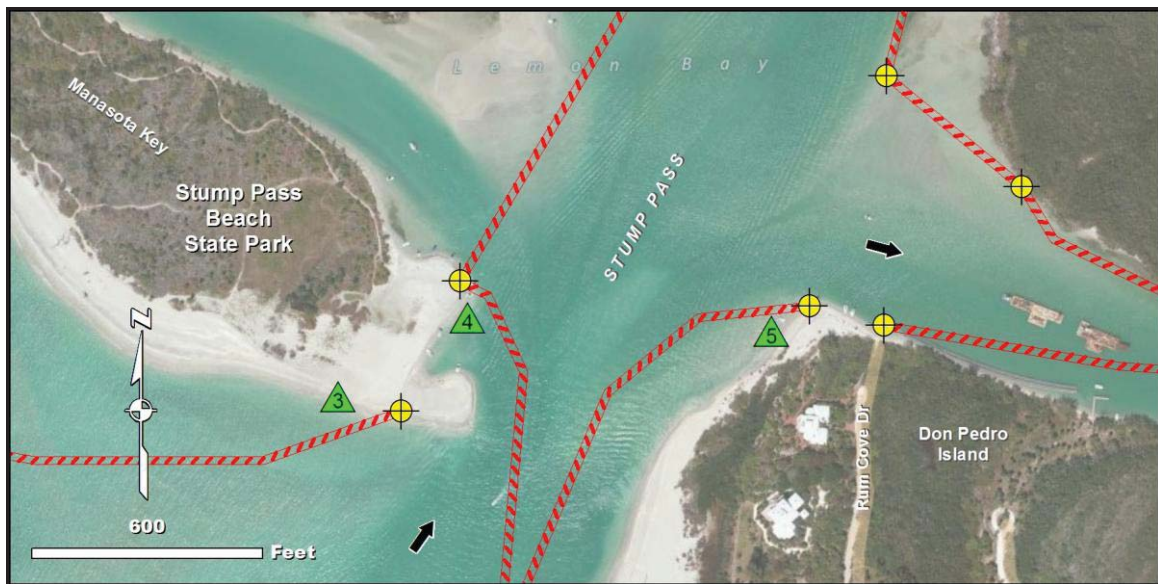
Shoreline Description: Sand beach. The boom extends out into the main inlet channel.

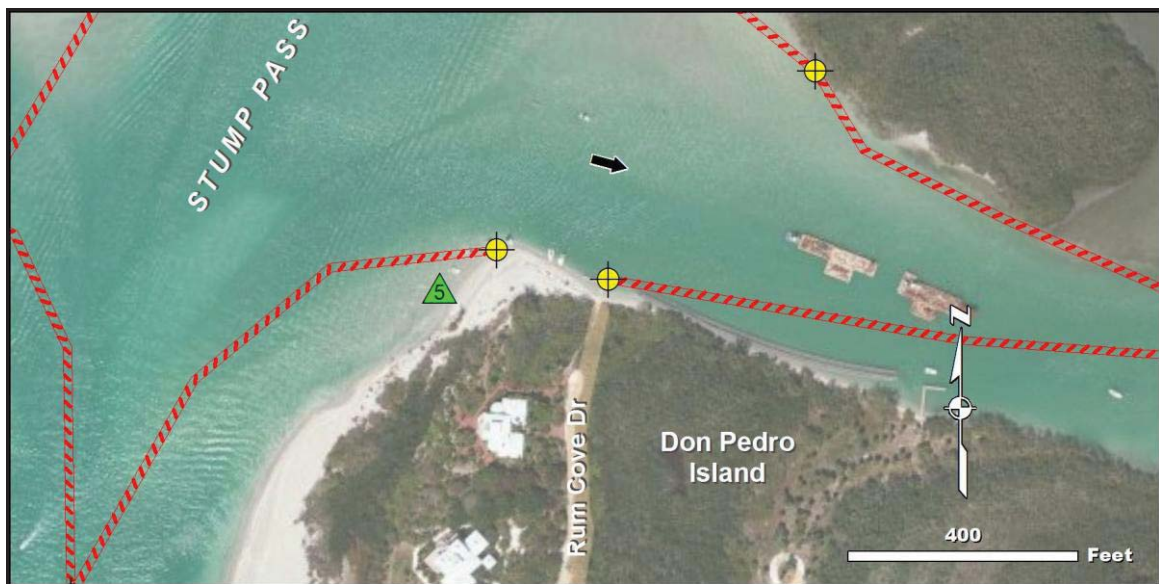
Shoreline Description: Sand beach. The boom extends out into the main inlet channel.
