# Tidal Inlet Protection Strategies for Oil-Spill Response

## U.S. Coast Guard Sector St. Petersburg

October 2011

Prepared by Miles O. Hayes, Jeffrey Dahlin, and Joseph Holmes,  
Research Planning, Inc.

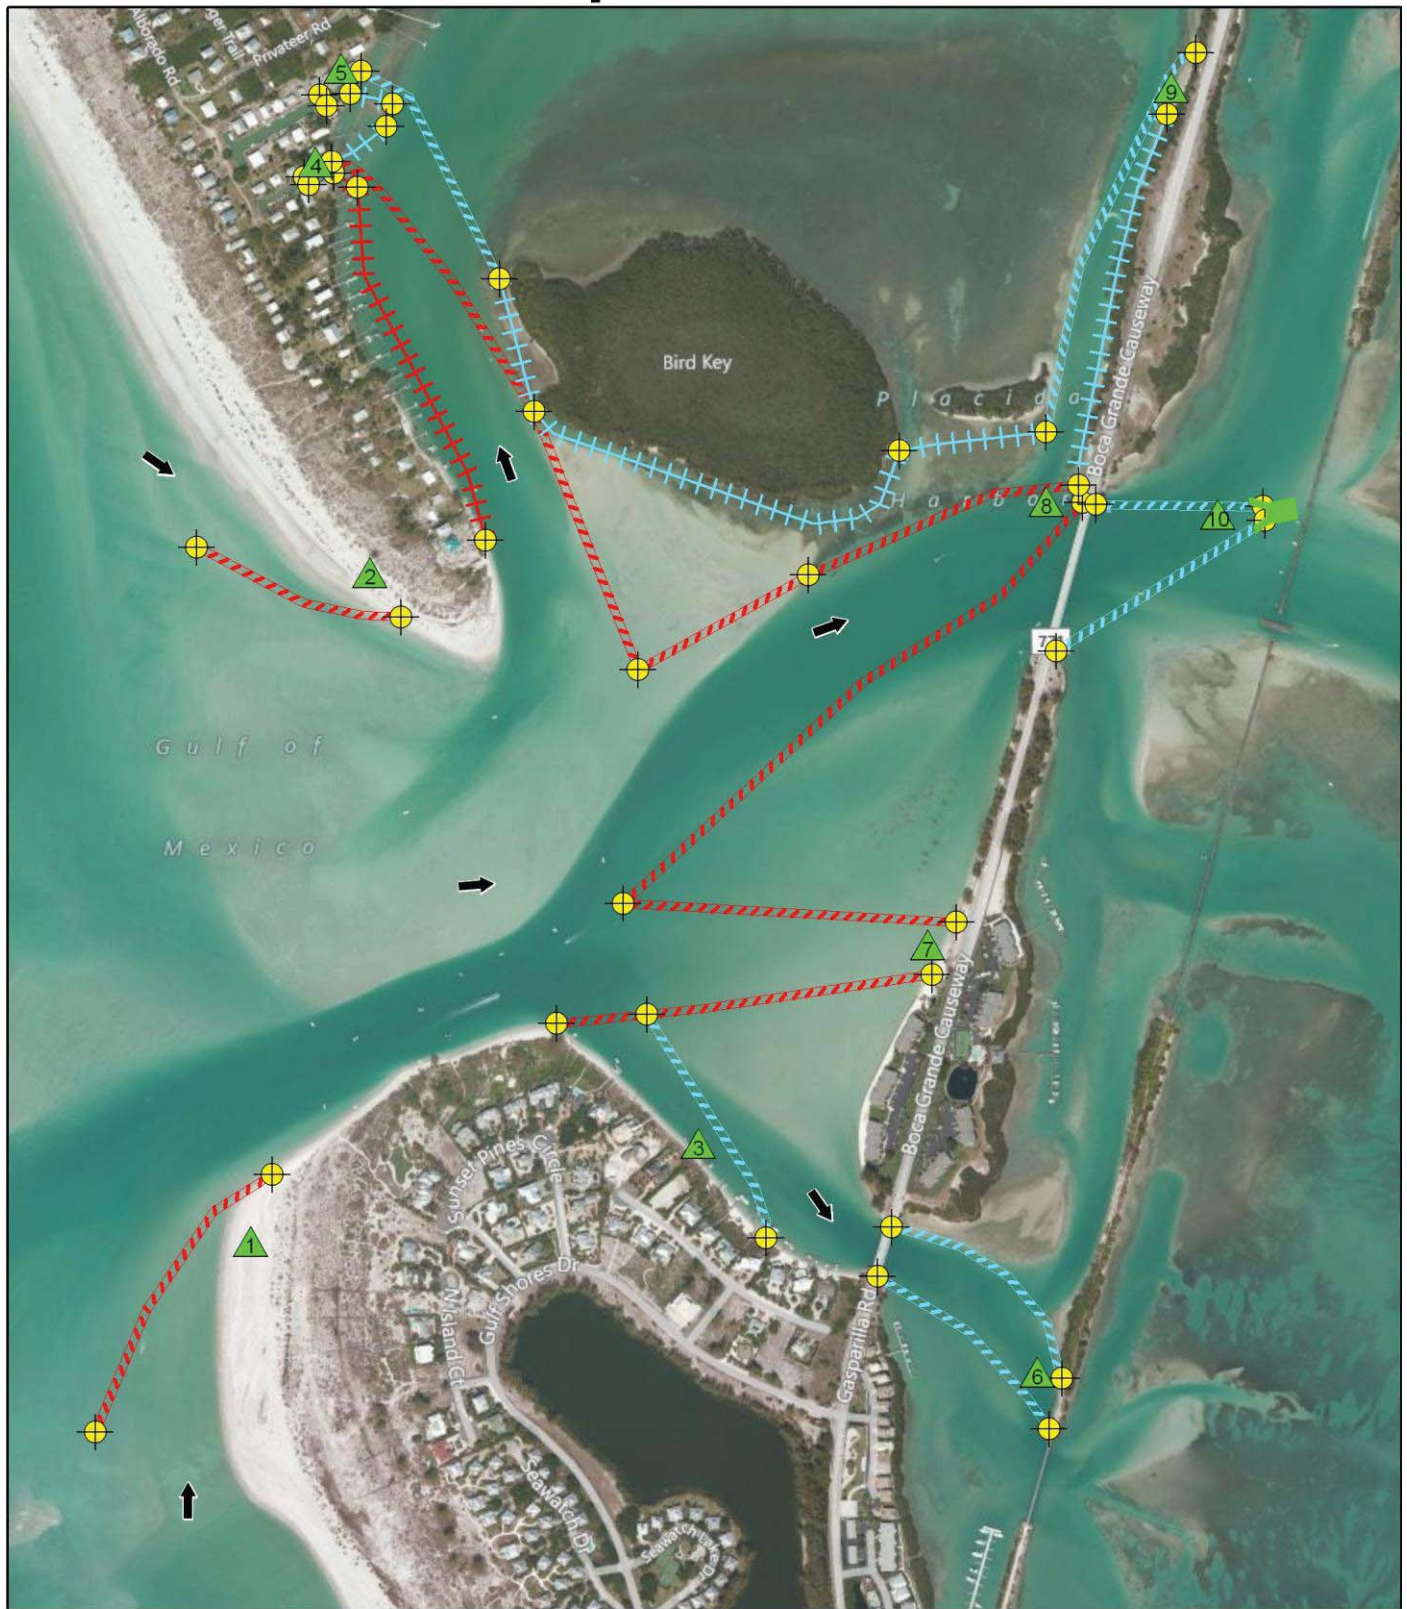
# Gasparilla Pass

Divert oil entering the inlet through the marginal flood channels of the ebb-tidal delta to collection points along the outer sand beaches (CPs 1 and 2). Inside the inlet, establish three Christmas tree configurations of deflection boom. The northern limb of the southern C. tree extends across the south lobe of the flood-delta to a sand beach on the west side of the Boca Grande Causeway (CP7), and the south limb extends to a sand beach on the northeast end of Gasparilla Island (CP3). The south limb of the central C. tree also extends to the sand beach at CP7, and the north limb extends along the southeast side of the north branch of the main inlet channel, finally crossing it to a seawall at the north end of the Boca Grande Causeway Bridge (CP8). The northern C. tree is designed to divert oil from impacting the sand flat on the north lobe of the flood-tidal delta, with its easterly limb extending to the seawall at CP8, and the west limb, which spits into two branches, extending to two small basins on the east shore of Little Gasparilla Island (CPs 4 and 5). Attach two lines of deflection to the east side of the Boca Grande Bridge over the south branch of the Main inlet channel. These lines of boom extend to a sand beach along the old railroad bridge (CP6). Also attach two lines of deflection to the east side of the Boca Grande Bridge across the north branch of the main inlet channel, which lead to

an open water skimmer about 270 yards to the east of the bridge (CP10). Stretch another long line of deflection boom along the west side of a channel that parallels the Boca Grande Causeway to a sand beach/tidal flat on the west side of the Causeway about 0.4 miles north of the middle of the north branch of the main inlet channel. Place protection boom along the south side of the mangroves on Bird Key and the adjacent small island as well as along the side of the Boca Grande Causeway between CP8 and CP9.

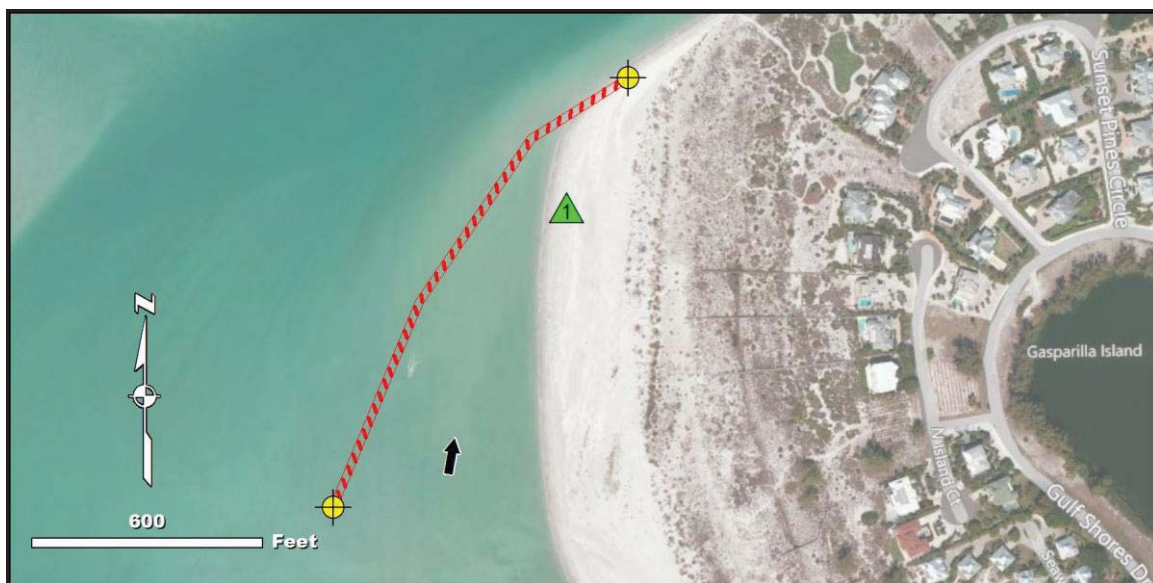
Shoreline Description: Sand beach. The boom reaches across the southern marginal flood channel of the ebb-tidal delta.

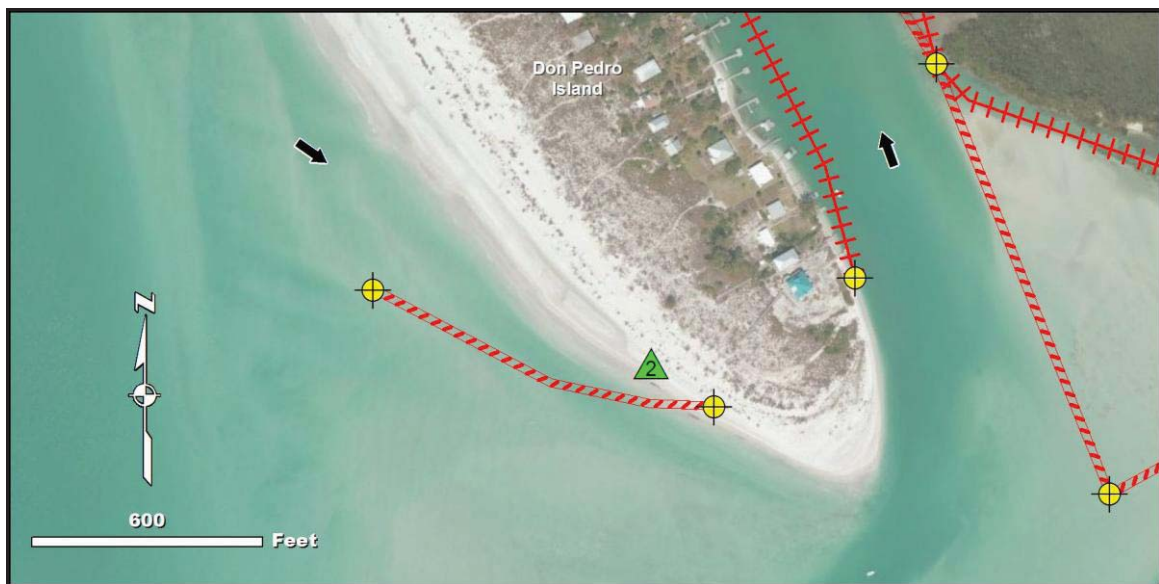
Shoreline Description: Sand beach. The boom reaches across the northern marginal flood channel of the ebb-tidal delta.

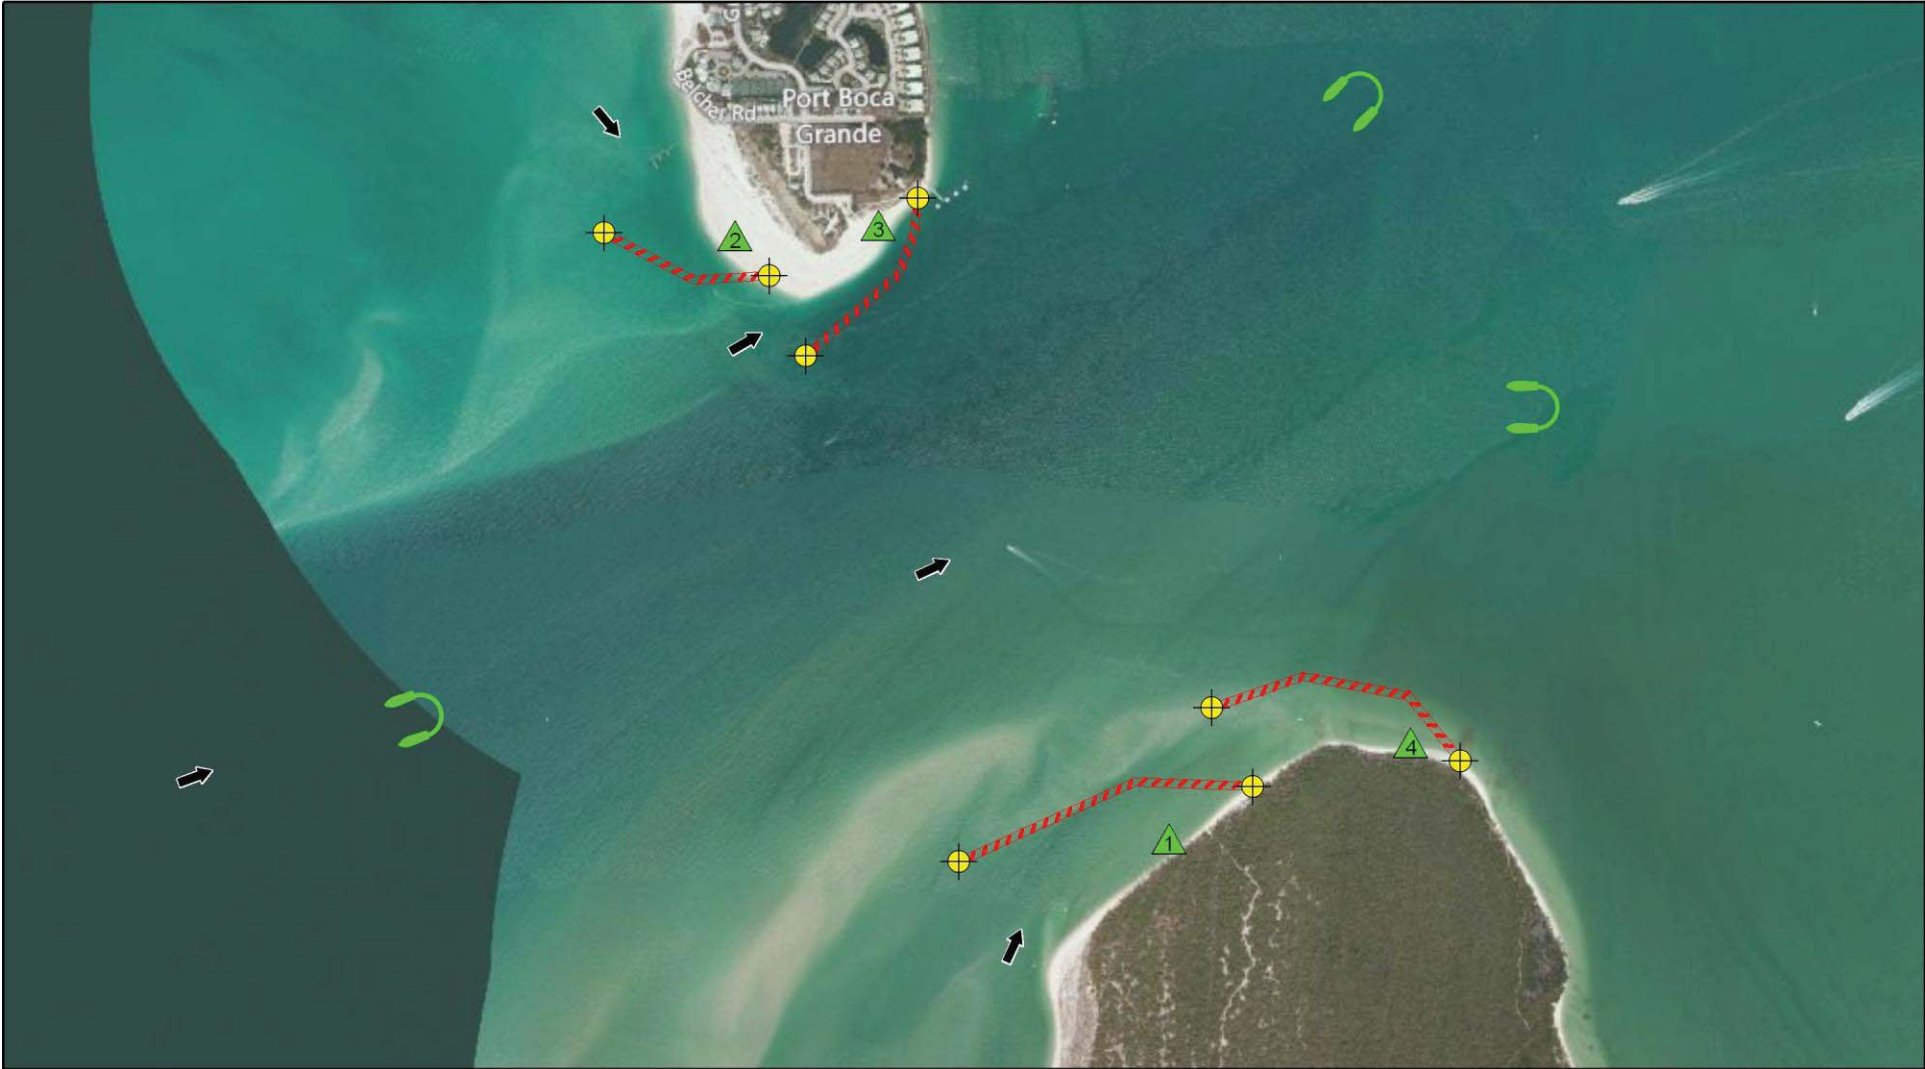
# Boca Grande Inlet

The 1995 NOAA Tidal Current Tables reported currents in Boca Grande Inlet to be 2.2 knots at maximum flood and 1.8 knots at maximum ebb. Also note that because of the age of the bridge, the weight limitations to Boca Grande are strictly enforced at the Boca Grande Causeway entrance near Placida off CR771. Limits as of 2011 are: 2 axles – 17 tons; 3 or more axles 20 tons.

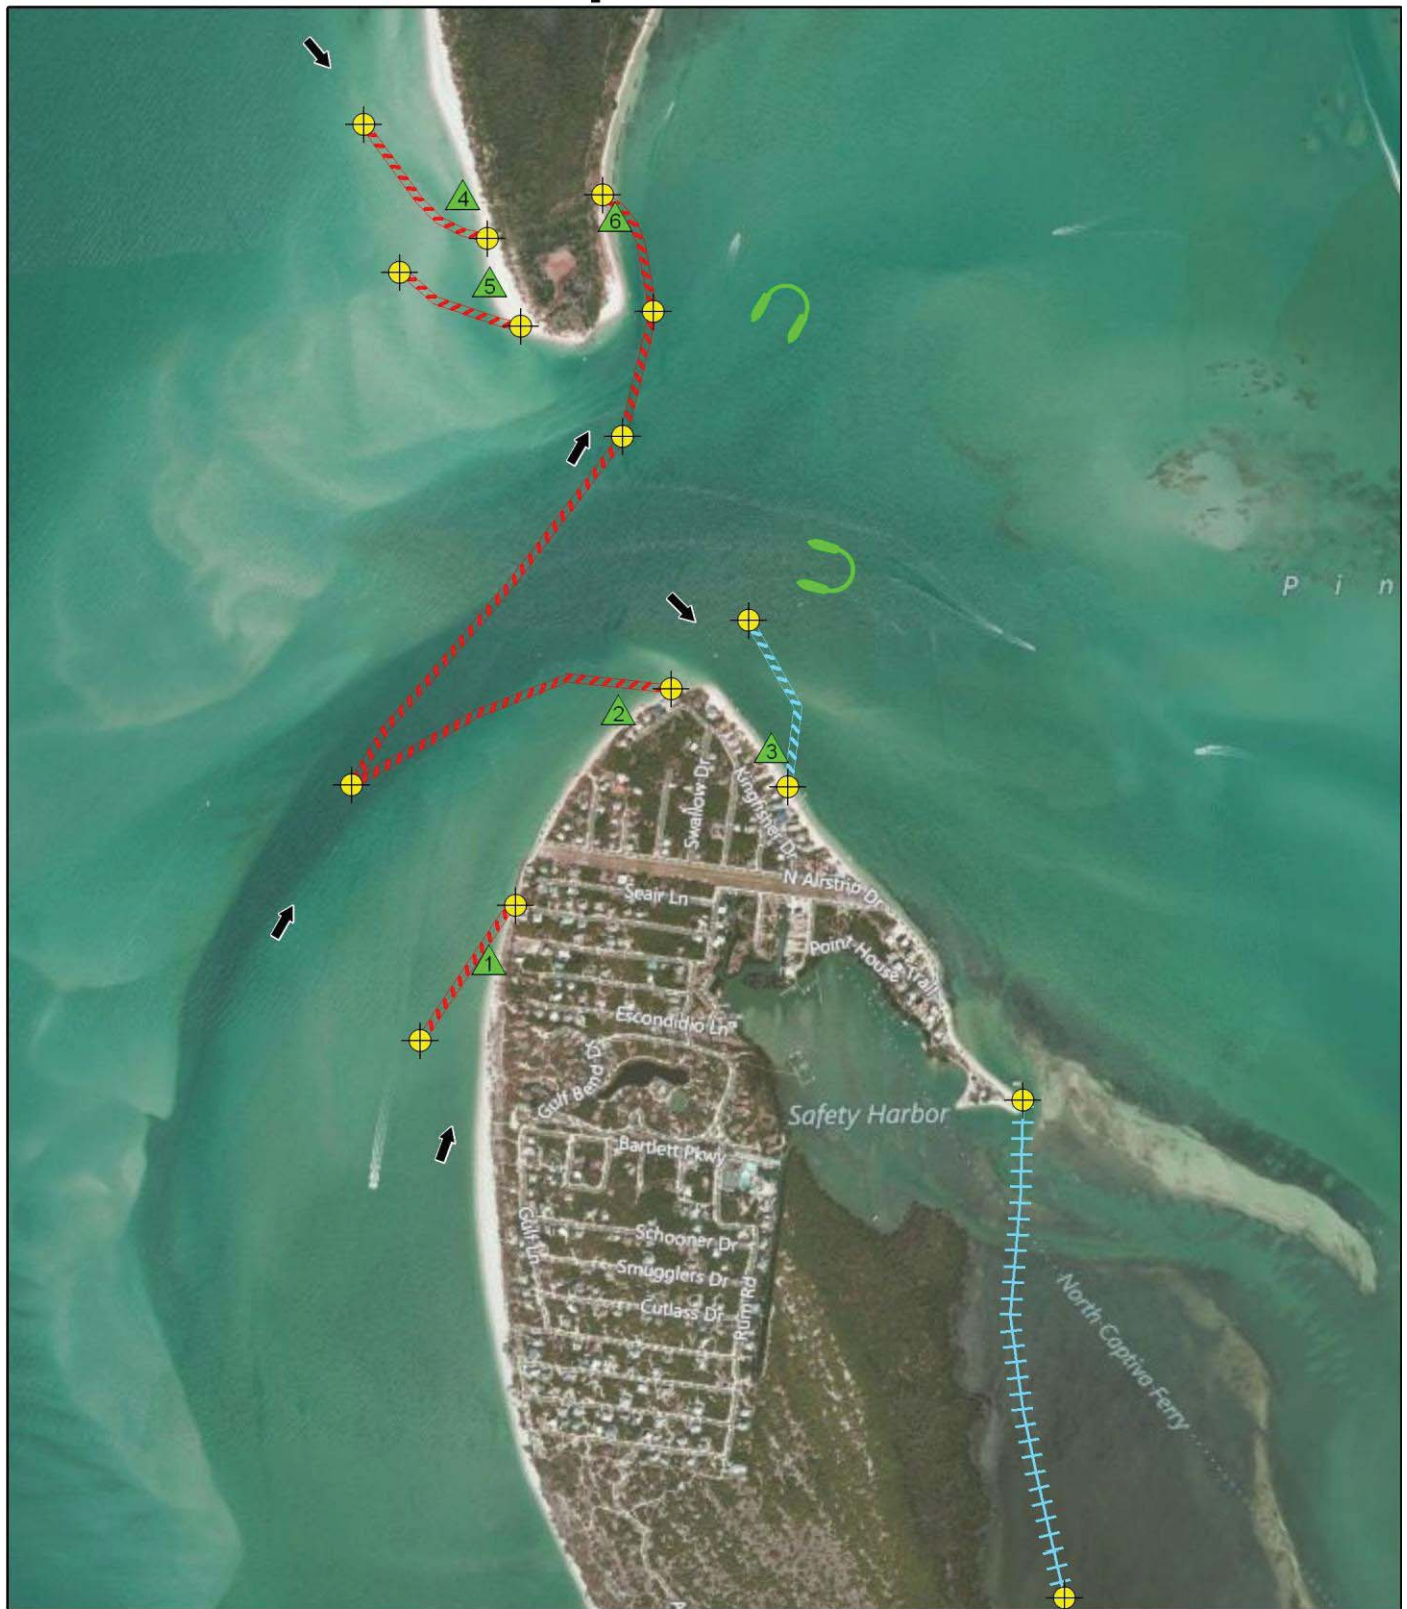
# Captiva Pass

The 1995 NOAA Tidal Current Tables reported currents in Captiva Pass to be 1.8 knots at maximum flood and 1.9 knots at maximum ebb. Also, other than a private grass landing strip on North Captiva Island, access is limited to watercraft only.

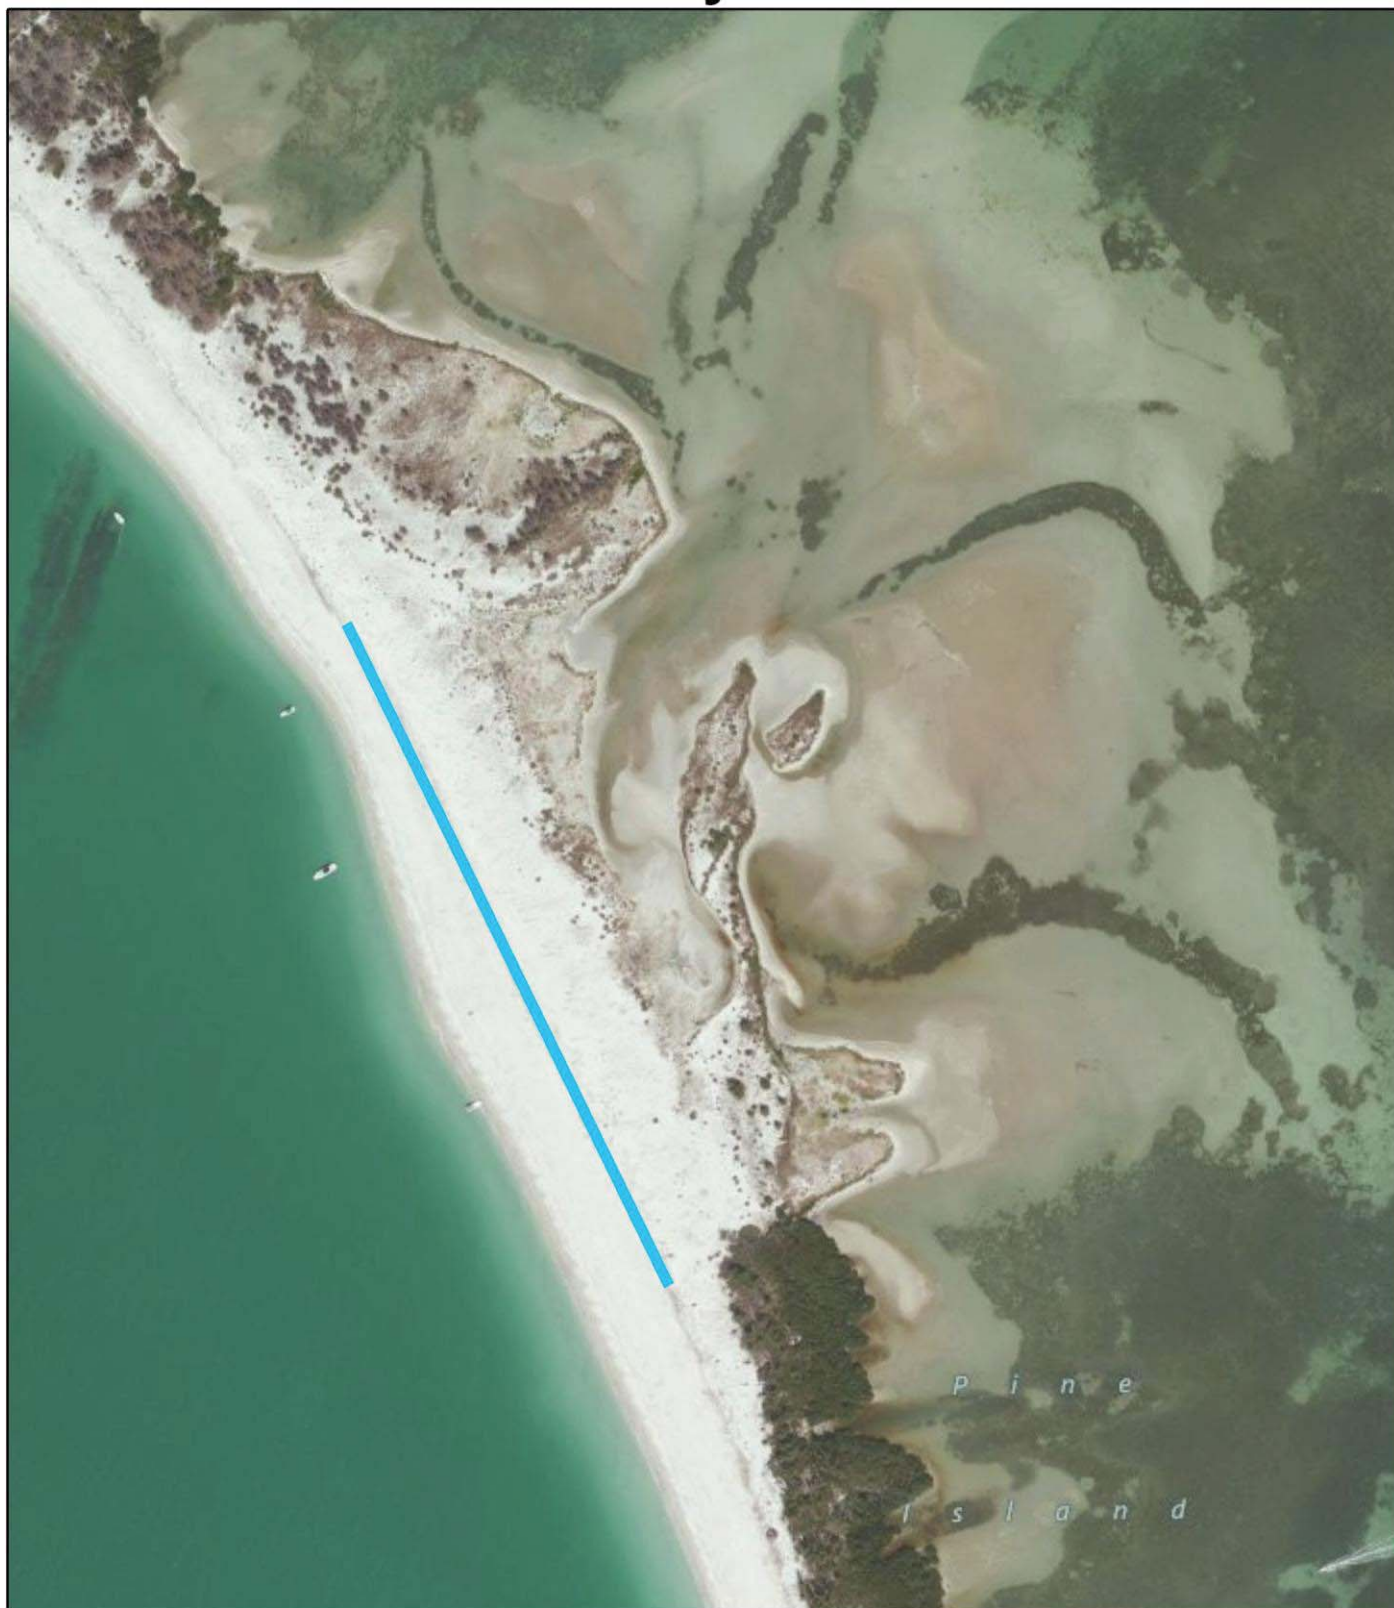
# Charley Pass

This is a new inlet that was not here when the 1995 survey was carried out. As best we can tell, it was created by Hurricane *Charley* on 13-14 August 2004. It is located on North Captiva Island about one mile north of Redfish Pass, and it is presently completely closed off by a low beach ridge. Our strategy for this inlet, in the event of a major oil spill, is to build a sediment dike across the former entrance to the inlet that would be about 425 yards long.

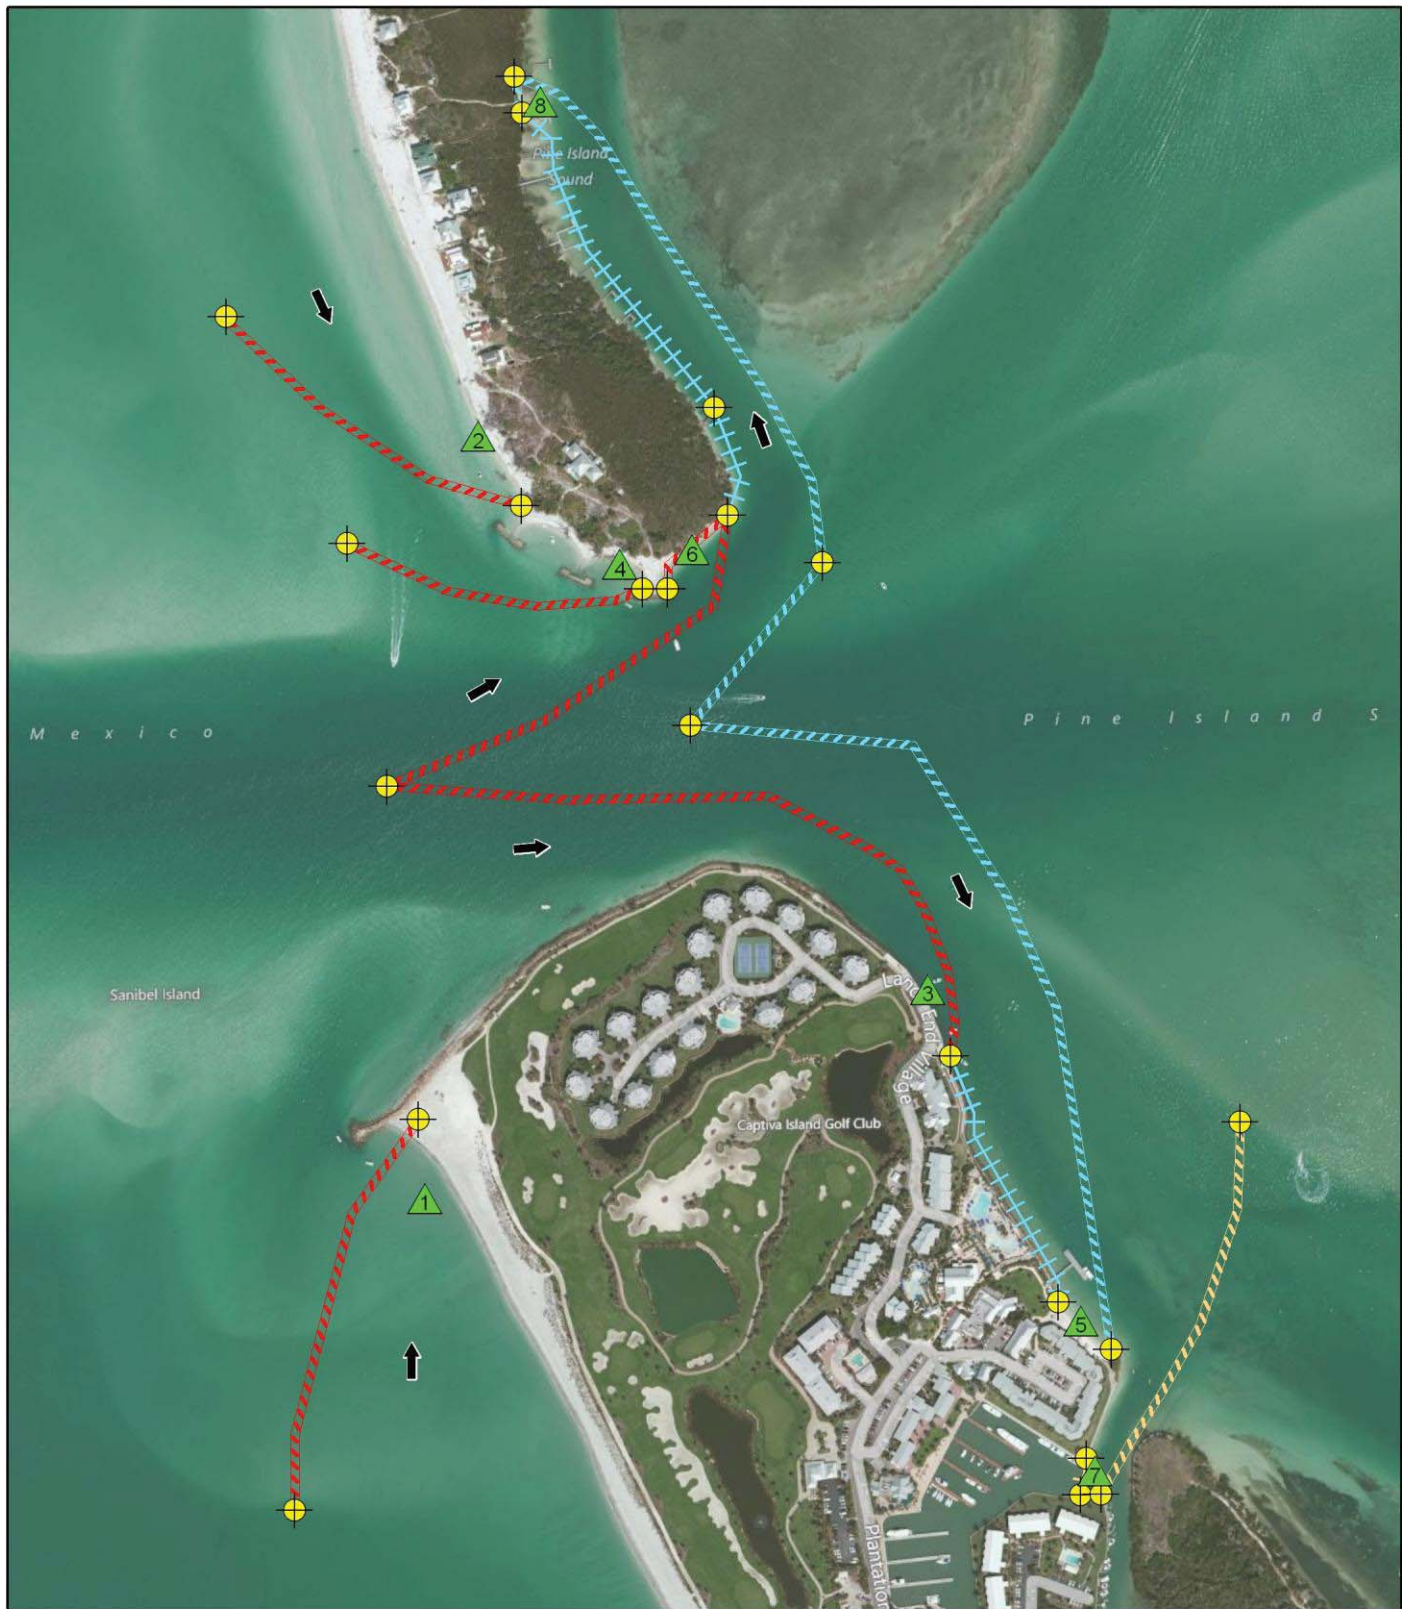
# Redfish Pass

Divert oil entering the inlet through the marginal flood channels of the ebb-tidal delta to collection points along the outer sand beaches (CPs 1, 2 and 4). In the main inlet channel, anchor two Christmas tree configurations of deflection boom. The north limb of the most seaward C tree diverts oil to a sand beach on the extreme southeast end of North Captiva Island (CP6), and the south limb diverts oil to a seawall on the northeast end of Captiva Island (CP3). The north limb of the most landward C tree extends for a long way along the east side of a channel called Pine island Sound, and then across this channel to a sand beach/sand flat on the east side of North Captiva island (CP8). The south limb of the most landward C tree diverts oil to a sand beach on the bay side of Captiva Island about 550 yards south of the northeast end of the island (CP5). Further south of CP5, extend a line of deflection boom across the channel on the west side of the flood-tidal delta that is designed to divert oil to a man-made basin surrounded by seawalls (CP7). Extend lines of protection boom along side of the riprap between CP3 and CP5, and by the docks and mangroves between CP6 and CP8.

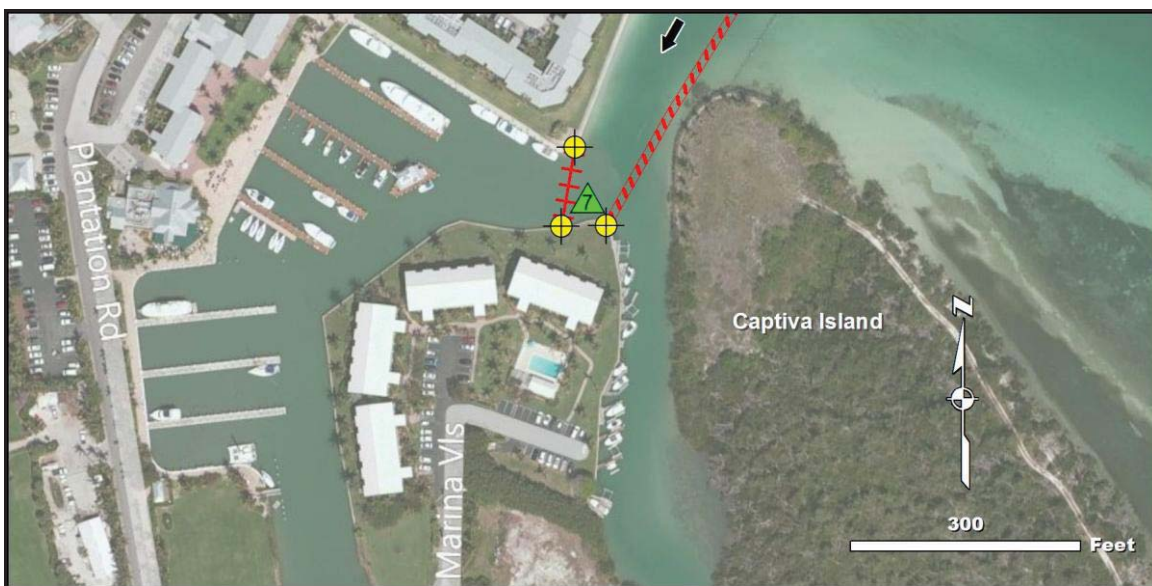
Shoreline Description: Man-made canal with seawalls along its side. Place protection boom across the entrance to the harbor to the west.

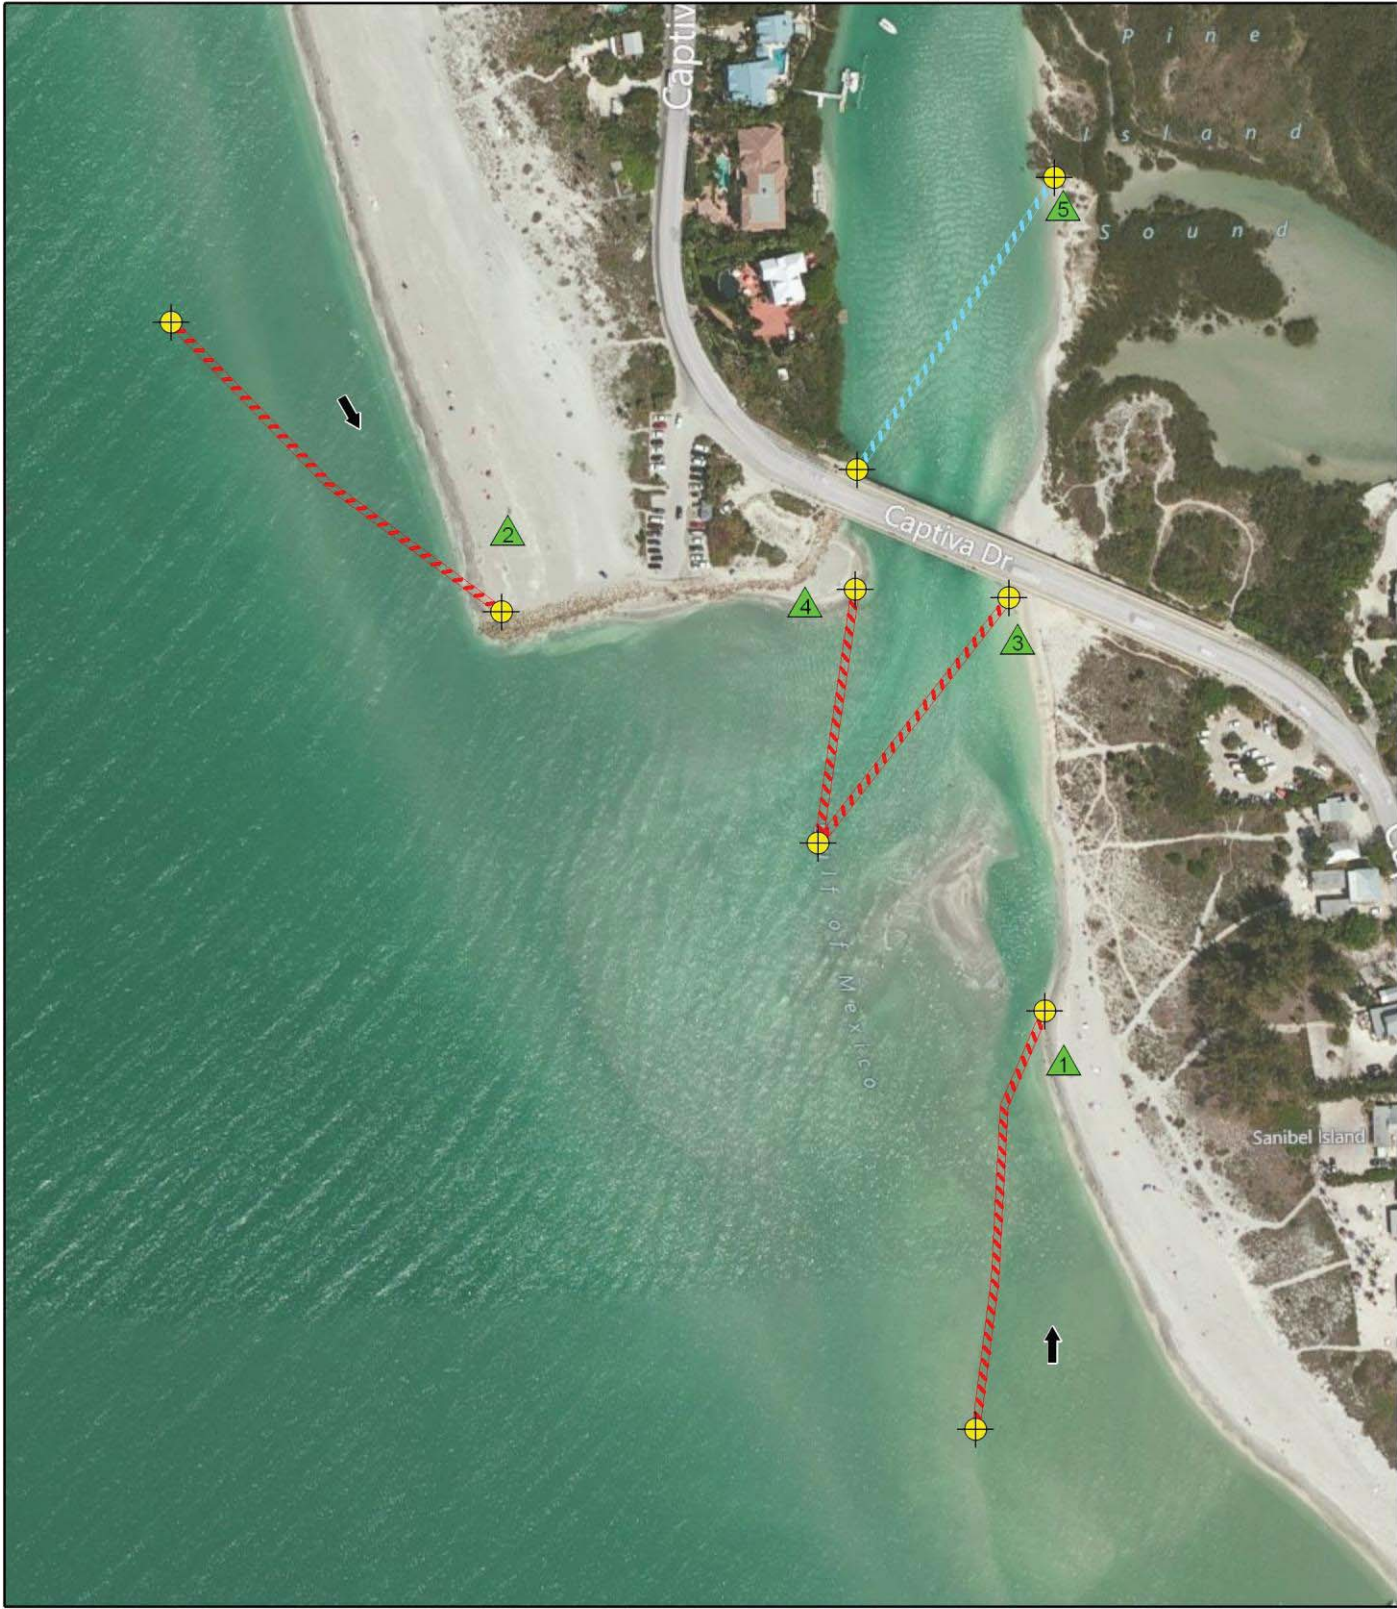
# Blind Pass (Lee)

This inlet was closed between 2002 and 2008, so it may be closed or nearly closed again in the future. Under those conditions, a sand dike would be the appropriate strategy, making this a class D inlet.

The 1995 NOAA Tidal Current Tables reported currents in Blind Pass to be 0.6 knots at maximum flood and 0.4 knots at maximum ebb. During the original field survey in 1995, a strong wind was blowing out of the southwest, large waves were breaking on the north jetty, and a strong flood current was observed.

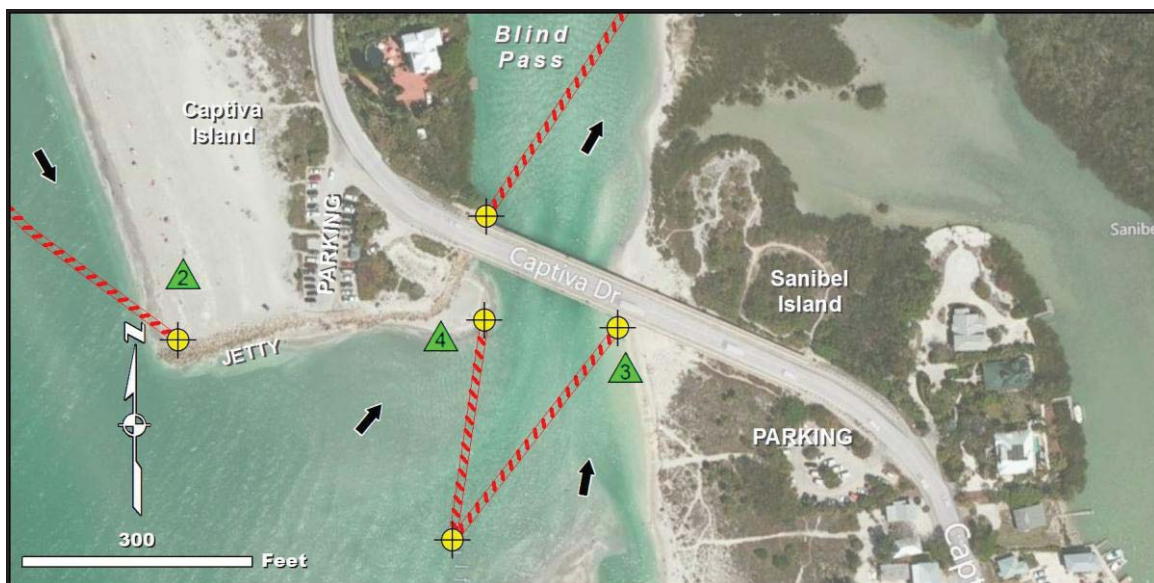
Shoreline Description: Sand beach with riprap at the high-tide line.

Access: There is a large parking area just behind the beach. However, the riprap may cause some difficulties with the cleanup. If so, use watercraft.

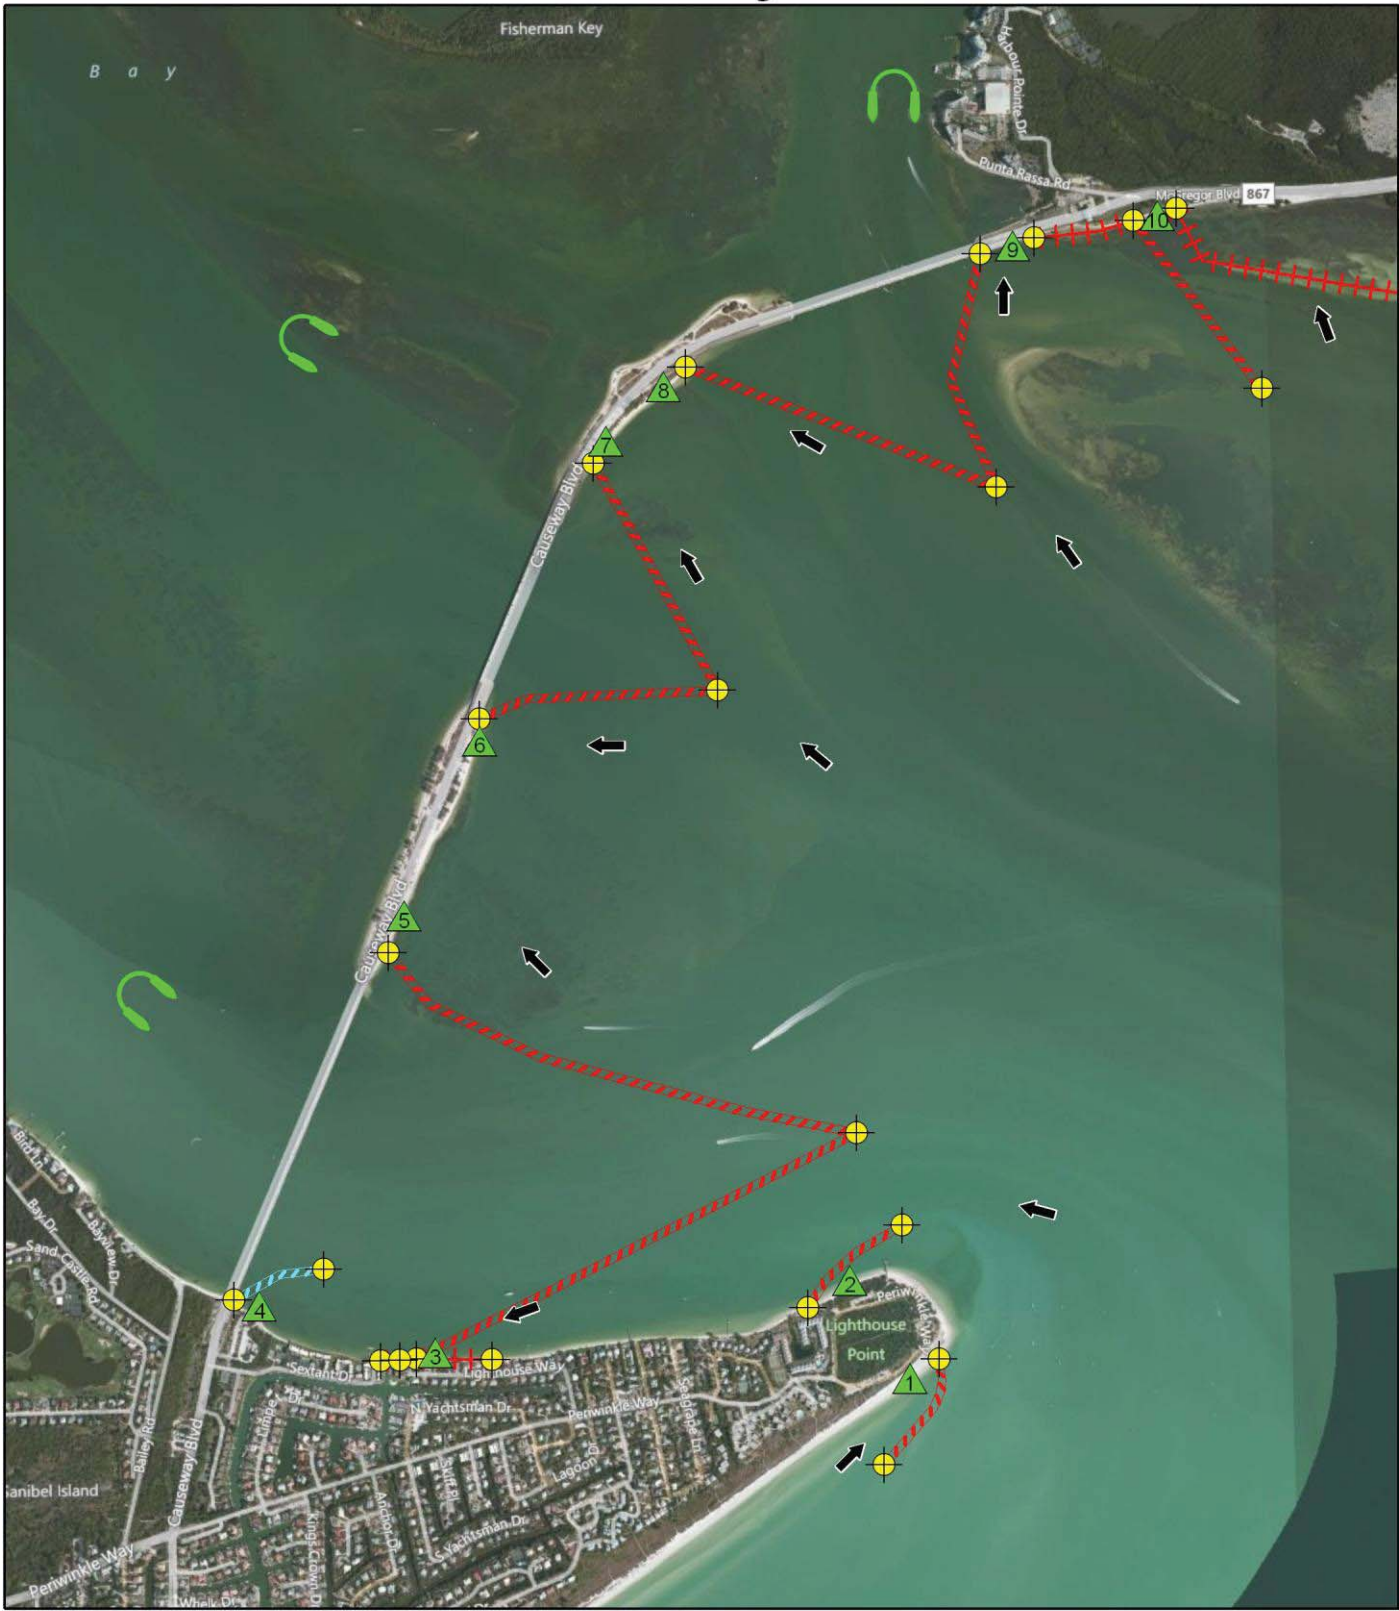
# San Carlos Bay Entrance

Divert oil to sand collection points along the outer beach (CP1) and the backside of Sanibel Island (CP2). Three channels pass beneath Route 867 and connect San Carlos Bay with the Gulf of Mexico. Anchor Christmas tree configurations of deflection boom in each of the three channels on the east side of the causeway. The south limb of the southern C. tree is designed to divert oil to a seawall on the shore of Sanibel Island about 400 yards east of the Causeway Blvd. (Route 867) Bridge (CP3). Place a line of protection boom across the entrance to the canal system just east of CP3. Project a short line of deflection boom out into the southern channel to divert oil to the sand beach/boat ramp just east of the southern end of the Causeway Blvd. Bridge (CP4). The north limb of the southern C. tree would divert oil to a sand beach on the south end of the southern fill area along the Causeway Blvd. Bridge (CP5). The south limb of the central C. tree would divert oil to the sand beach at the north end of the same fill area (CP6), and the north limb would divert oil to a sand beach at the south end of the central fill area (CP7). The south limb of the third (most northerly) C. tree would divert oil to the sand beach at the north end of

the central fill area (CP8), and the north limb would divert oil to the seawall along the abutment at the northeast end of the Causeway Blvd. Bridge (CP9). A line of deflection boom extending away from the south side of McGregor Blvd. (Route 867) about 450 yards east of the toll gate for the Causeway Blvd. Bridge would divert oil to a sand beach (CP10). Place protection boom as needed between CP9 and CP10 to keep oil out of the riprap. Inside the bay, use open water collection skimmers to recover oil that entrains the initial lines of defense.

Waves in the bay could pose a problem for response operations.

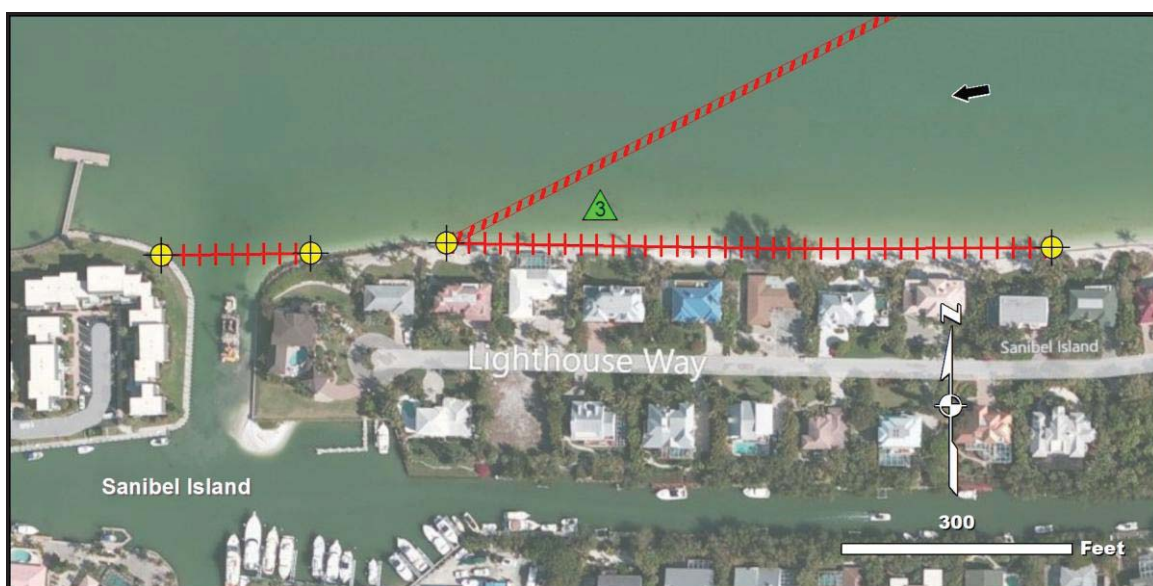
Relative Location: The shore of Sanibel Island about 400 yards east of the Causeway Blvd (Route 867) Bridge.

Shoreline Description: Seawall.

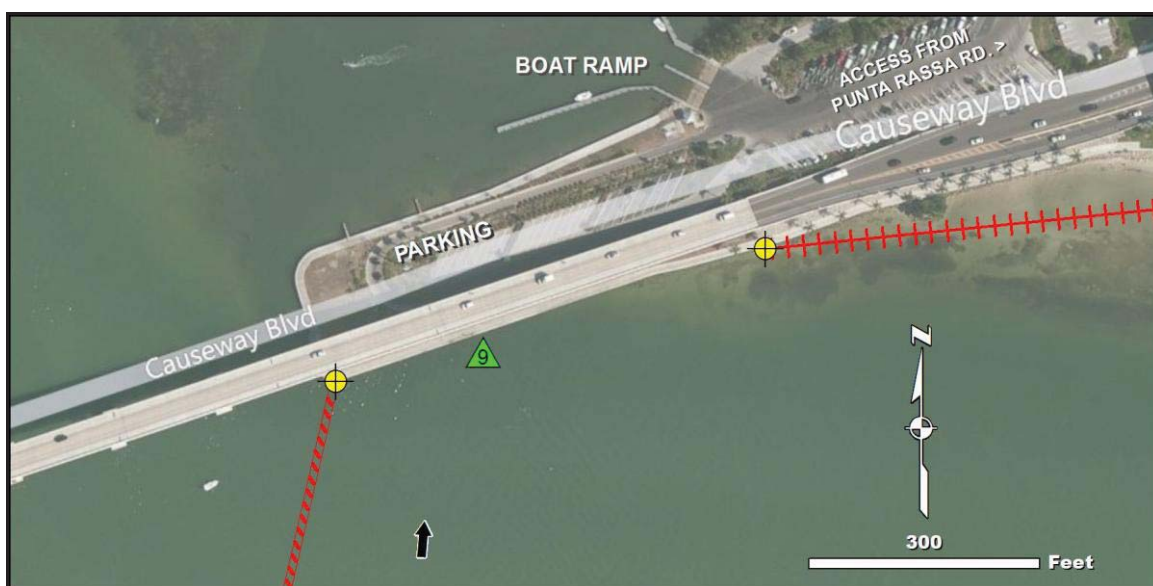
Relative Location: Northeast end of the Causeway Blvd. (Route 867) Bridge (bridge abutment).

Shoreline Description: Seawall.

Access: There is a large parking area and boat ramp on the north side of the bridge. It looks as if you can drive under the bridge to get to the seawall.
