# Tidal Inlet Protection Strategies for Oil-Spill Response

## U.S. Coast Guard Sector St. Petersburg

October 2011

Prepared by Miles O. Hayes, Jeffrey Dahlin, and Joseph Holmes,  
Research Planning, Inc.

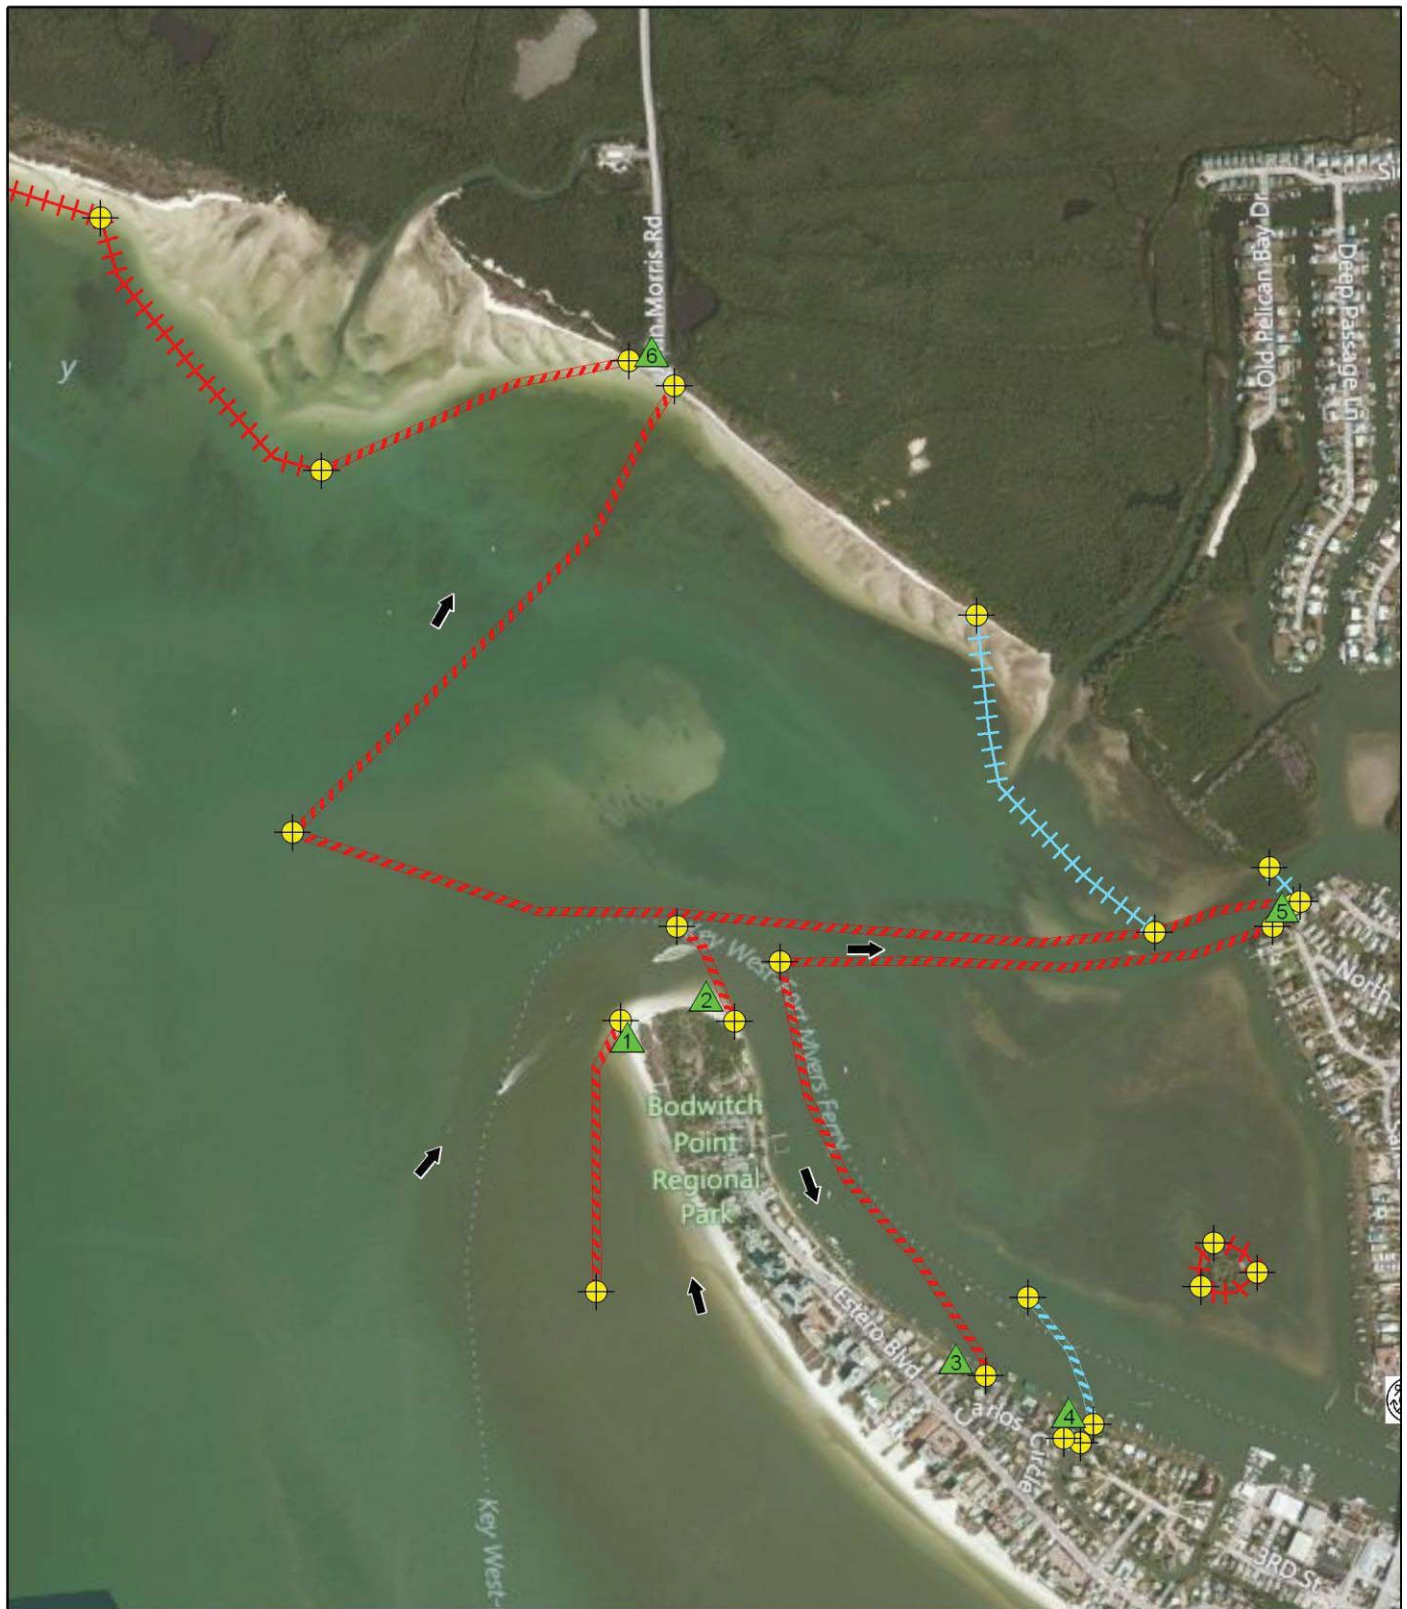
# Estero and Matanzas Pass

The outer bay and pass are extremely shallow and there are extensive tidal flats exposed at low tide. Also, there may be wave action causing problems at CP6 from time to time.

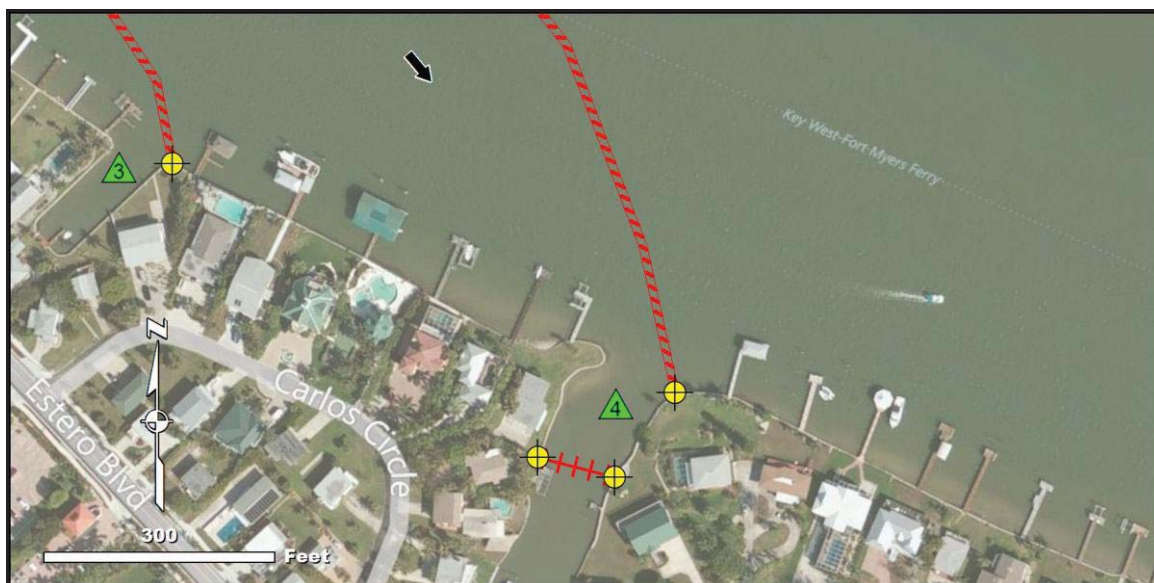
Shoreline Description: A man-made basin surrounded by seawalls. Place protection boom across the basin a ways inside it.

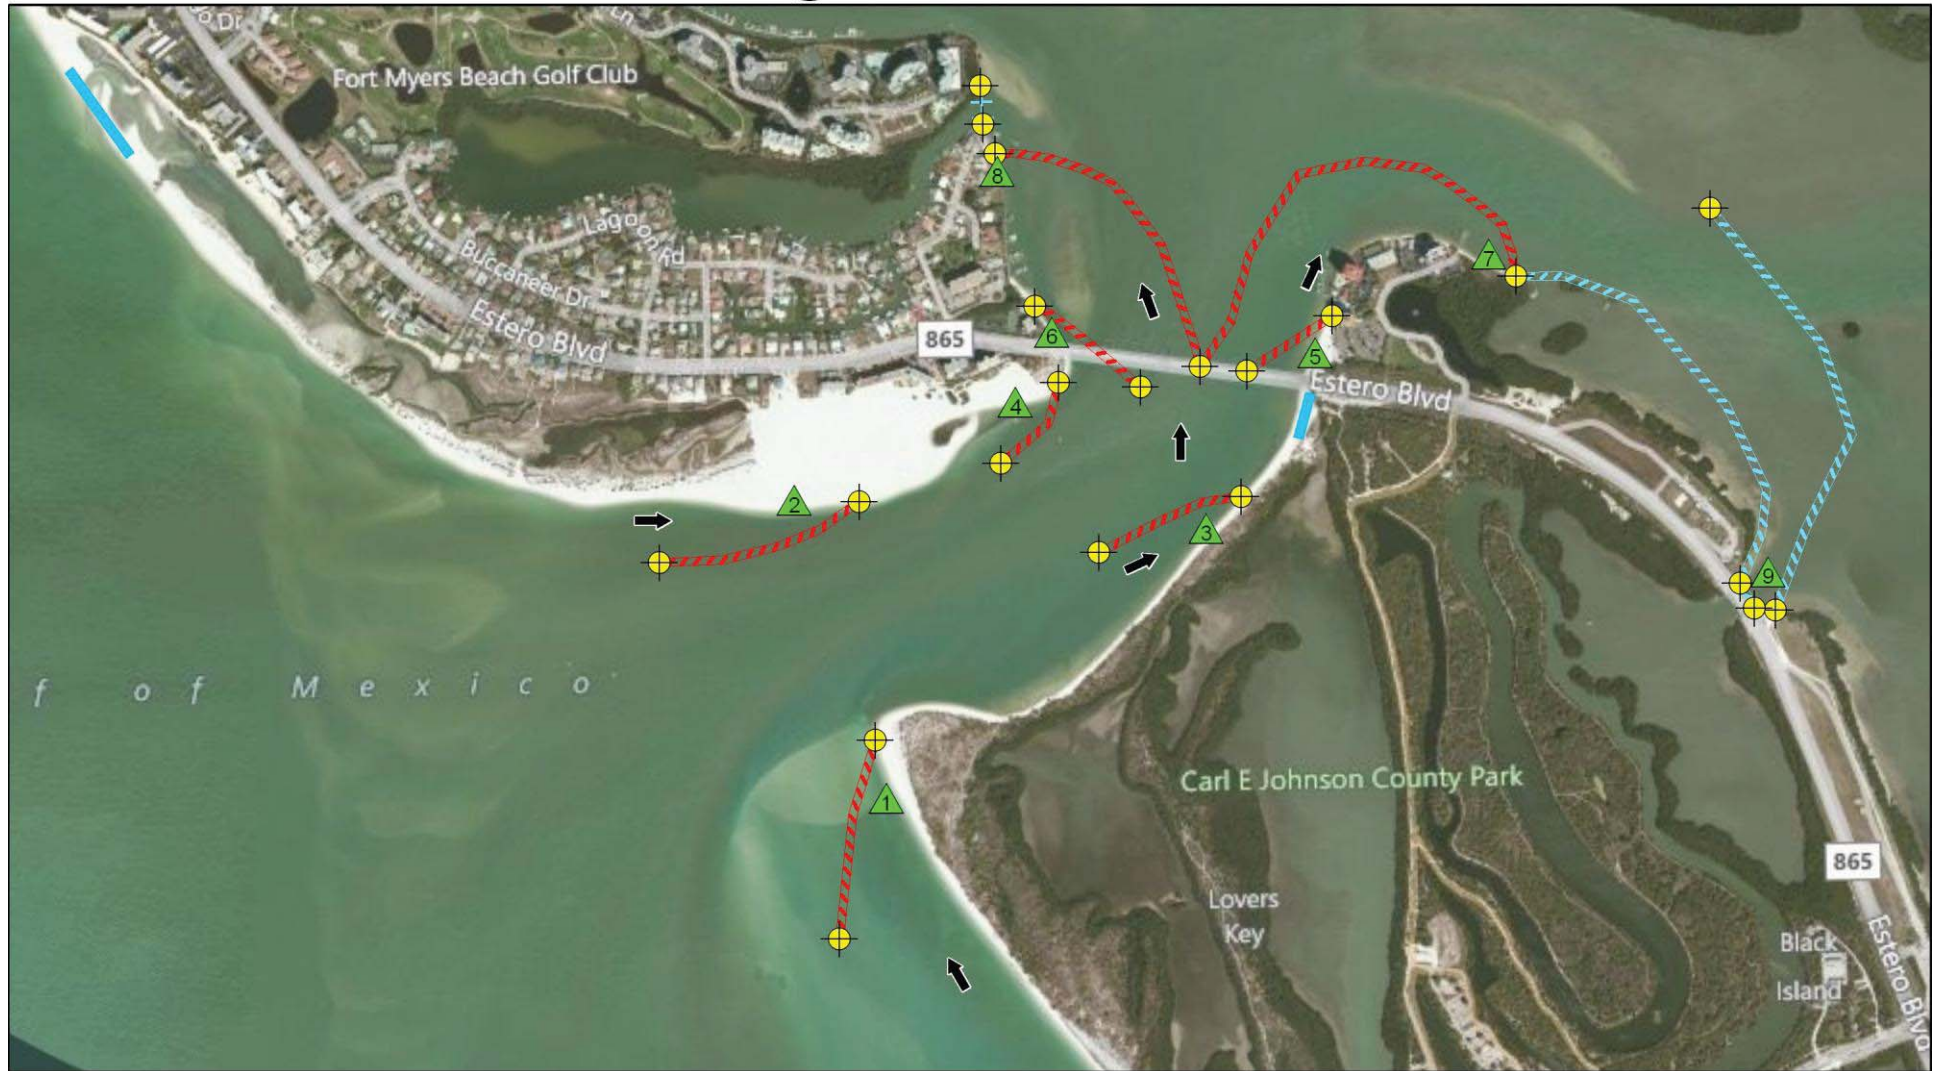
# Big Carlos Pass

Florida Sea Grant Report Number 37 (Jones, 1980) reported currents in Big Carlos Pass to be 1.5 knots at maximum flood and 1.6 knots at maximum ebb.

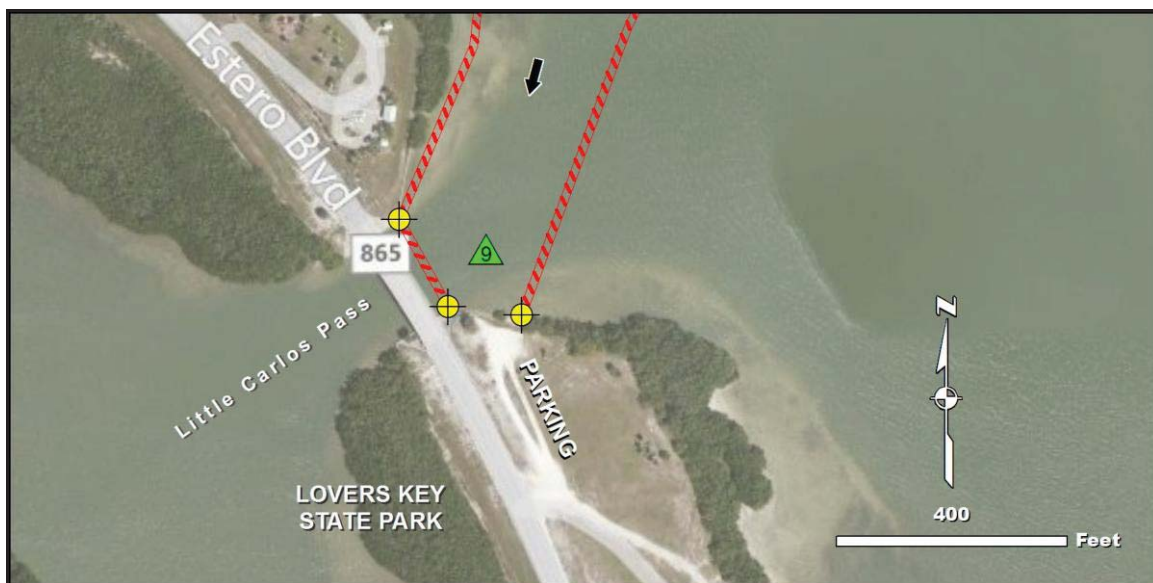
Shoreline Description: Seawall

Access: Excellent. You can drive right up to the top of the seawall and there is parking space available.

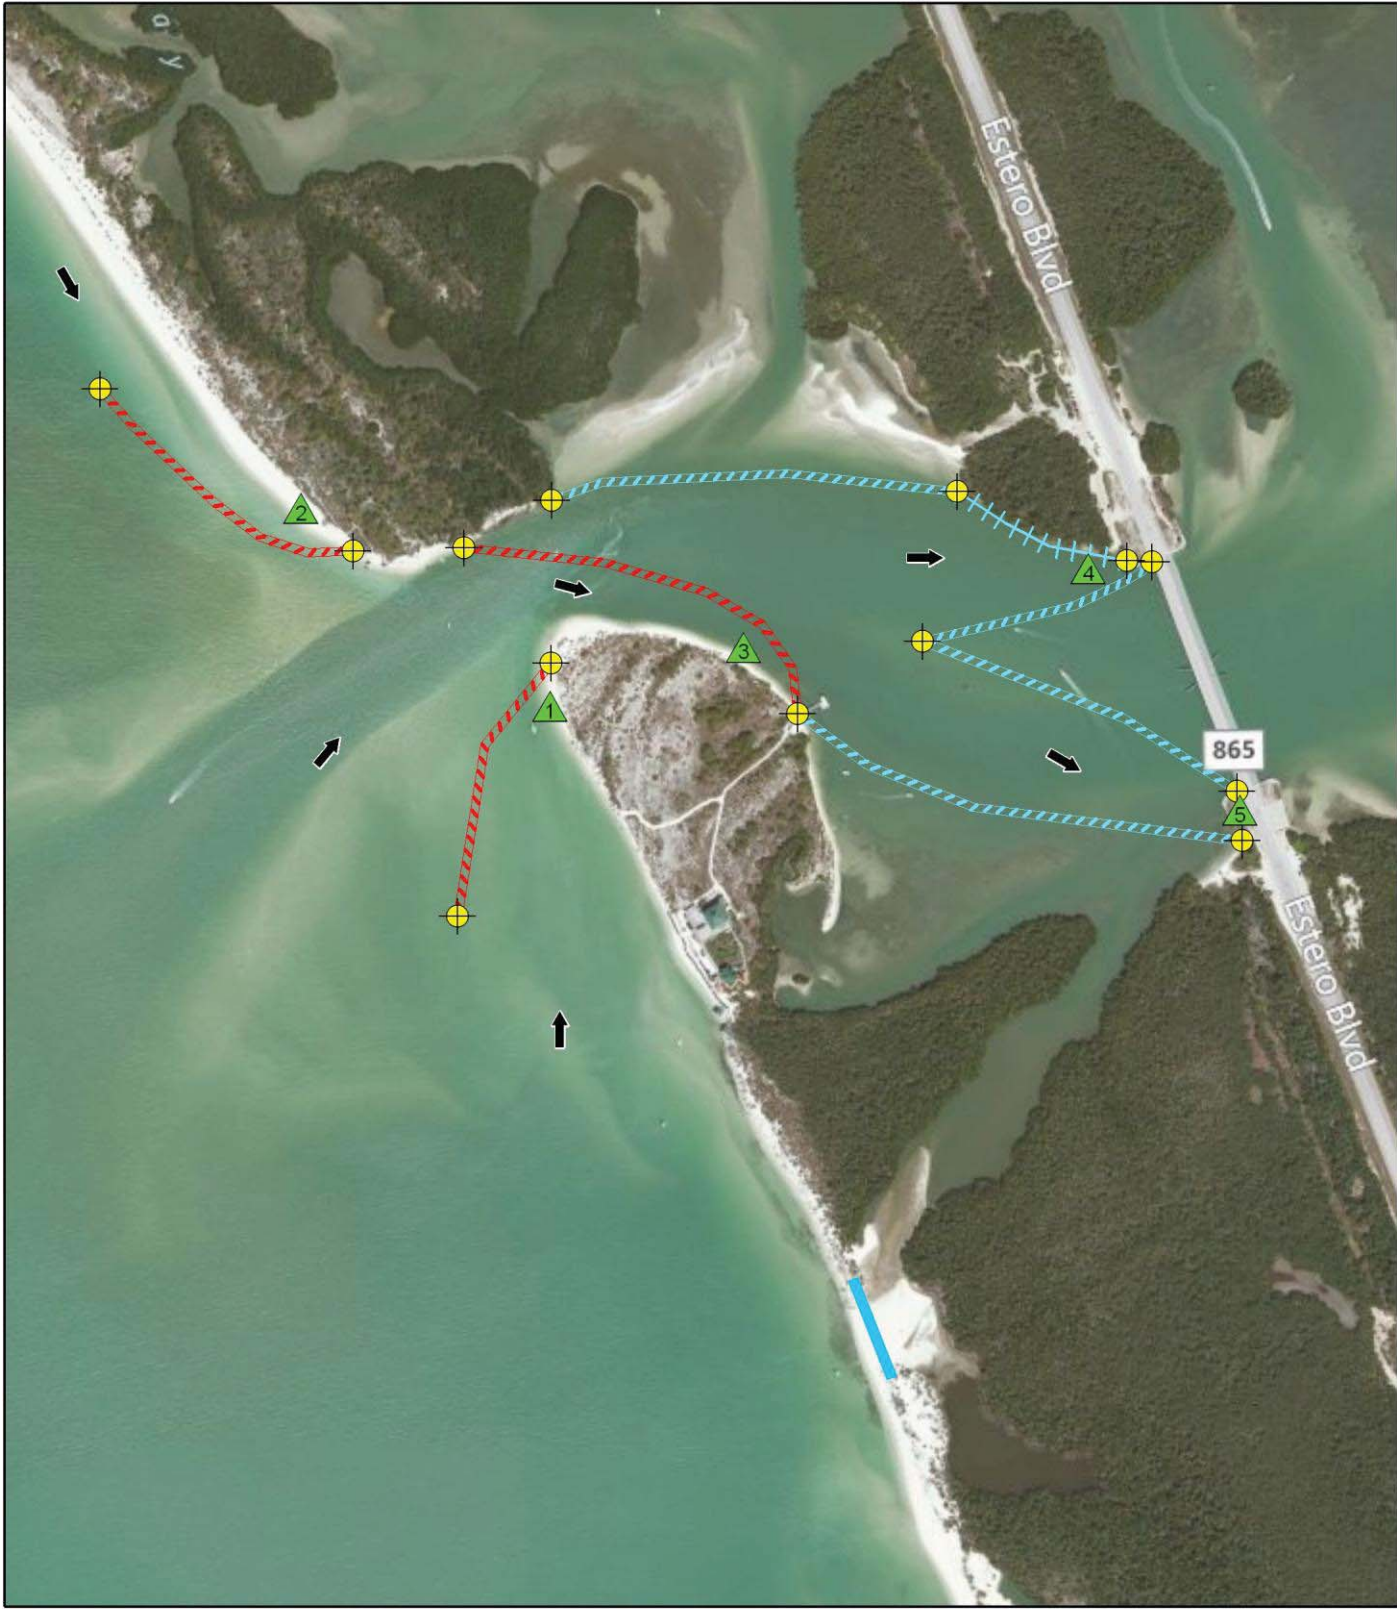
# New Pass (Lee)

Florida Sea Grant Report Number 37 (Jones, 1980) reported currents in New Pass to be 1.5 knots at maximum flood and 1.3 knots at maximum ebb.

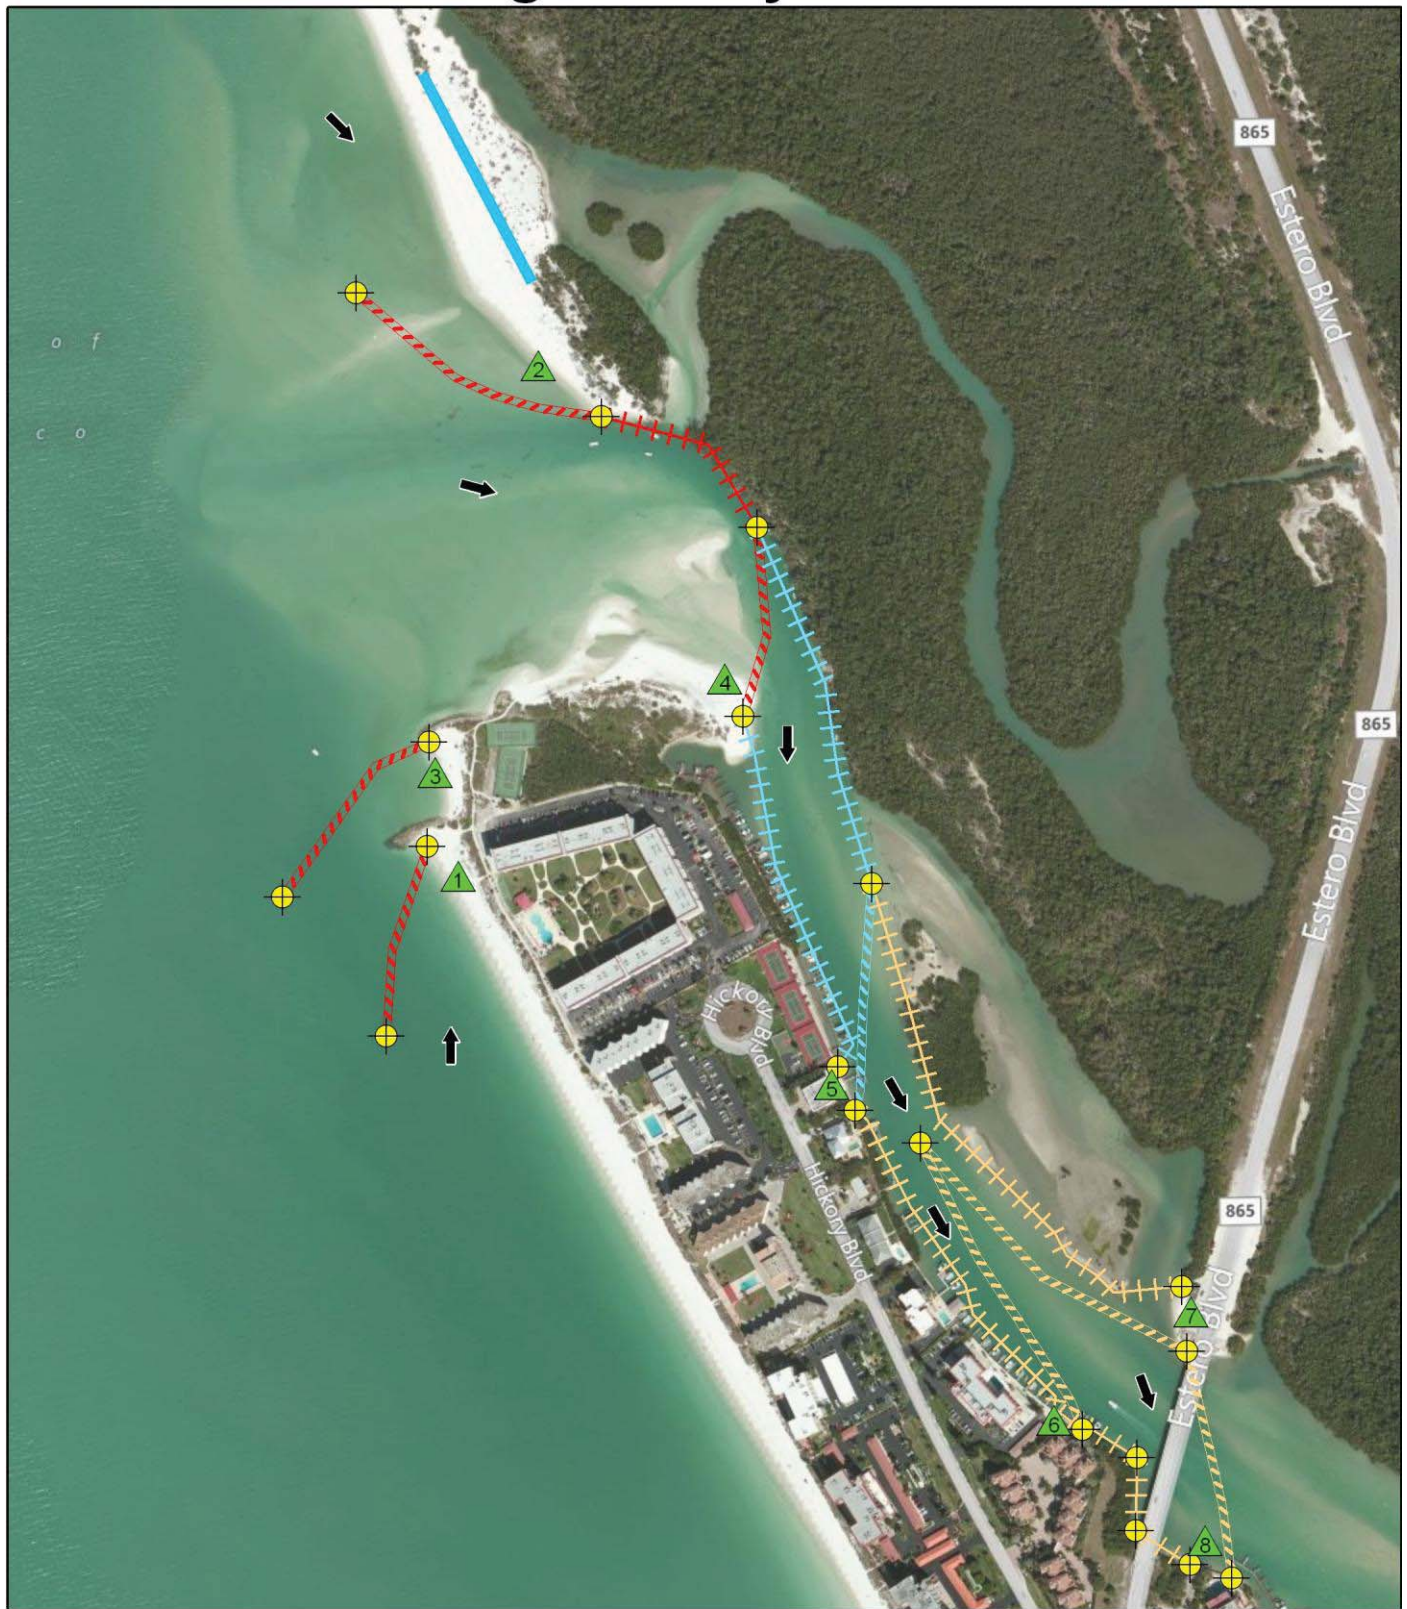
# Big Hickory Pass

Florida Sea Grant Report Number 37 (Jones, 1980) reported currents in Big Hickory Pass range from 1.8-3.0 knots.

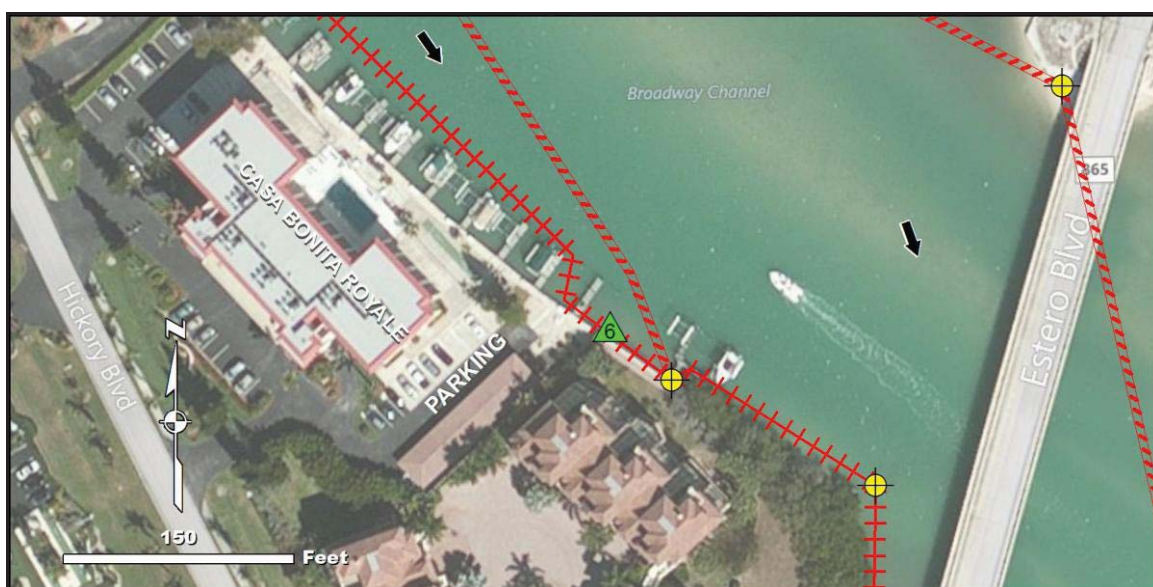
Shoreline Description: Seawall. Place a line of protection boom in front of the sea wall for the oil to accumulate on.

Access: There is a paved area right up to the seawall, but this is private property. If you cannot gain access from land, use watercraft.

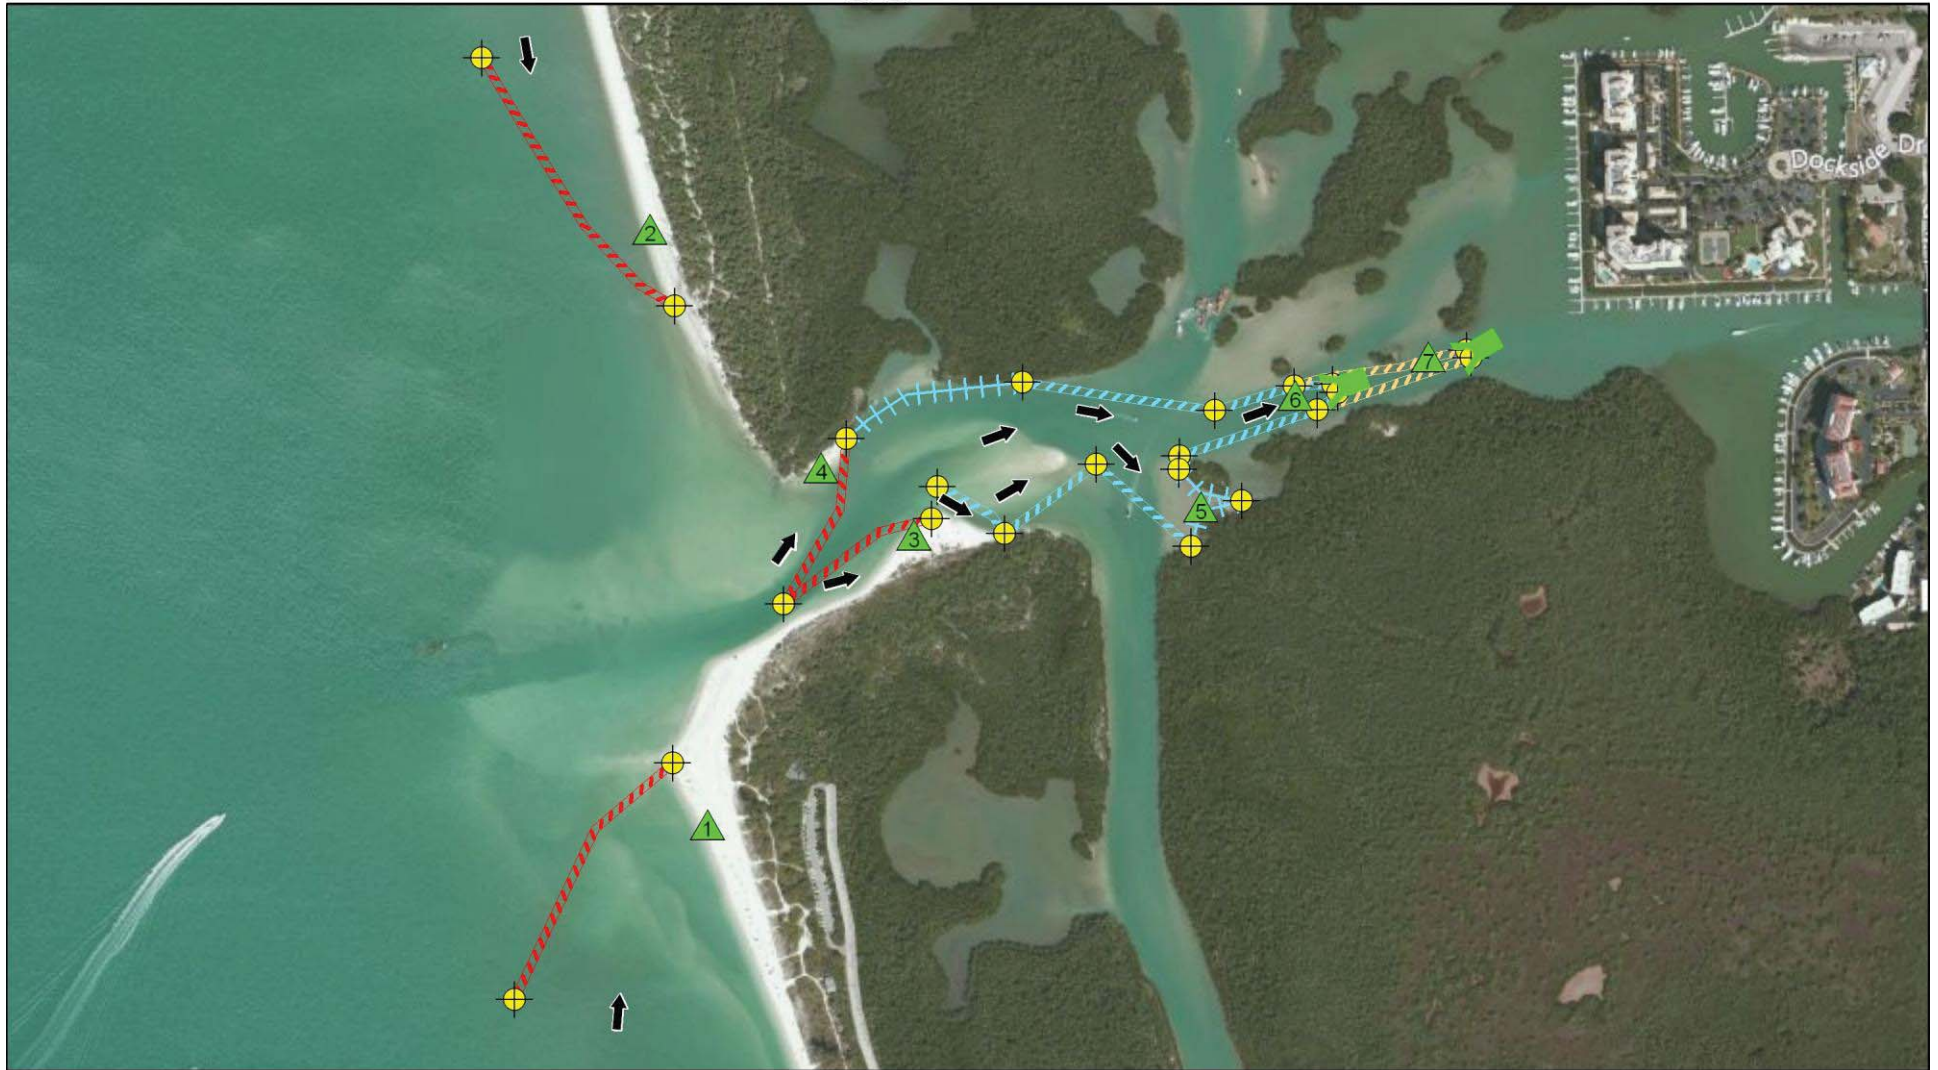
# Wiggins Pass

Despite its relatively small size, this inlet is ranked B during adverse conditions, because very strong ebb-tidal currents (3 knots; estimated) were observed in the main inlet channel during the original field survey in 1995.

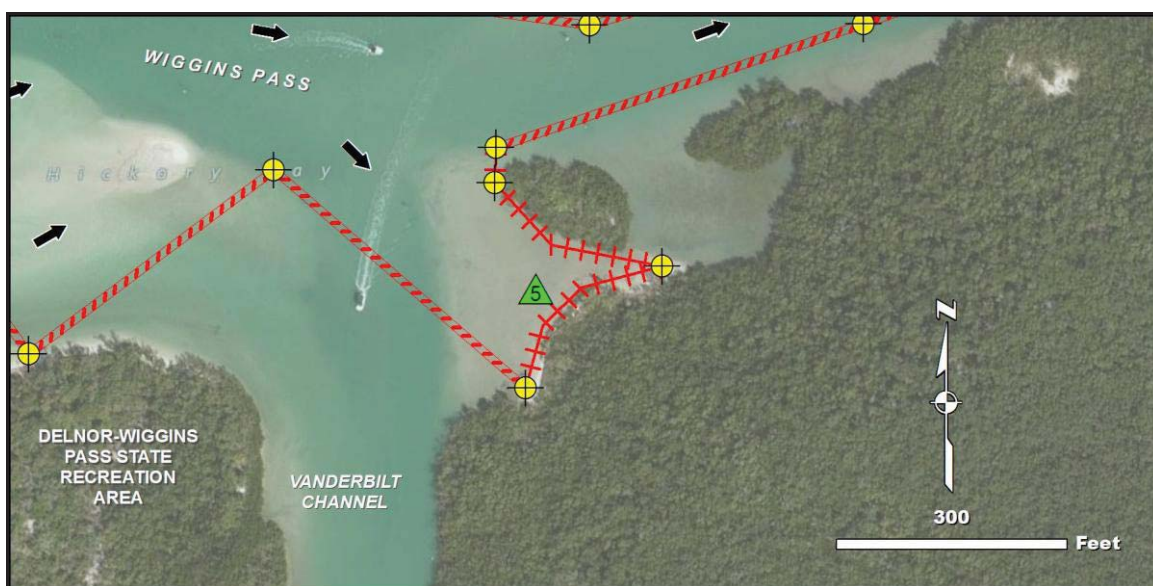
Shoreline Description: Sand beach/sand flat. Place protection boom along the high-tide line for the oil to accumulate on.

Access: By watercraft.

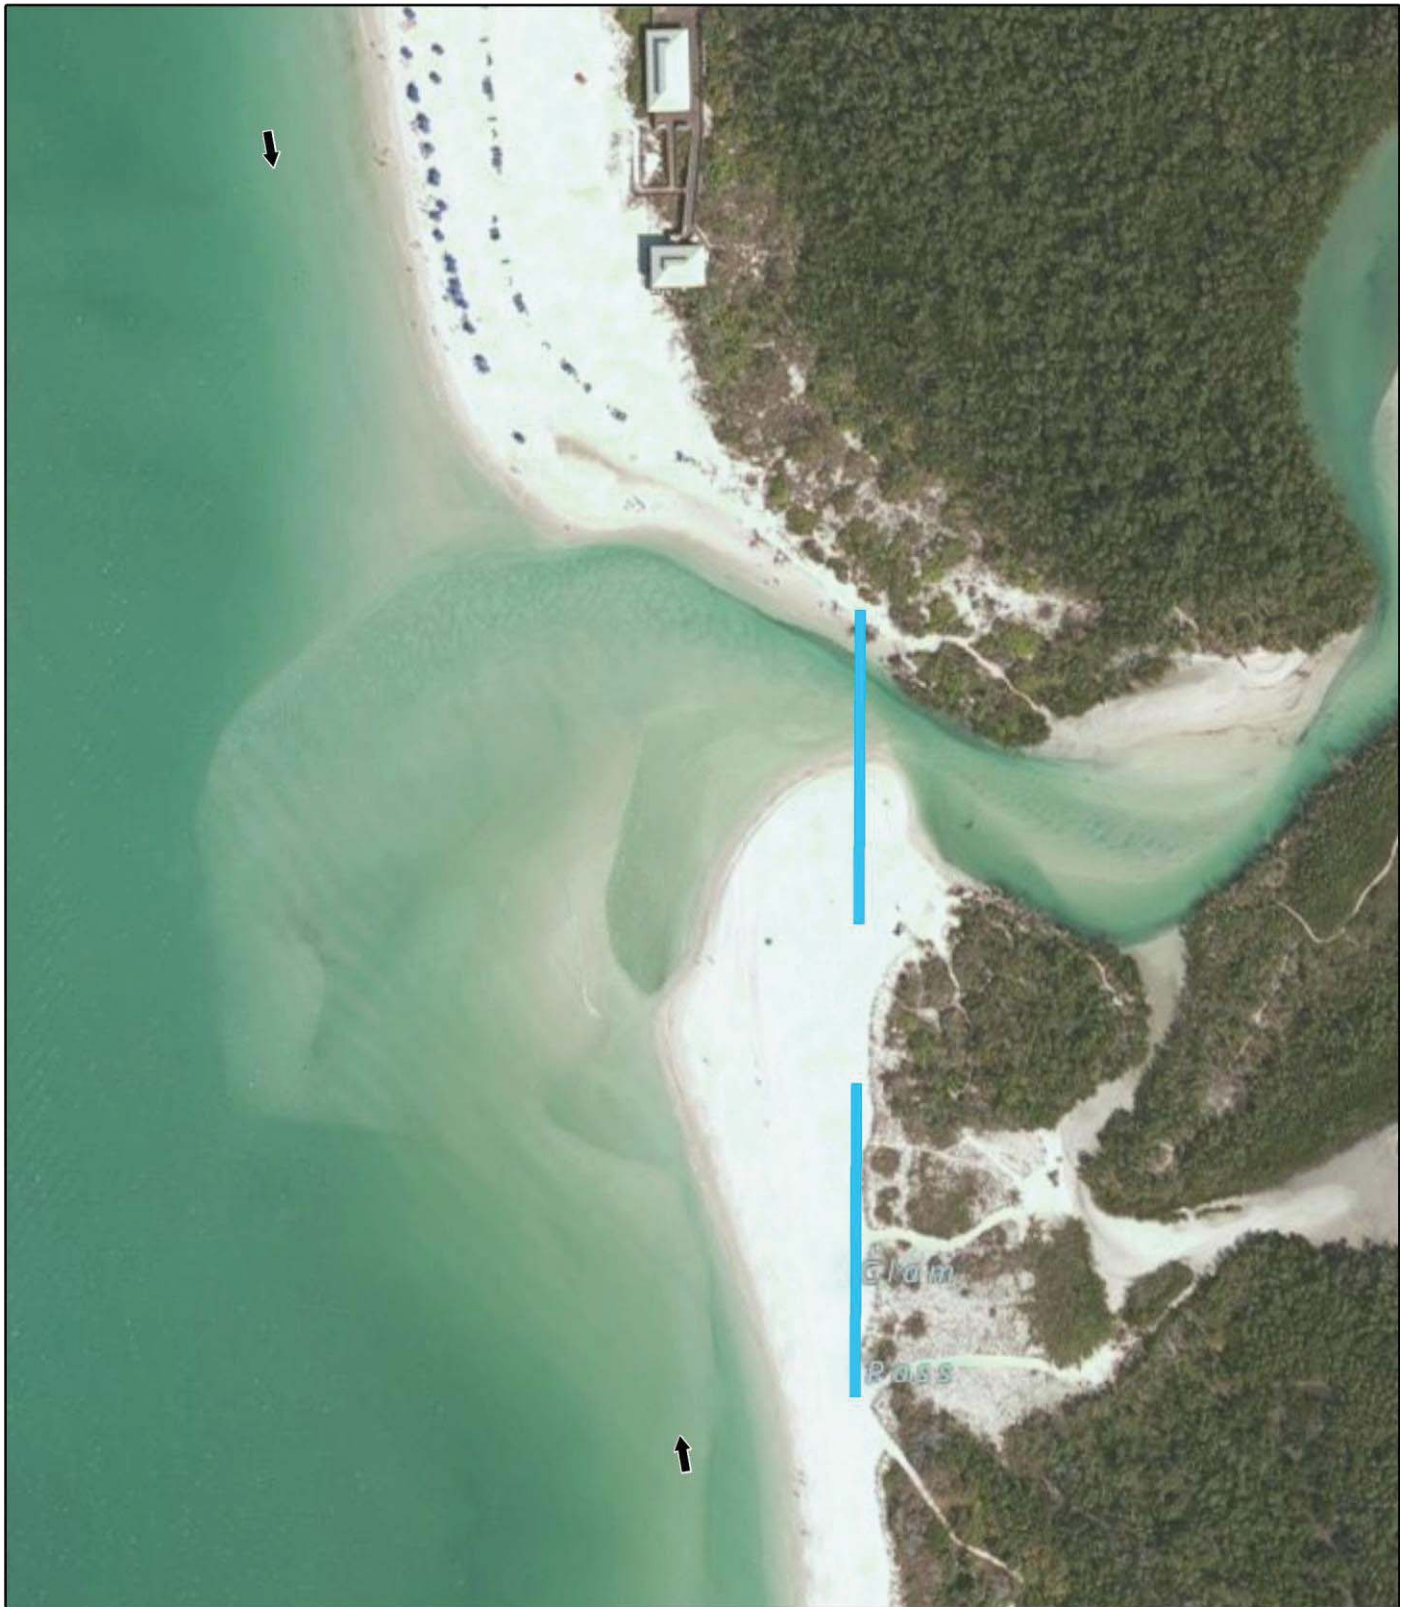
# Clam Pass

Close off the main inlet channel and the washover channel to the south with sand dikes, both of which should be about 75-100 yards long.

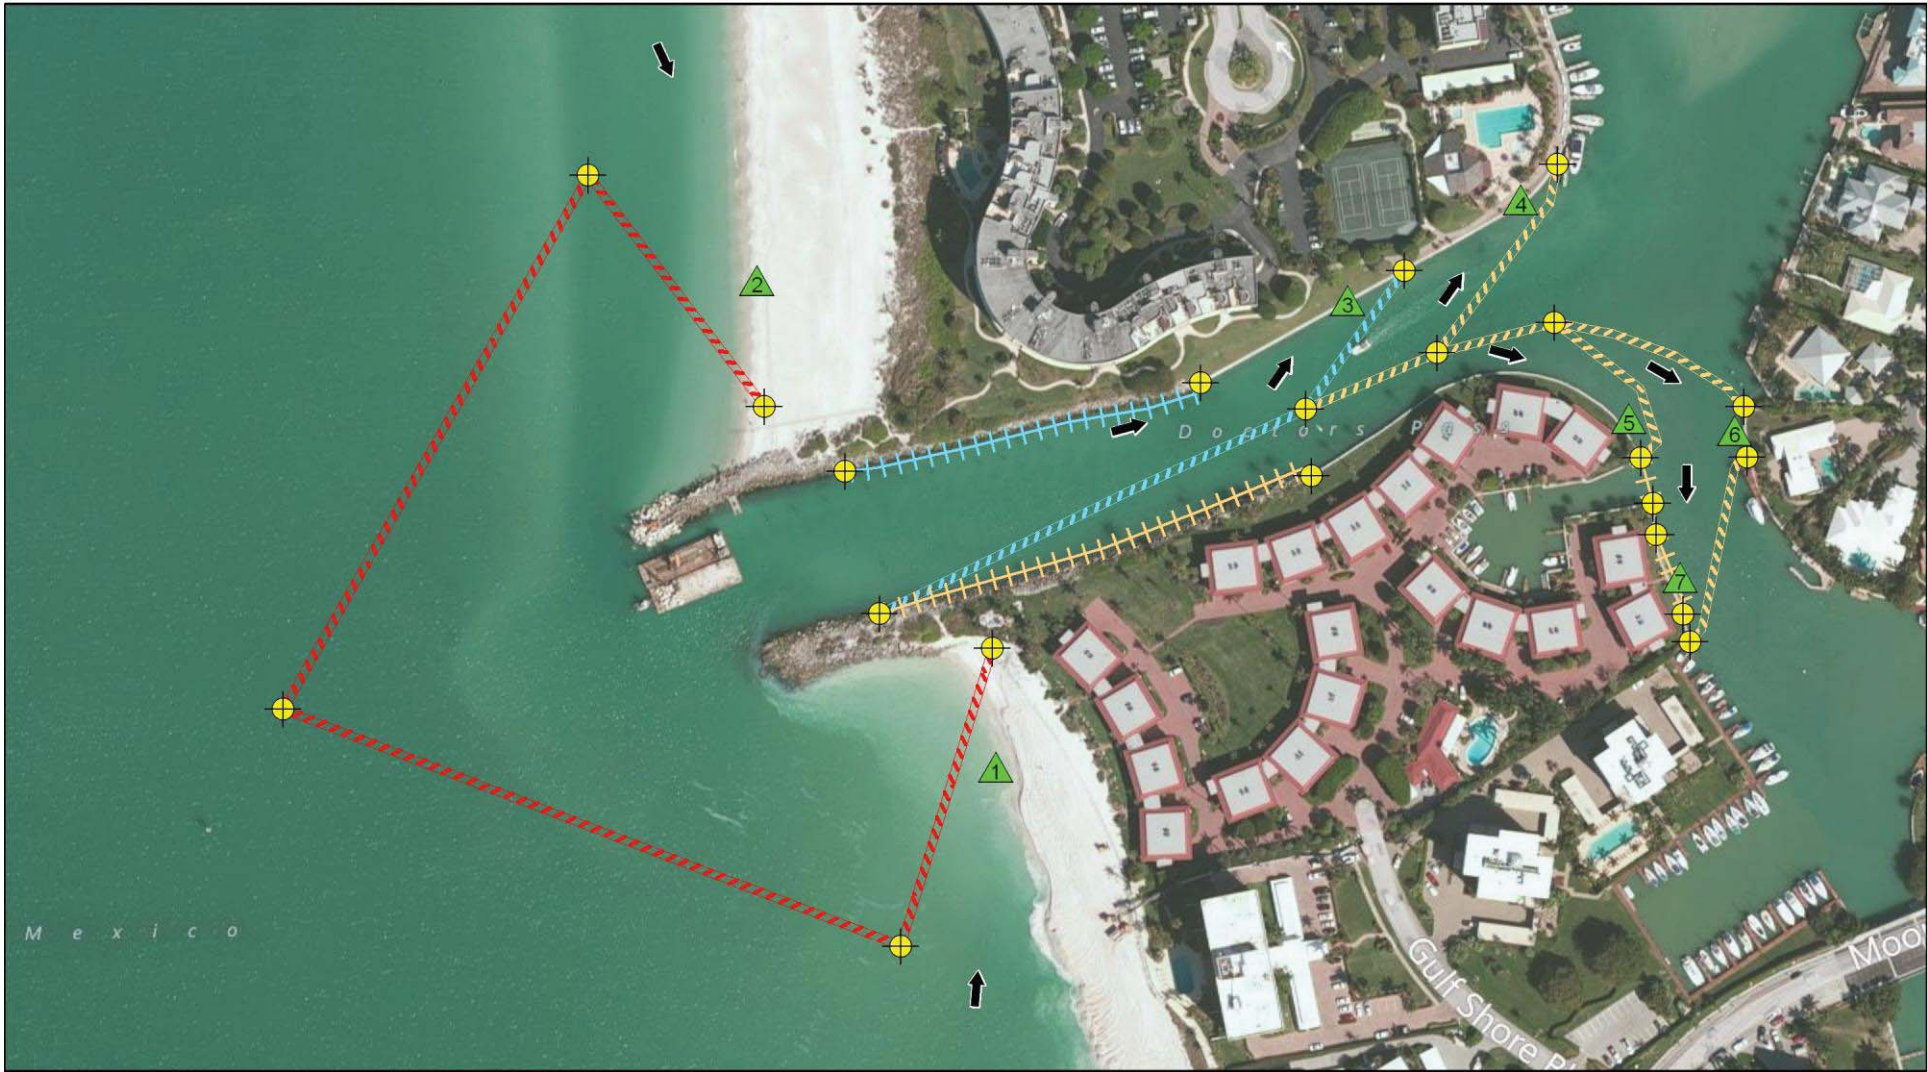
# Doctors Pass

Conditions permitting, anchor a Christmas tree configuration of deflection boom offshore of the entrance to the main inlet channel to divert oil away from the inlet. Divert oil approaching the inlet through the marginal flood channels of the rather small ebb-tidal delta to collection points along the outer sand beaches (CPs 1 and 2). Line the riprap on both sides of the entrance portion of the main inlet channel with protection boom. Anchor a long line of deflection boom to the middle of the south jetty that leads to three Christmas tree configurations of deflection boom further inside the inlet. The north limb of the first (most seaward) C. tree would divert oil entering the inlet to a seawall on the north shore of the main inlet channel about two thirds of the way inside the inlet (CP3), and the north limb of the second C. tree would also divert oil to a seawall on the north shore about 90 yards east of CP3 (CP4). The south limb of the third C. tree would divert oil to the seawall at the east end of the peninsula along the south side of the main inlet channel (CP5), and the north limb would divert oil to the seawall just across the north/south channel to the south of Moorings Bay (CP6). From CP6, extend a line of deflection boom toward the southwest across the adjoining channel to the seawall at CP7. Place a line of protection boom along the platform over the seawall at CP7, as well as across the entrance to the basin between CP7 and CP5.

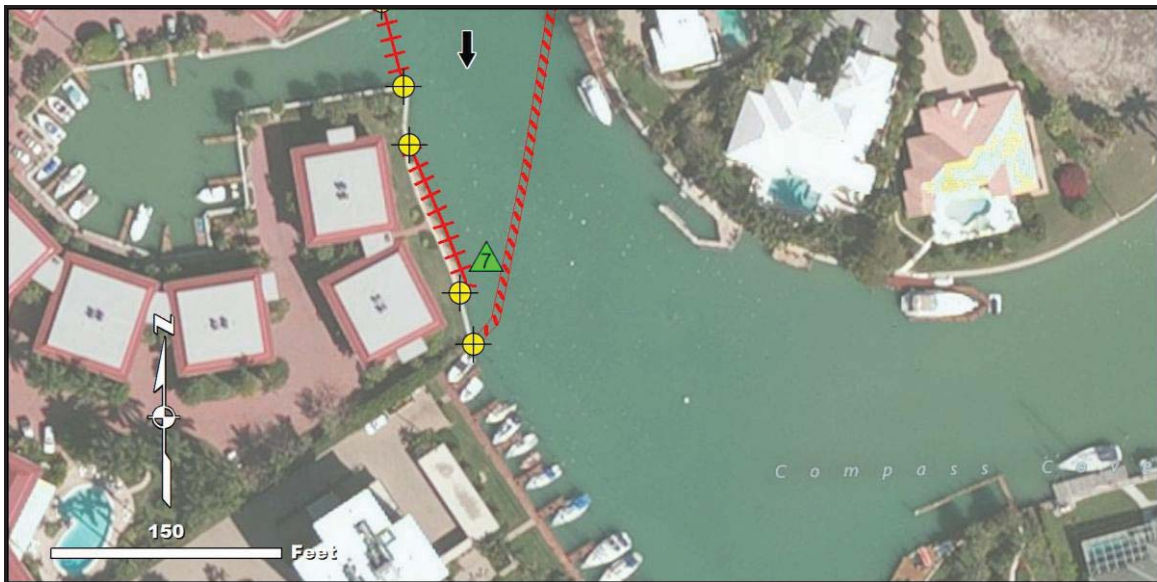
Shoreline Description: Seawall. Place protection boom along the overhang for the oil to accumulate on.

Access: By watercraft.

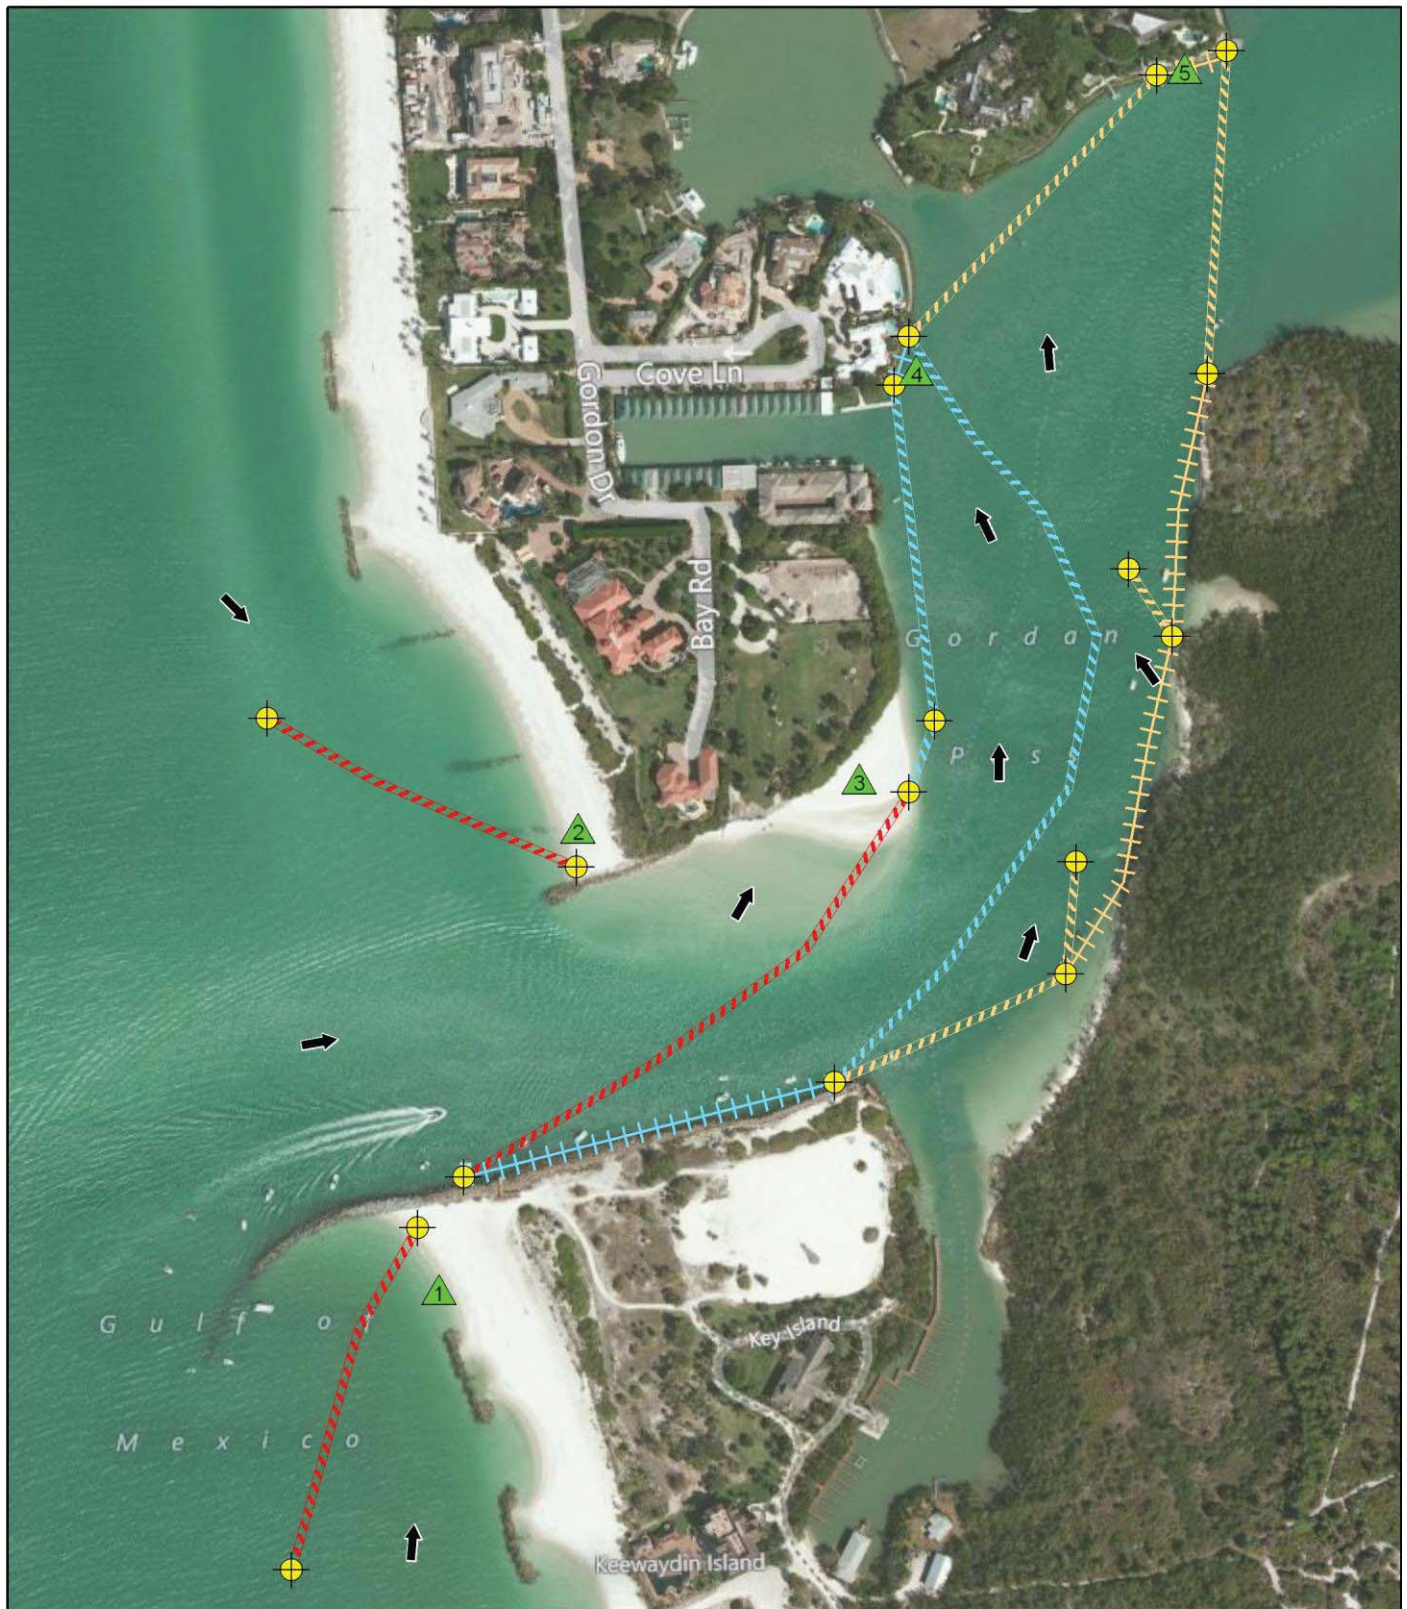
# Gordon Pass

Divert oil entering the inlet through the marginal flood channels of the ebb-tidal delta to collection points along the outer sand beaches (CPs 1 and 2). Place protection boom along the riprap along the north end of Keewaydin Island. From the south jetty, project a line of deflection boom obliquely across the main inlet channel to the sand beach on the north side of the main inlet channel (at the east side of the southern end of the Naples peninsula) (CP3). Extend a line of deflection boom in a northerly direction away from CP3 along the east shore of the Naples peninsula beyond the entrance to a large boat basin and on to a riprap shoreline near the end of Cove Lane (CP4). From CP4, extend another line of deflection boom in a northeasterly direction to another riprap shoreline at the end of another south trending peninsula further to the northeast (CP5). From the east end of the riprap on the north end of Keewaydin Island, project a long line of deflection boom out into the main inlet channel and on to the north until it eventually crosses the channel to divert oil to CP4. From that same spot on the north end of Keewaydin Island, extend another line of deflection boom across the entrance to the basin to the south. Then run a long line of protection boom along the mangrove shoreline on the east side of the main inlet channel. Place two short lines of deflection boom out into the channel that will divert the oil away from the mangroves. At the end of the mangroves, extend a line of deflection boom across the main inlet channel to CP5.

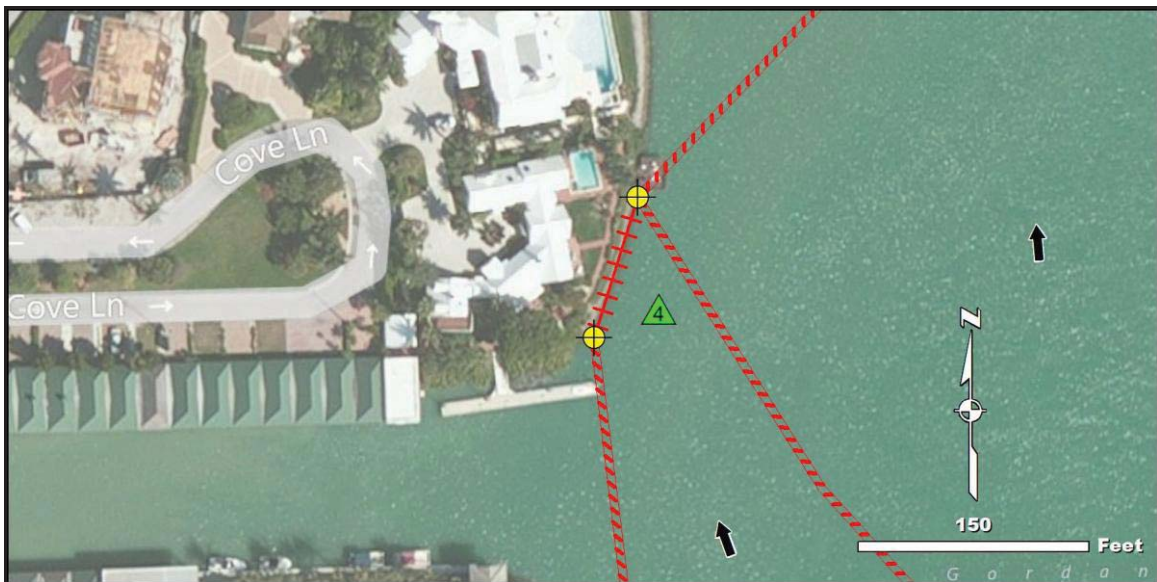
Shoreline Description: Riprap zone lined with protection boom for the oil to accumulate on.

Access: By watercraft.
