# Tidal Inlet Protection Strategies for Oil-Spill Response

## U.S. Coast Guard Sector St. Petersburg

October 2011

Prepared by Miles O. Hayes, Jeffrey Dahlin, and Joseph Holmes,  
Research Planning, Inc.

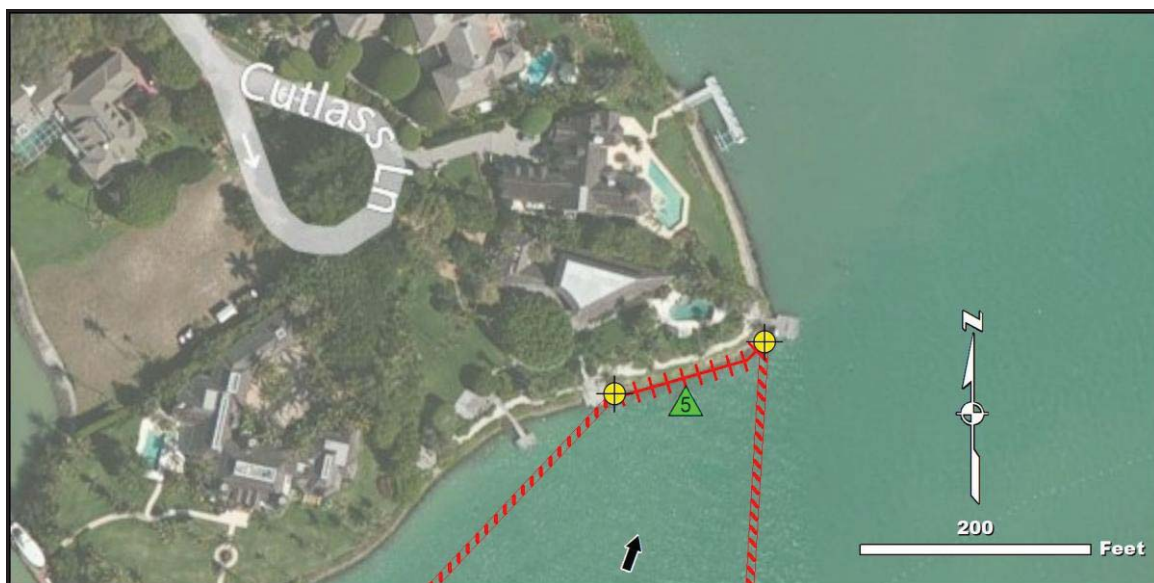
Shoreline Description: Zone of riprap lined with protection boom for the oil to accumulate on.

Access: By watercraft.

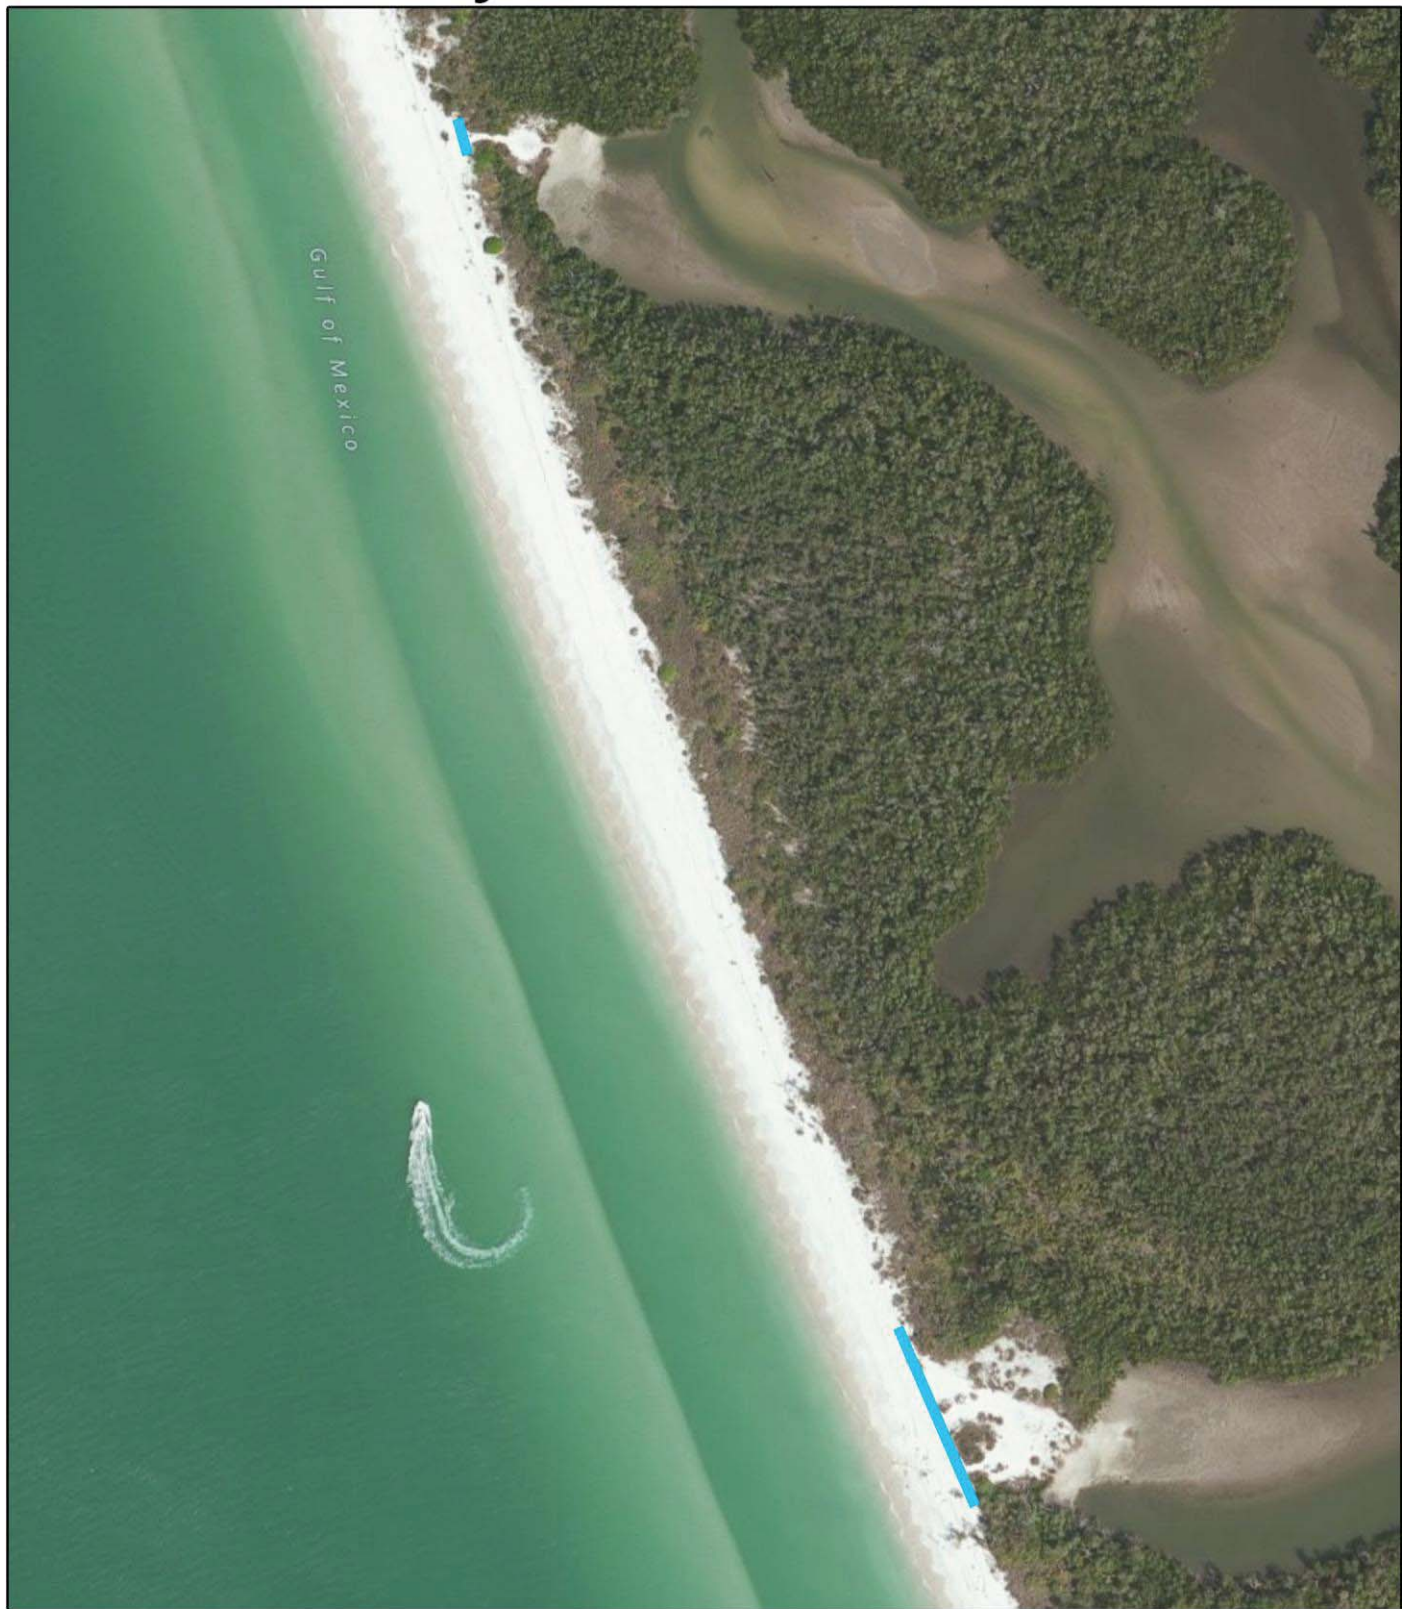
# Keewaydin Island Washovers

(NOTE: These are two washover channels through Keewaydin Island into Bartell Bay.) Place sand dikes across the entrances of the two washover channels. The north dike should be about 25 yards long and the southern one should be about 75 yards long.

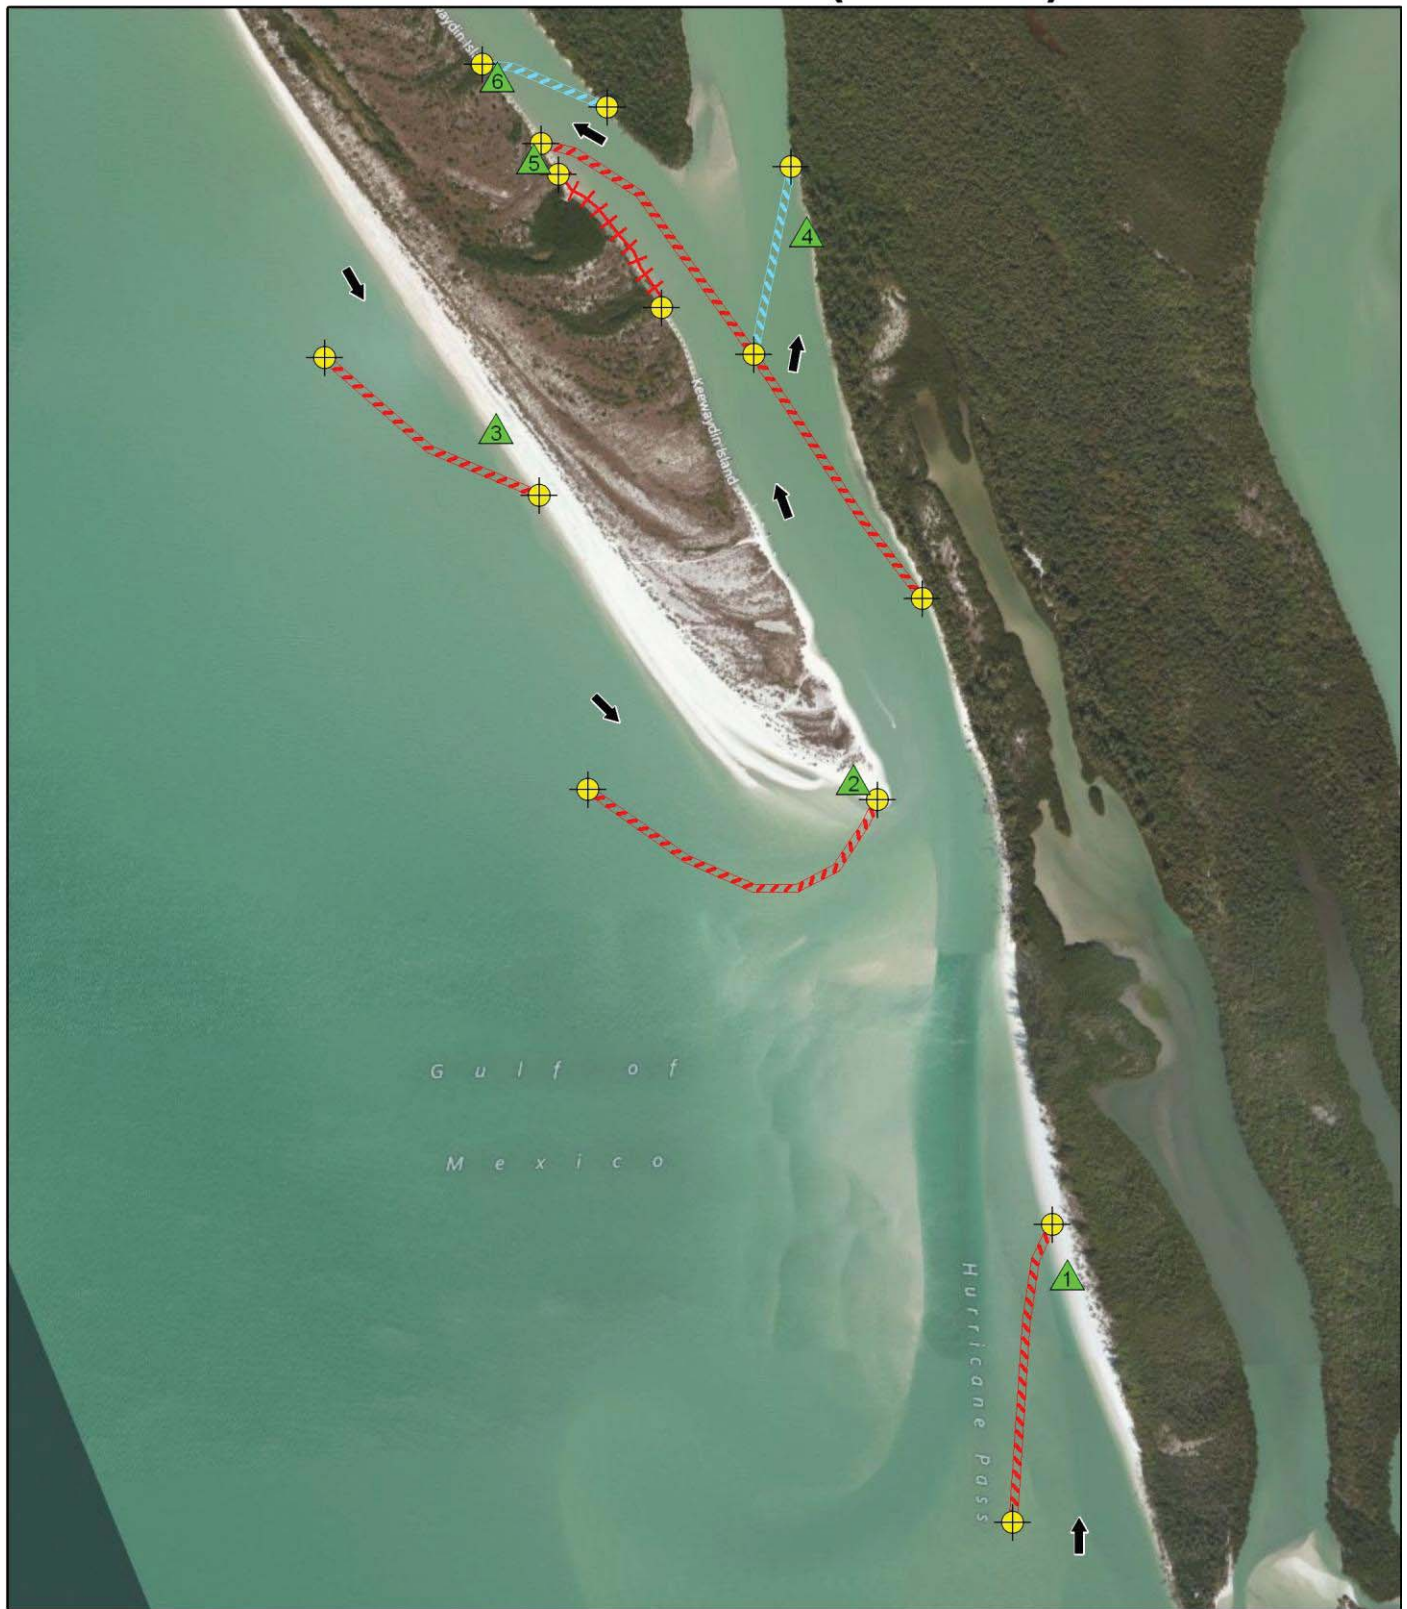
# Hurricane Pass (Collier)

During both surveys, the ebb-tidal delta was elongated, with a well-defined main ebb channel oriented south/southwest.

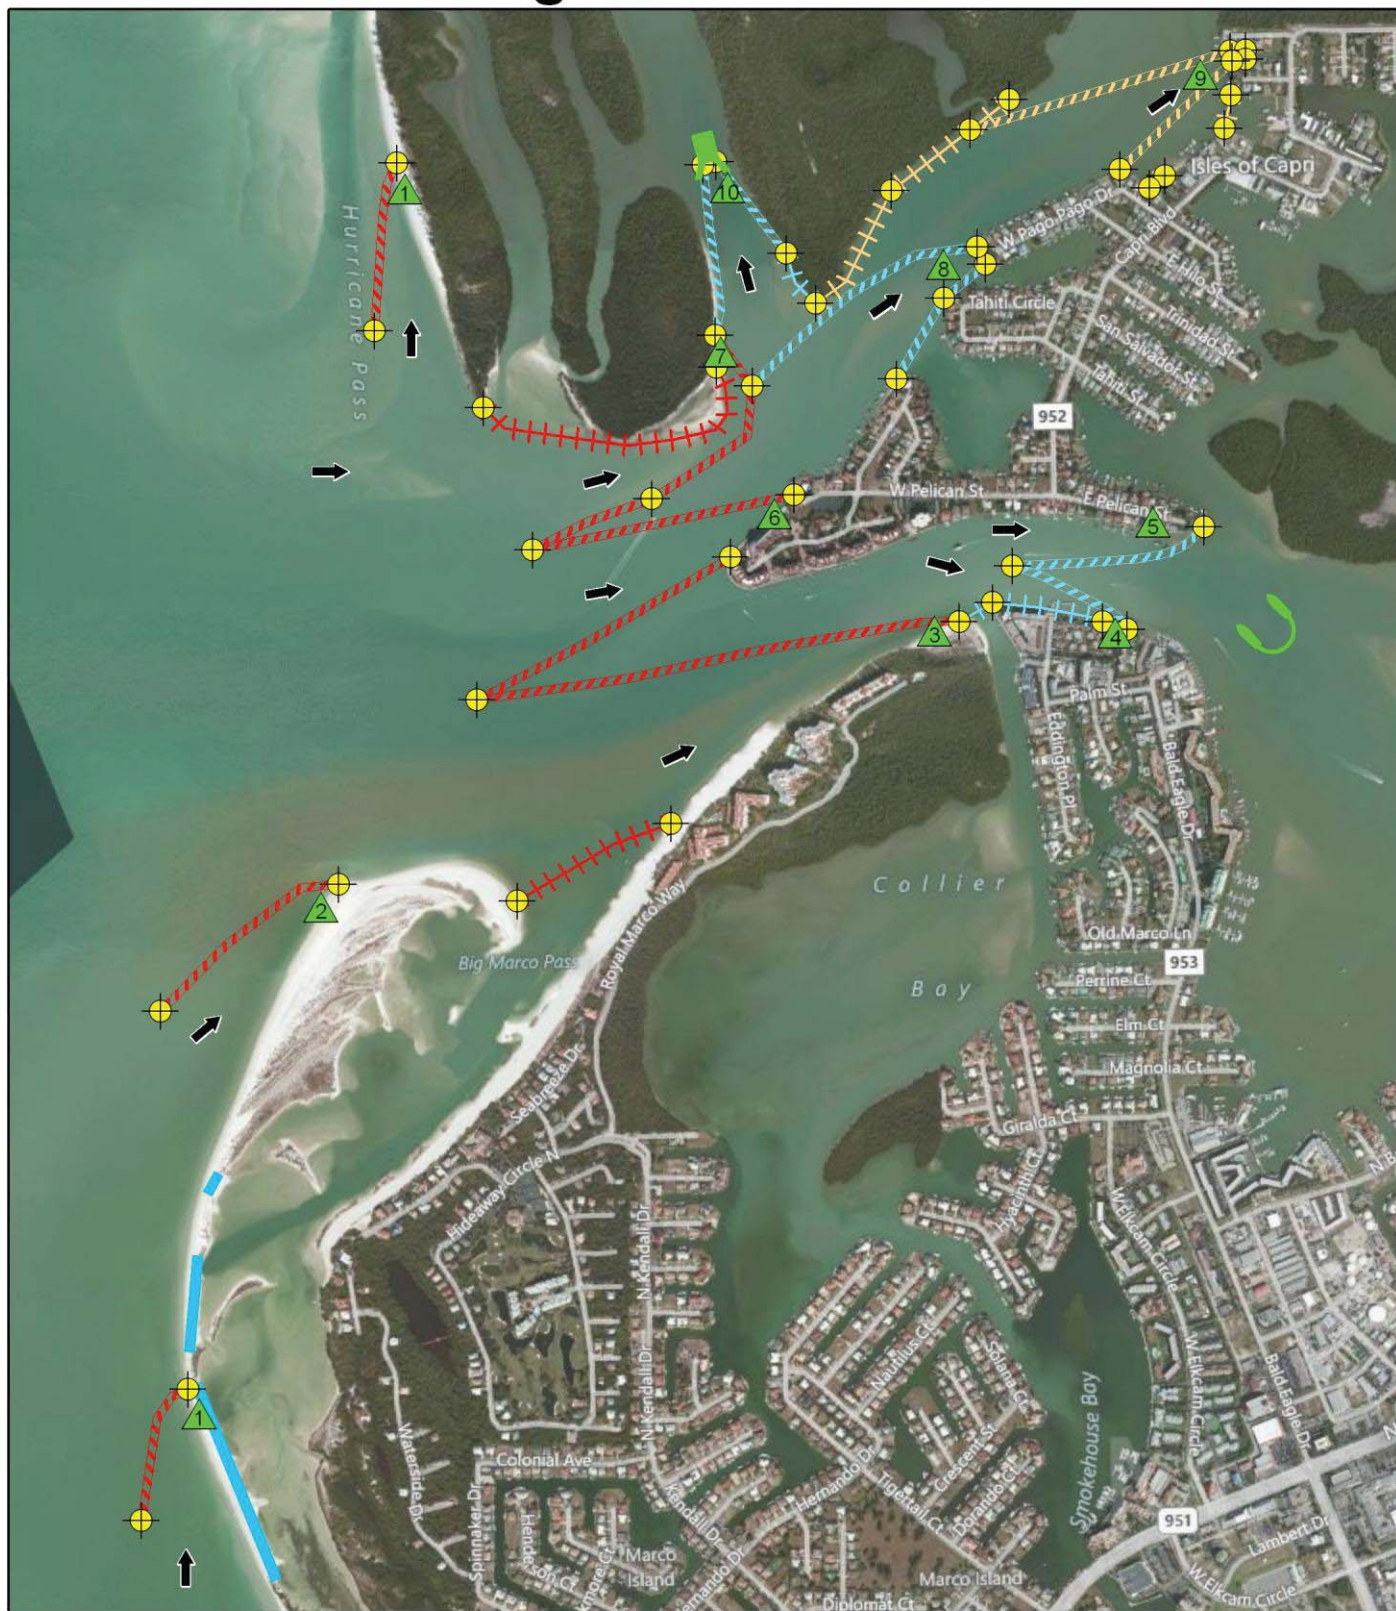
# Big Marco Pass

obliquely across the channel to a small man-made basin on the eastern shoreline (CP9). A shorter line of deflection boom in the south also leads to CP9. Place the lead anchor point for a small Christmas tree configuration of deflection boom in the middle of the south fork of the main inlet channel about 750 yards east of the entrance. The north limb of this C. tree leads to a seawall on the north shore, on the Isles of Capri (CP5), and the south limb leads to a seawall on the south shore (CP4). Establish an open water protection skimmer further to the east of CPs 4 and 5. Place an open water skimmer about 600 yards up inside the north/south channel on the west side of Johnson Island (CP10). Build three sand dikes on the southern outer shore of the new recurved spit: 1) On the washover terrace south of CP1 (about 550 yards long); 2) On the washover terrace north of CP1 (about 230 yards long); and 3) On another small washover terrace 150 yards north of dike number 2 (about 75 yards long). Place protection boom in the following five areas: 1) From the southern end of Sea Oat Island around the shore to CP7 (to keep oil out of the fallen trees along the shore and off the tidal flats); 2) Around the southern shore of Johnson Island (to keep oil out of the mangroves); 3) Across the entrances to two small basins south of CP9; 4) Along the shoreline between CP3 and CP4, including across the entrance to Collier Bay; and 5) Across the entrance to the bay in the lee of the new recurved spit.

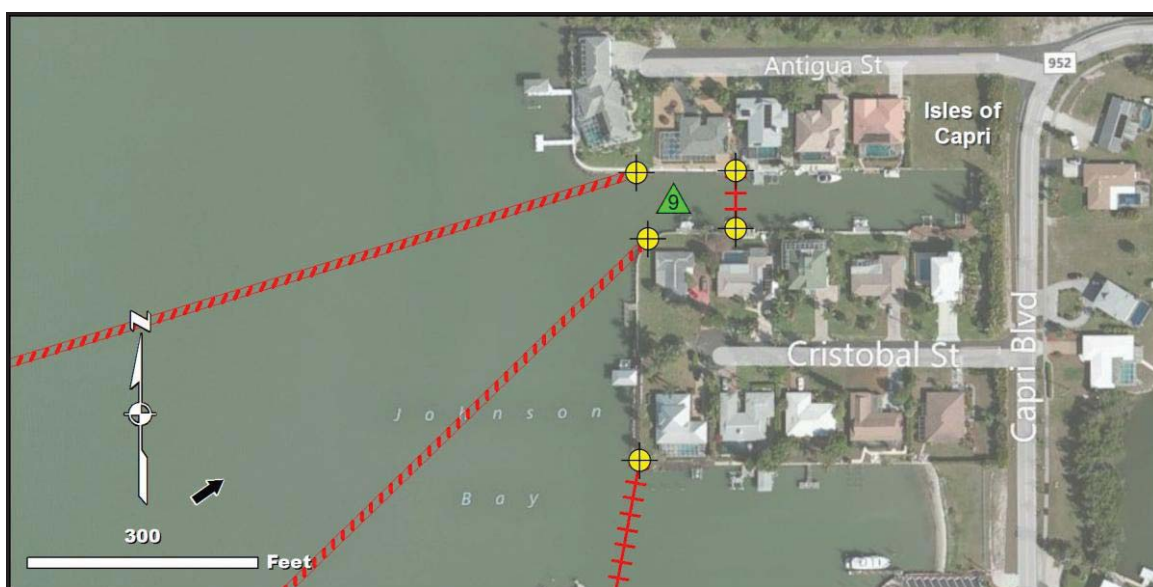
Shoreline Description: Small man-made basin surrounded by seawalls. Close the channel with protection boom a ways inside the basin.

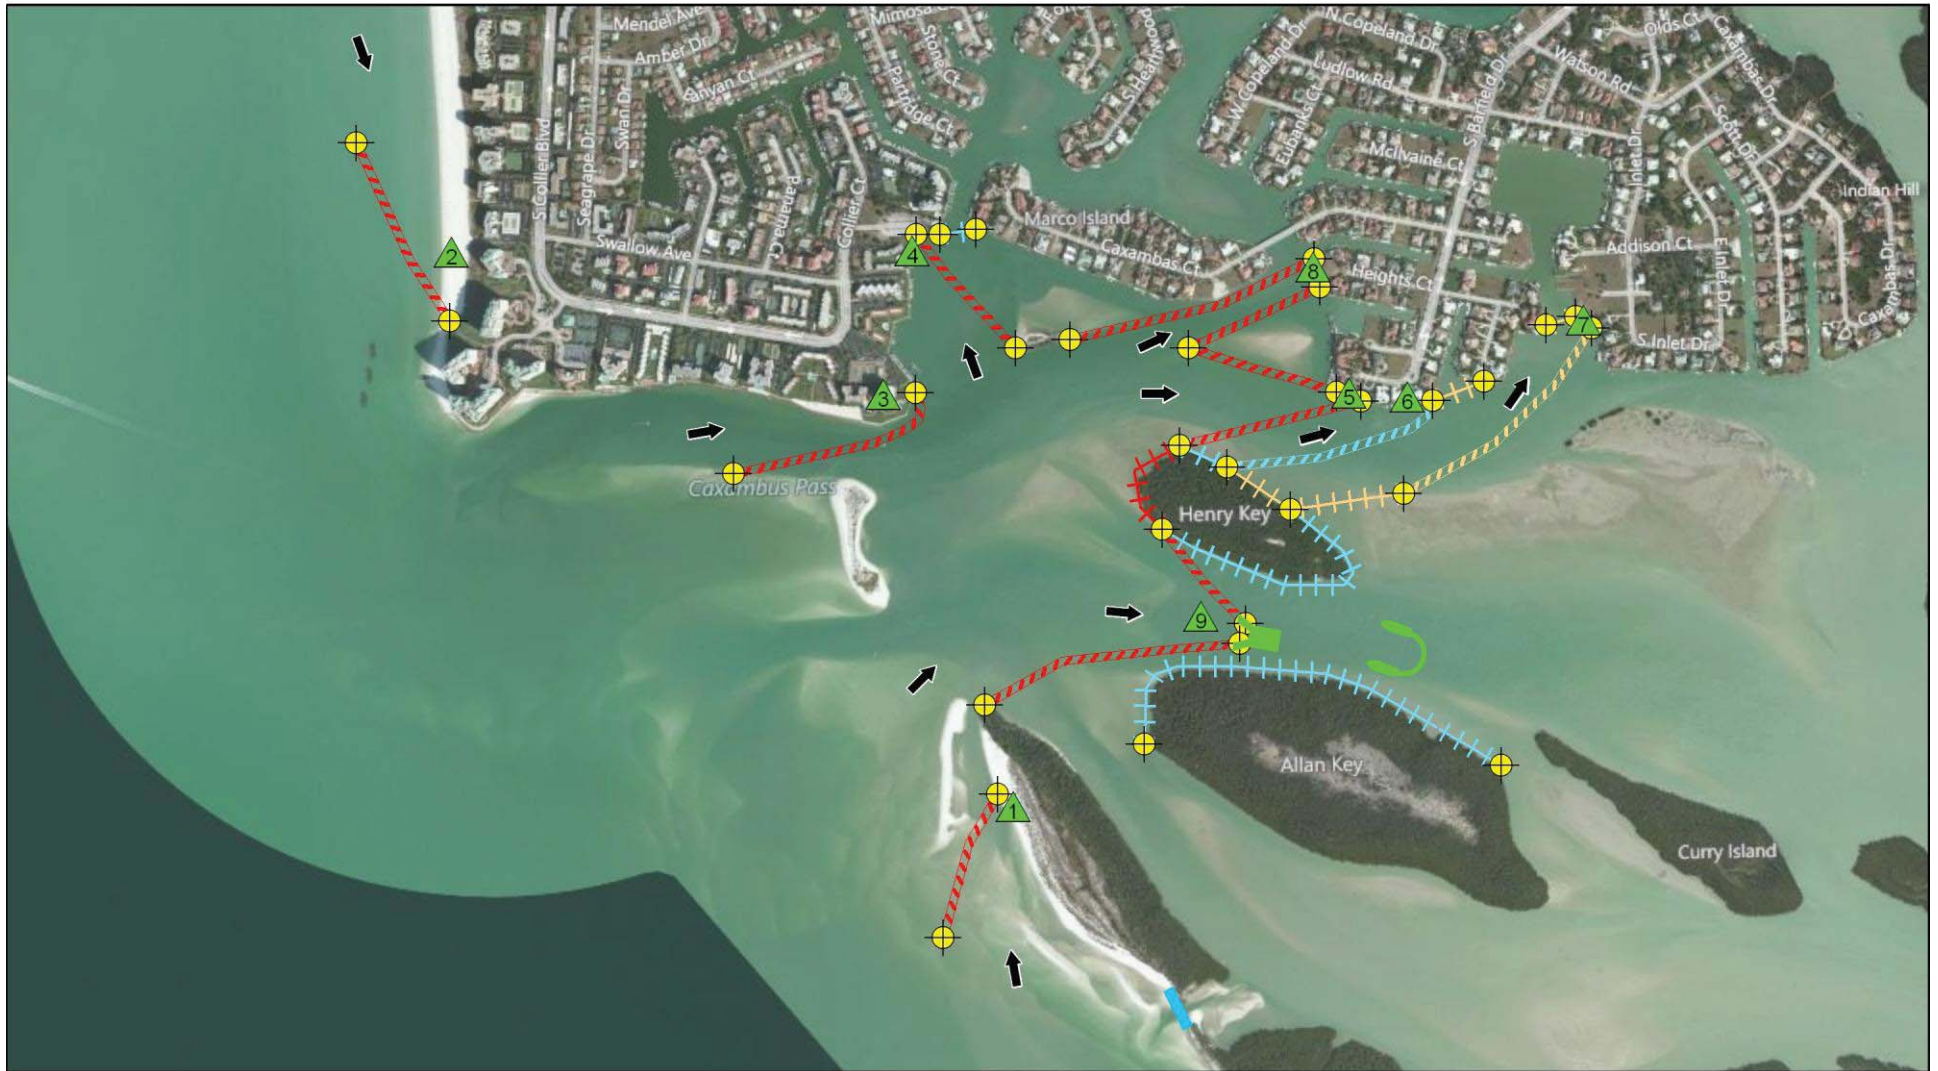
# Caxambas Pass

following five areas: 1) Around the north shore of Allan Key (to protect the mangroves); 2) All the way around the shore of Henry Key; 3) Across the entrance to the man-made canal east of CP4; 4) Across the entrance to the man-made canal east of CP6; and 5) Across the entrance to the man-made channel west of CP7. Use open water collection in Caxambas Bay. Place a sand dike across the small open inlet about 750 yards southeast of CP1.

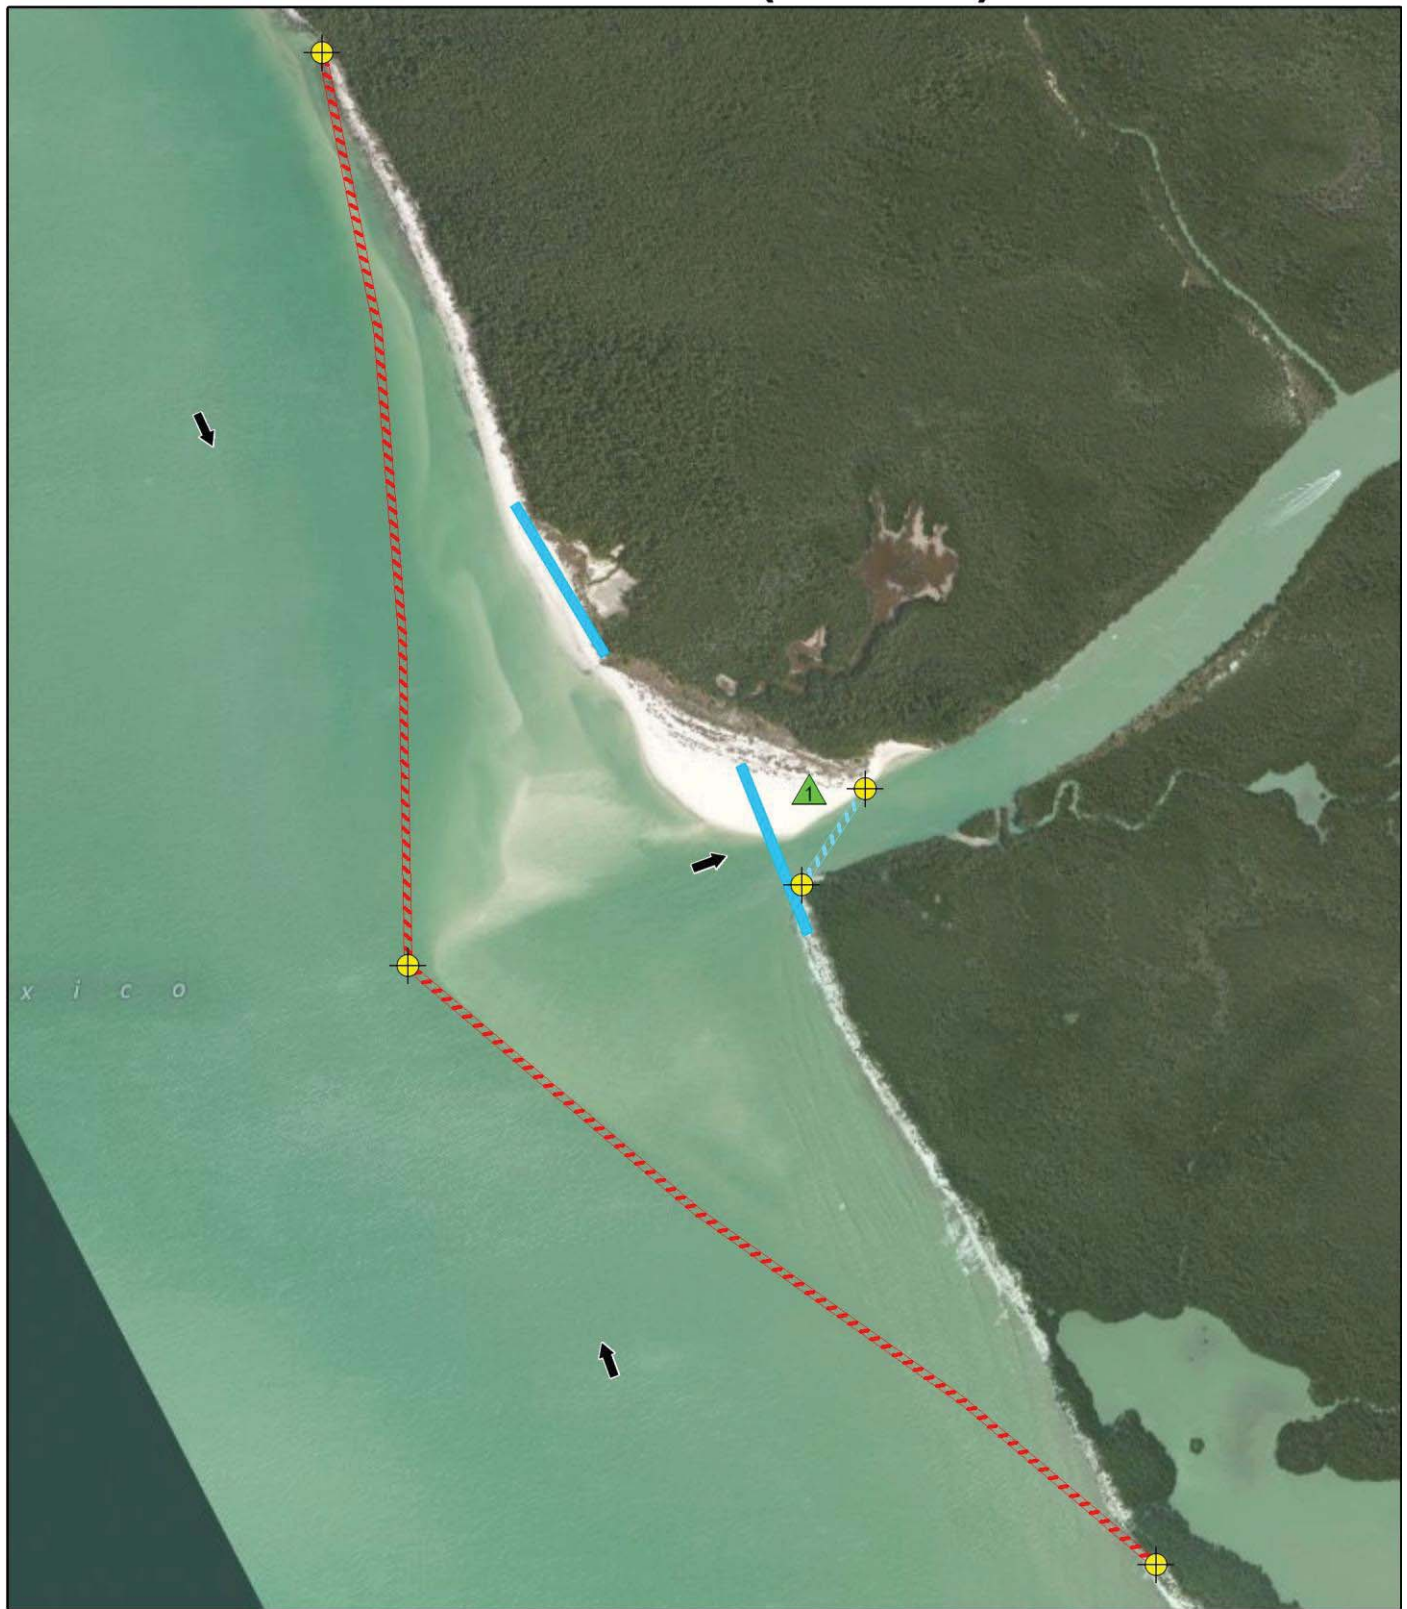
# Blind Pass (Collier)

Wave conditions permitting, anchor a Christmas tree configuration of deflection boom offshore of the small ebb-tidal delta designed to divert oil away from the inlet. This shoreline is in a constant rate of flux, so it may be quite different in the future. Ideally, the main inlet channel could be closed with a sand dike about 200 yards long. The washover terrace to the north should also be closed with a sand dike (about 130 yards long). If, for some reason this cannot be done, such as there is not enough sand available to build the dikes, place a line of deflection boom obliquely across the inlet channel so that the oil will be diverted to the sand beach on the north side of the inlet (CP1).

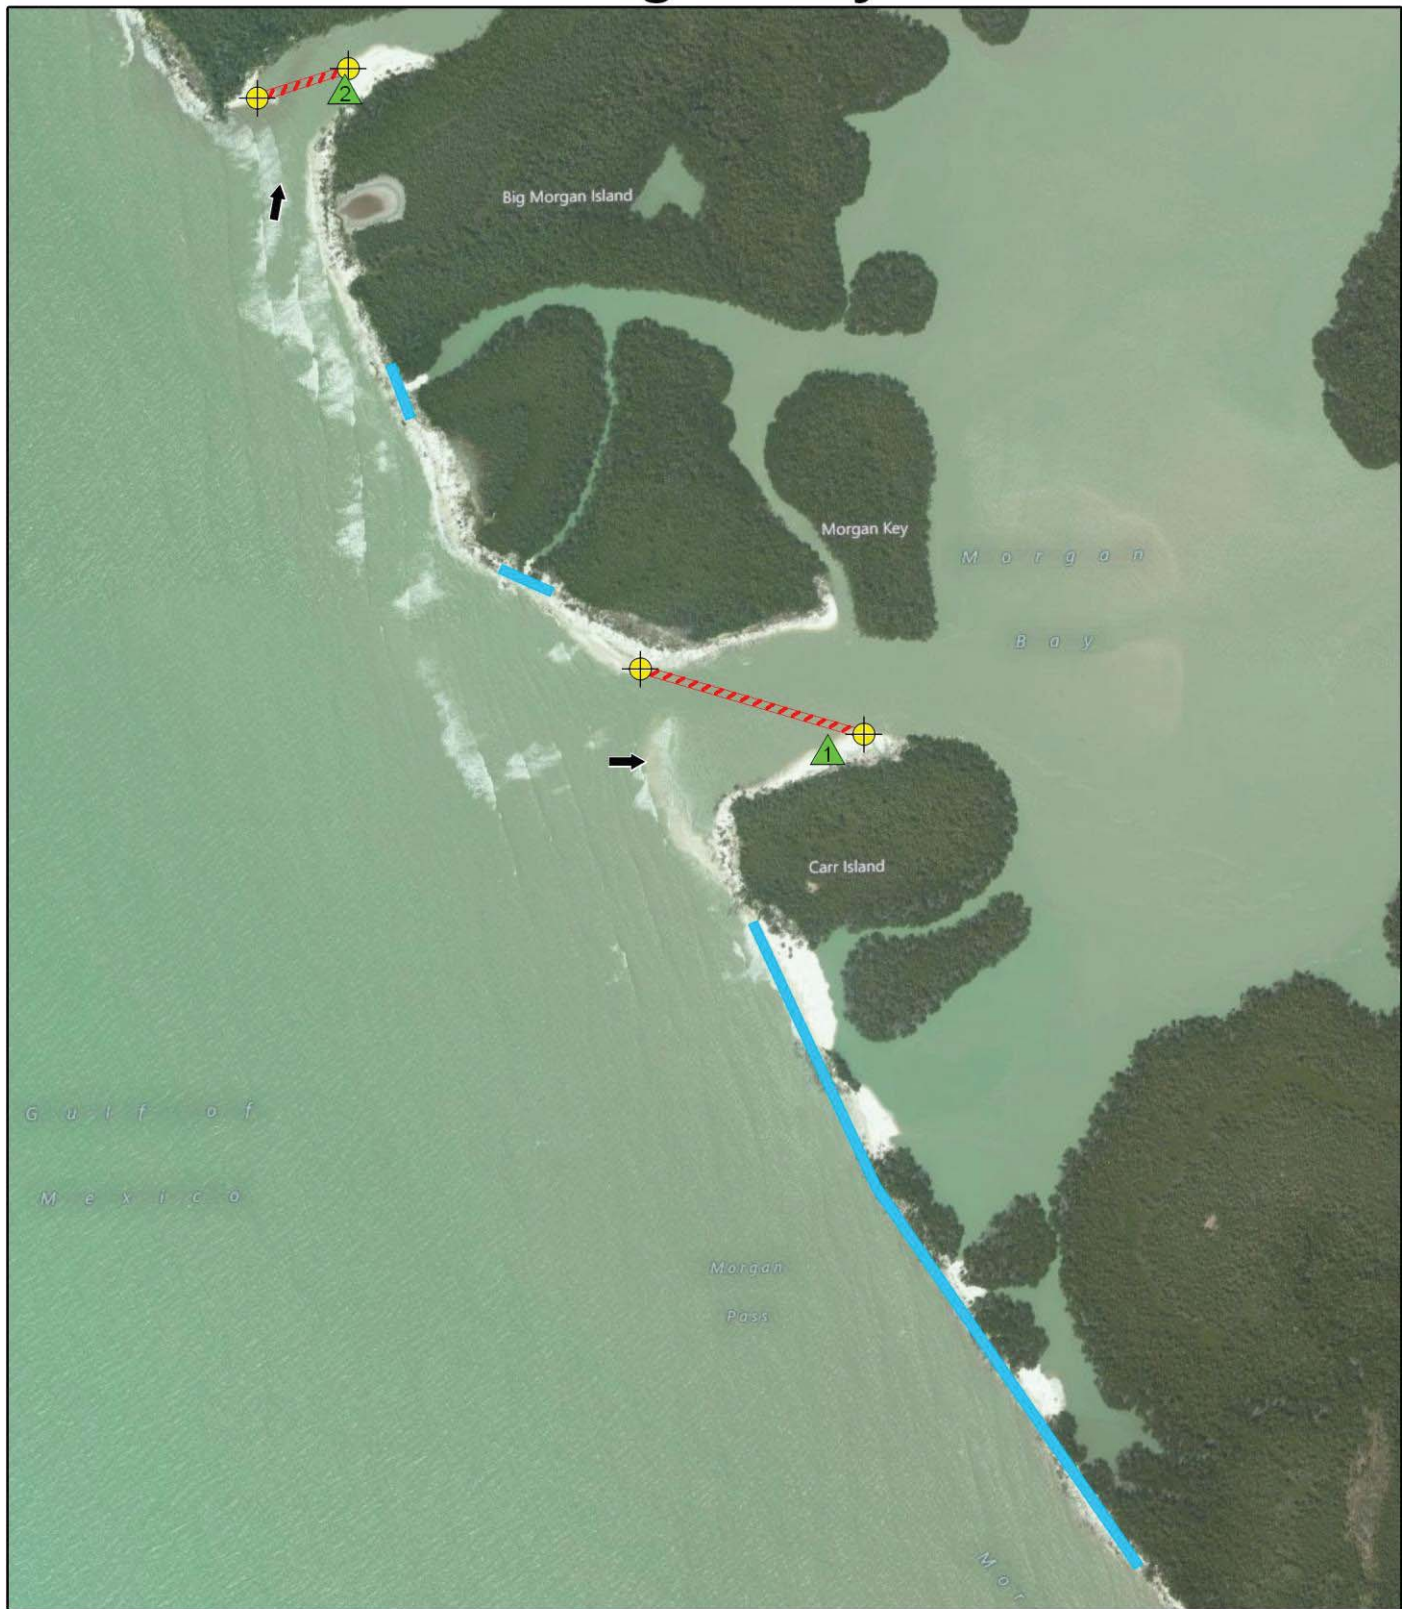
# Morgan Bay

(NOTE: We estimate that this shoreline has eroded 120 yards since 1995. Therefore, expect some major changes here.) There are two open inlets. For the inlet on the north side of Big Morgan Island, place a line of deflection boom obliquely across the inlet entrance to divert oil to the steep sand beach on the south side of the inlet (CP2). Do the same thing for the inlet between Carr Island and Morgan Key (CP1). We are proposing that sand dikes be constructed in three areas: 1) Across the washover channel in the middle of Big Morgan Island (about 40 yards long); 2) Across the washover channel about 200 yards north of the southern inlet (also about 40 yards long); and 3) Along the almost continuous washover zone to the south of Carr Island (about 680 yards long). Making these sand dikes may be a problem, because of the possible paucity of sand to build them with. Obviously, this will be a very difficult area to deal with in the event of a major oil spill.
